UPDATE Technical Bulletin

October 28, 2014

97AX UPDATE – BCM Software (NVLW)

Model(s)	Year	Engine Code	Trans. Code
Golf, GTI	2015	All	All

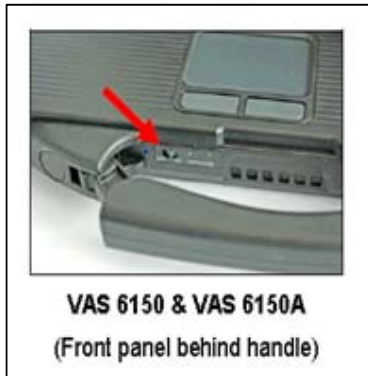
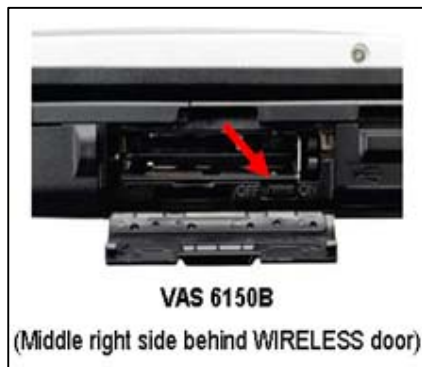
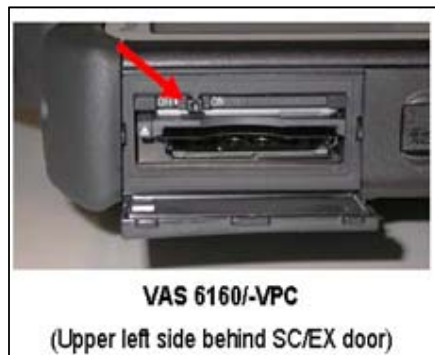
SVM Update Instructions

Warning: The Bluetooth function of the scan tool **MUST BE PHYSICALLY SWITCHED OFF** prior to performing this update.
<See pictures>

- Connect the tester to the on-line network using an Ethernet cable.
- Connect the VAS 5054A transmitter head to the VAS tester using the USB cable.
- Disable Bluetooth by physically turning the switch to the off position.

Note: If the Bluetooth wireless VAS 5054A transmitter head is used in conjunction with a VAS tester, the transmitter head **MUST BE** connected with a USB cable to the tester.
