Technical Service Bulletin

GROUP	NUMBER
BODY	23-BD-013G
DATE	MODEL(S)
AUGUST 2023	G80 (RG3)

SUBJECT: CENTER CONSOLE ARMREST STORAGE DIFFICULT TO OPEN

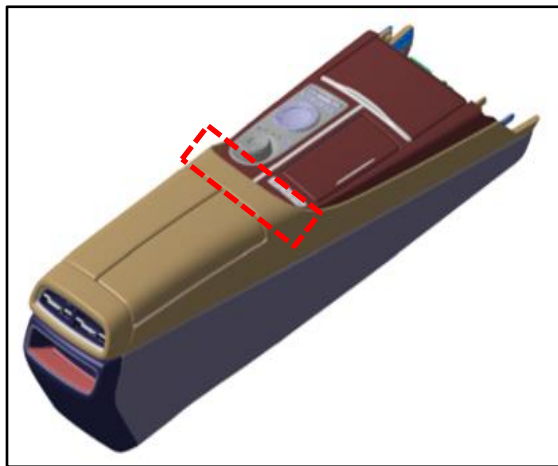
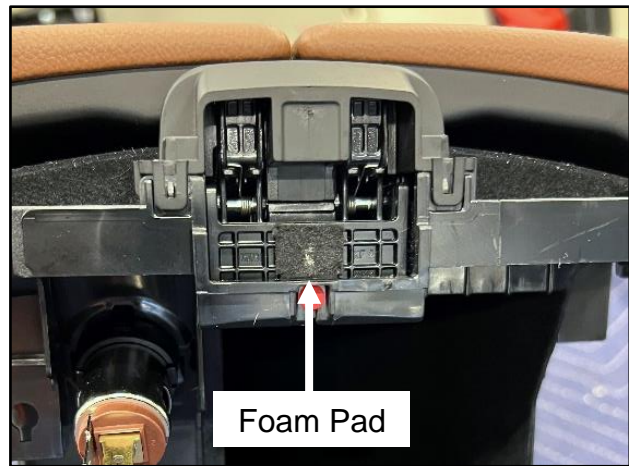
Description: This bulletin provides information to address difficulty with opening of the center console armrest storage on certain G80 (RG3) vehicles. The foam pad attached to the release button may interfere with its normal opening function. Follow the procedure in this bulletin to remove the foam pad and allow for easier opening of the center console armrest storage.
