Technical Service Bulletin

GROUP	NUMBER
CAMPAIGN	23-01-069G
DATE	MODEL(S)
AUGUST 2023	G80 Electrified (RG3 EV) GV60 (JW1 EV)

SUBJECT: DTC P1A9096 CHECK FOR ICCU & FUSE REPLACEMENT AND ICCU SOFTWARE UPDATE (SERVICE CAMPAIGN 907G)

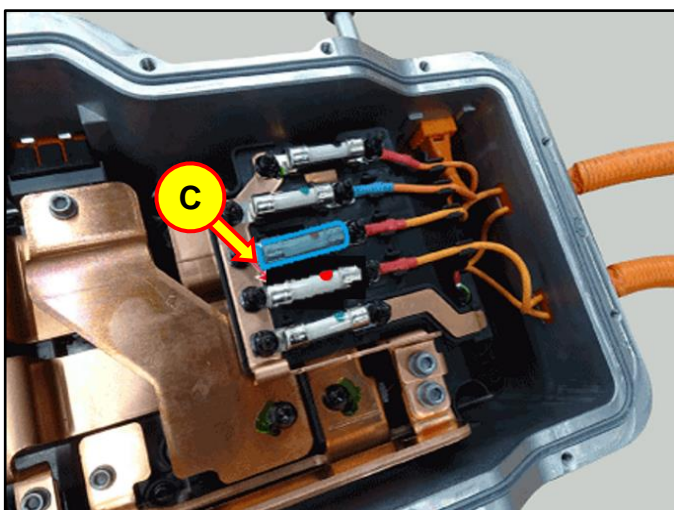
NOTICE

Any foreign substance in this area may cause poor contact between terminals.

- D4. After removing the bus bar, remove Loctite residue with a screwdriver or other tool.
