Technical Service Bulletin: TSB210154

Released Date: 22-Aug-2023

Fault Codes 3492, 319, and Real Time Clock Settings

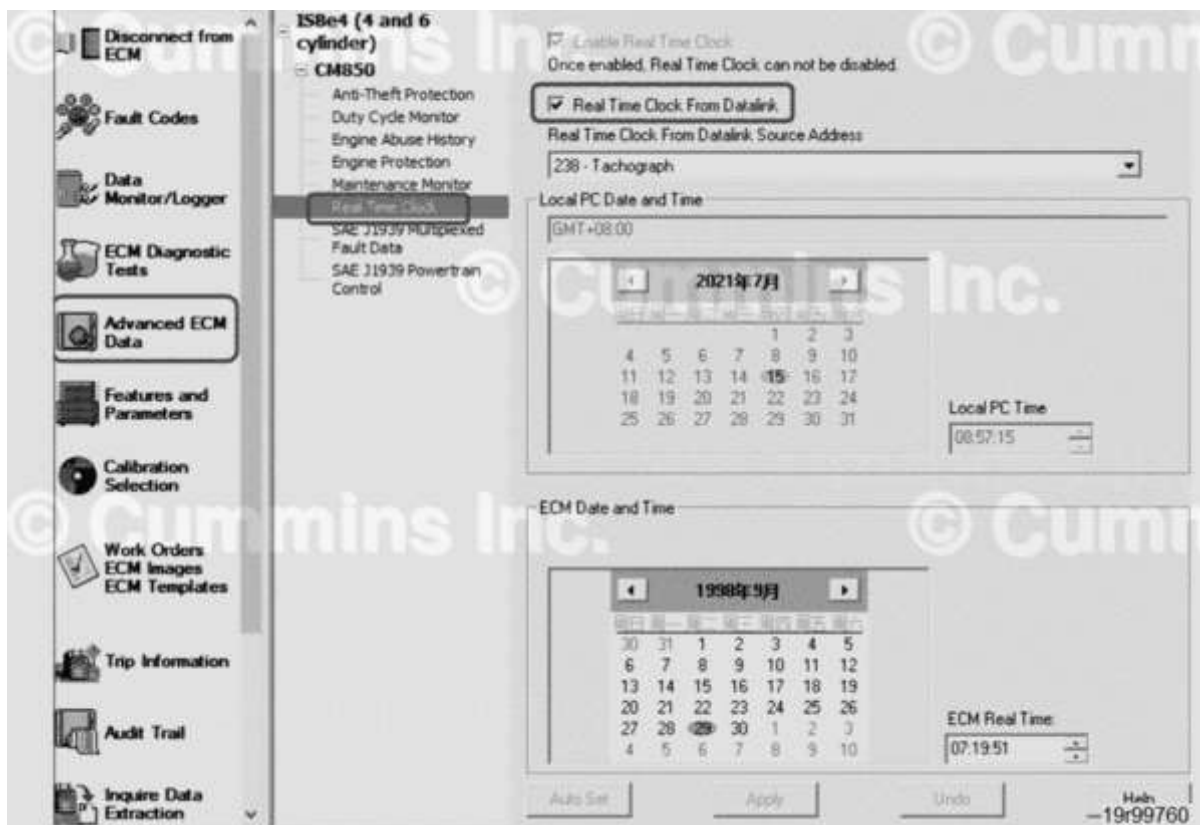
- The real time clock from the data link device is **not** accurate.

Figure 1, Verification of Real Time Clock Setting.

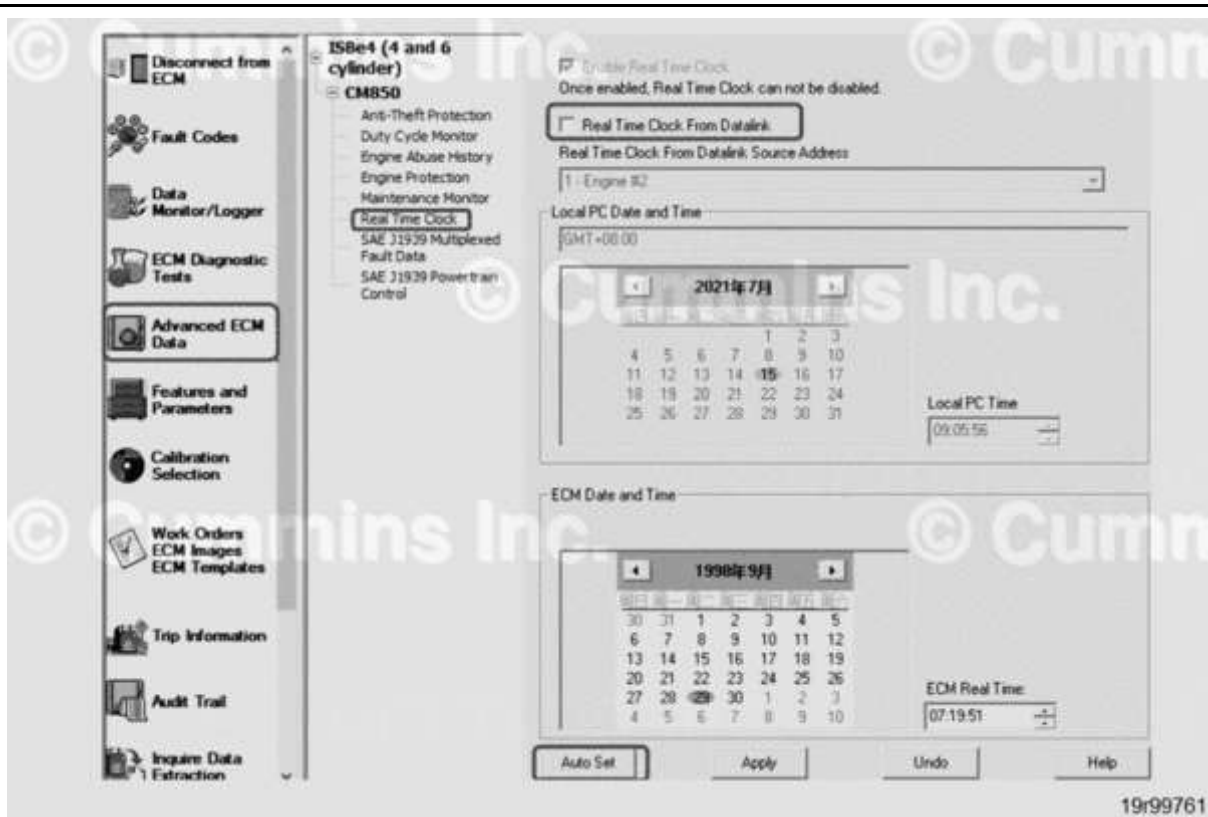
Figure 2, Example of Equipped Real Time Clock Battery.

- If equipped the real time clock battery, cancel the real time clock from datalink and use the recommended Cummins® electronic service tool to set the ECM date and Time to Local PC Date and Time. See corresponding Service Manual. Reference Procedure 019-311 in Section 19.

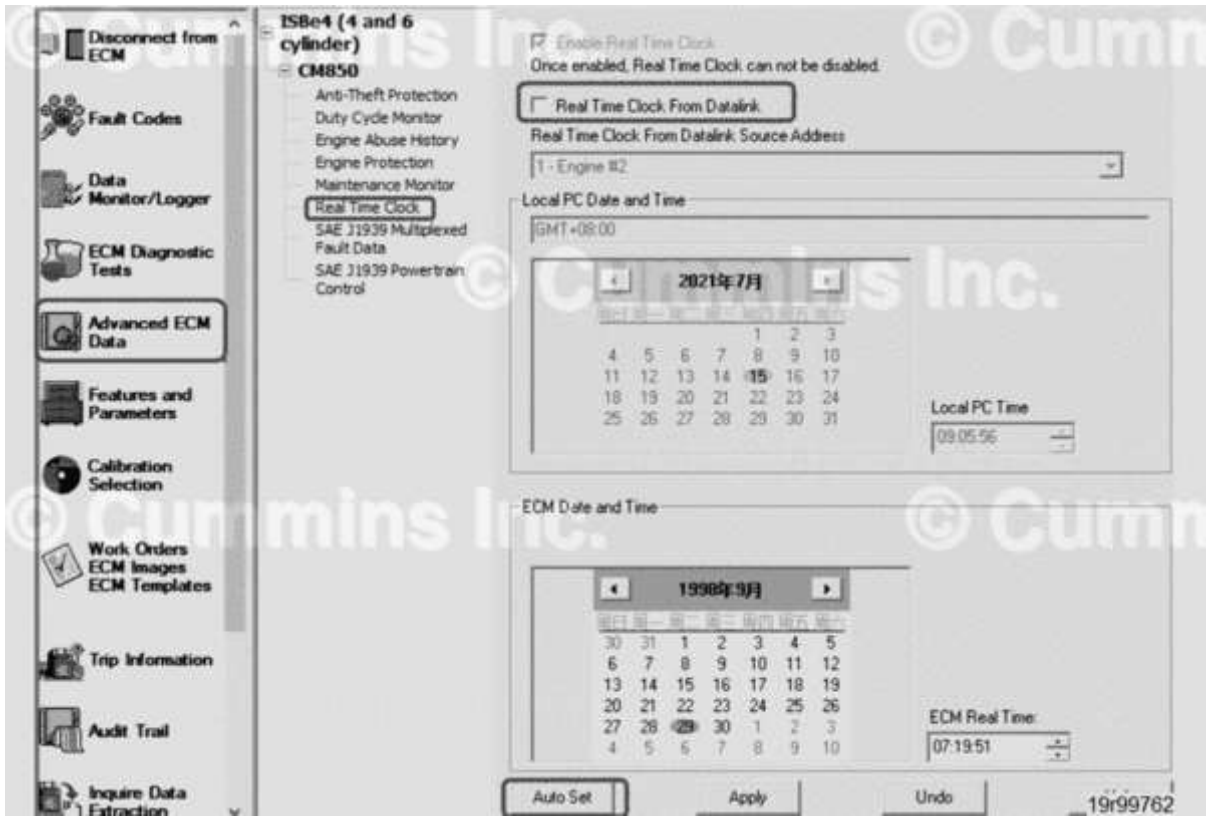
Figure 3, Example Without Real Time Clock Battery or Battery Disconnect Switch.

- If the engine is **not** equipped with the real time clock battery, and is **not** equipped with the battery disconnect switch (see equipment manufacturer service information to verify); cancel the real time clock from datalink and use the recommended Cummins® electronic service tool to set the ECM date and Time to Local PC Date and Time.
