Service Bulletin

Bulletin No.: 21-NA-271

Subject: Information on Malfunction Indicator Lamp (MIL) Illuminated - DTC P026A Set

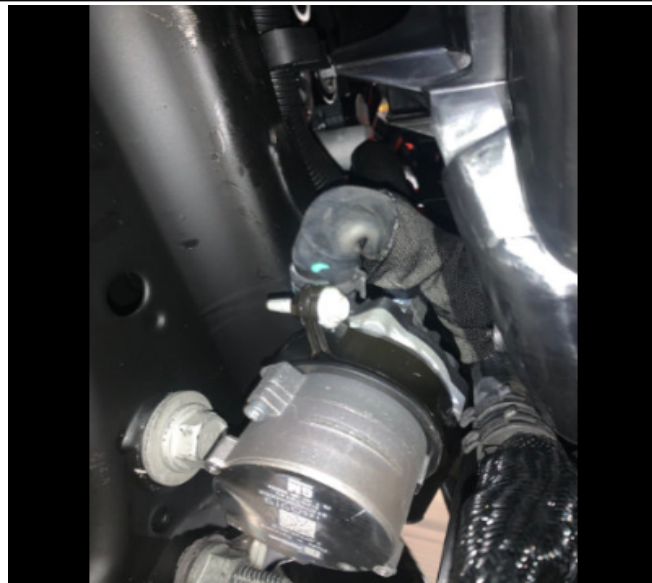
5635568

Involved Region or Country	North America, Uzbekistan, Russia, Middle East, Chile, Columbia, Ecuador, Paraguay, Peru, Uruguay, Japan, S. Korea, Thailand, Australia, New Zealand, Europe.
Condition	Some customers may comment that the MIL is illuminated. Some technicians may find DTC P026A set in the Engine Control Module (ECM).
Cause	This may be due to a kinked hose at or near the low temperature auxiliary coolant pump.

If this condition is encountered, loosen the hose clamp and rotate the hose to allow for proper coolant flow.
