Technical product information

Topic	Coolant pump leaking (part number 07P 121 008C) - Low coolant warning - Engine overheating - DTC's evident
Market area	Australia E04 Bentley rest Asia and Australia (6E04),China 796 VW Import Comp. Ltd (Vico), Beijing (6796),Germany E02 Bentley rest Europe (6E02),Japan E03 Bentley Japan (6E03),Korea, (South) E08 Bentley South Korea (6E08),United Arab Emirates E06 Bentley Middle East and Africa (6E06),United Kingdom E01 Bentley UK (6E01),United States E05 Bentley USA and rest America (6E05)
Brand	Bentley
Transaction No.	2071239/1
Level	EH
Status	Approval
Release date

W12 Bentayga - New Continental GT/GTC - New Flying Spur

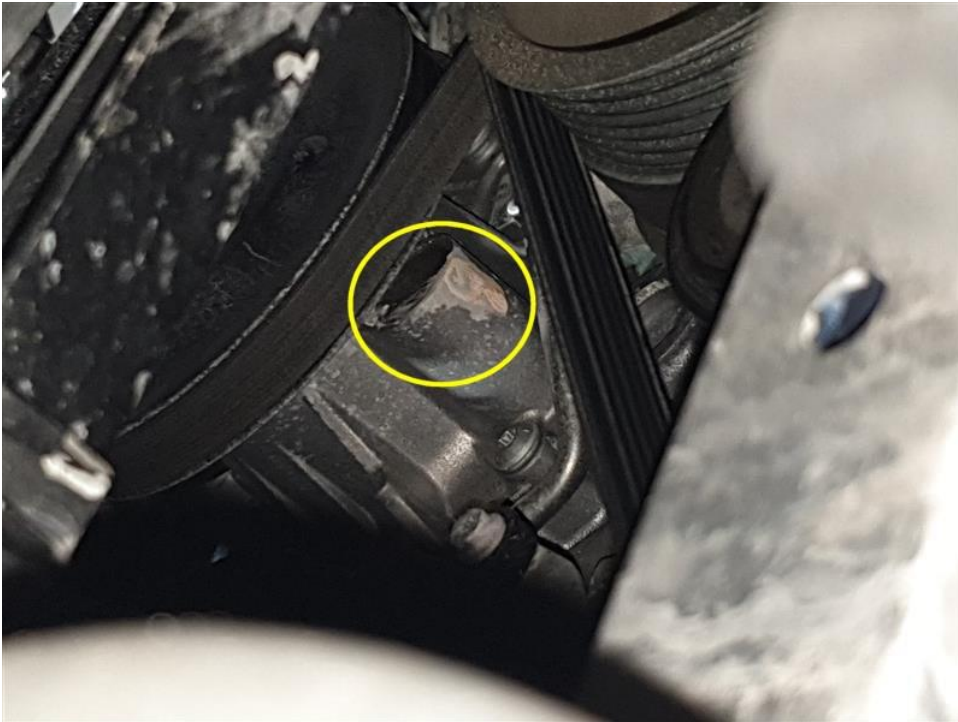
Figure 1

- Refer to the video located within the Bentley Hub reference TPI 2071238/- the video shows an example of a coolant pump with no leak although a small coolant witness mark is evident (Figure 1) in this scenario the coolant witness mark should be cleaned off (using a suitable cleaning agent) to the condition shown in Figure 2

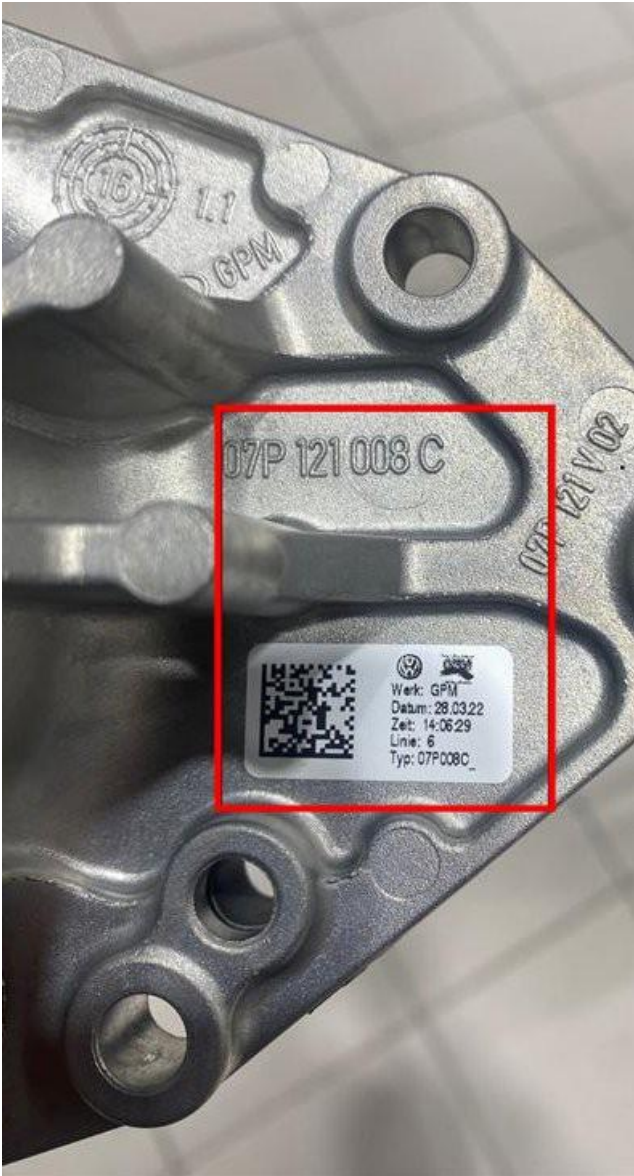
NOTE: The photo shown in Figure 4 is a C level coolant pump (shown removed from the vehicle for photographic purposes) a borescope may have to be used for photographs of the coolant pump when fitted

6) Once permission has been given via the technical DISS query, replace the following

- Mechanical coolant pump - Rep.Gr 19
- Solenoid for coolant circuit N492 assembly - Rep.Gr 19
