Description: This bulletin provides instructions on how to service the panoramic sunroof on certain G80 (RG3) vehicles that experience creaking or rattling noises while driving on uneven roads.

2021 - 2023MY G80 (RG3) vehicles produced from 07/25/2020 - 04/06/2023

TSB #: 23-BD-014G Page 2 of 12

PANORAMIC SUNROOF NOISE REPAIR

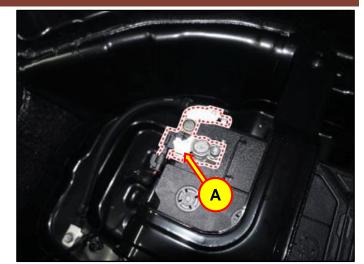
Disconnect the negative (–) battery terminal (A).

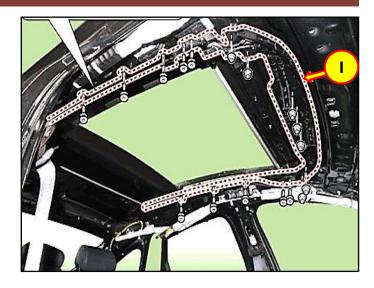
11. Remove the lower mounting bolts and nuts of the sunroof mechanism rail assembly (I).

Be careful not to damage the Torx bolts and nuts as they will be reused.

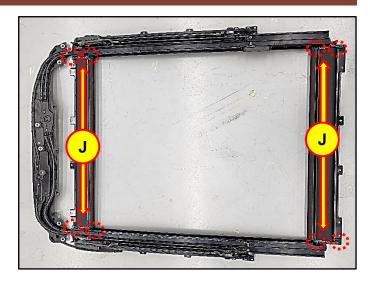
13. Remove the upper bolts (J) of both roller blind support brackets.

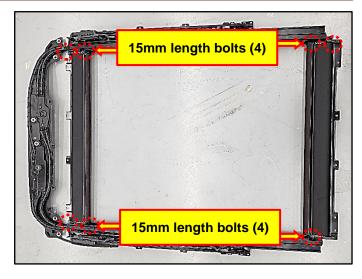
15. Reinstall both roller blind support brackets onto the sunroof mechanism rail assembly.

Use the new bolts when reinstalling both roller blind support brackets. **DO NOT** reuse the previous bolts.

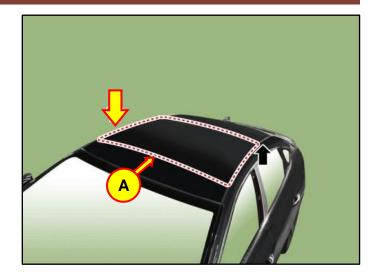
17. Ensure the sunroof movable glass (A) is properly aligned after reinstallation.
