GEARBOX FAULT DETECTED ON INSTRUMENT CLUSTER

Jaguar

- 19-21 I-PACE

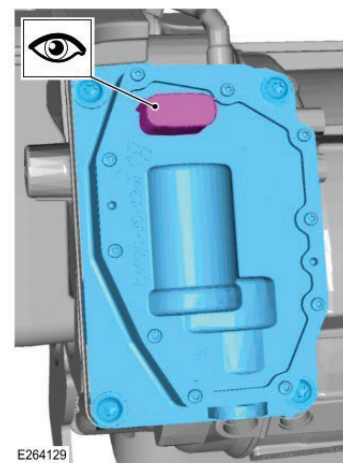
E256857

- No retention to the front Electric Drive Unit (EDU) causing strain on the wiring going to the EDU parking lock actuator connector (C1YE113A)..

- Possible DTC's could be stored:
 - P07E4-00
 - P272C-13
 - P303F-15
 - P303F-29
 - P07E6-00
 - P272C-11.
- Make sure any required FRED submissions are completed before installing a new front compartment wiring harness.
- Inspect the electrical connector pins of the EDU parking lock actuator for signs of water ingress or corrosion.
- Refer to JLRTB02012NAS5 - 'Gearbox Fault Detected' Displayed On The Instrument Panel Cluster (IPC)
