JLRTB02052NAS3

TECHNICAL BULLETIN

Rear Doors Difficult To Open

MODEL:	MODEL YEAR:	VIN:	ASSEMBLY PLANT:	APPLICABILITY:
Defender (LE)	2020 Onwards	000431 Onwards	Nitra (Slovakia)	5-Door

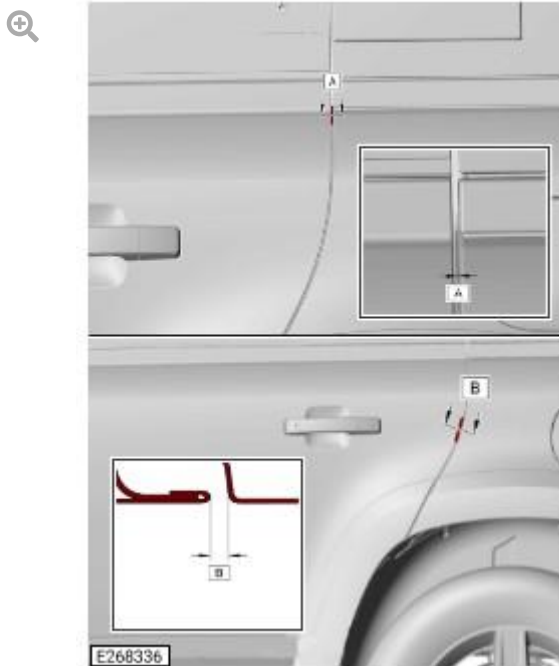
Check the alignment of the rear door(s) in the areas shown in the illustration.

SECTION	DESCRIPTION	GAP	PROFILE
A	Rear door to rear quarter	N/A	0.0 ± 0.5 mm
B	Rear door to rear quarter	3.5 ± 0.7 mm	0.0 ± 0.7 mm

Only adjust the rear doors that are either out of alignment tolerance or do not have a gap of 2.8 mm.

Adjust the rear door(s) to be as far rearward as possible while still being within tolerance, the gap must be 2.8 mm (see TOPIx Workshop Manual section 501-26: Body Repairs: Vehicle Specific Information and Tolerance Checks - General Procedures - Rear Door Alignment).

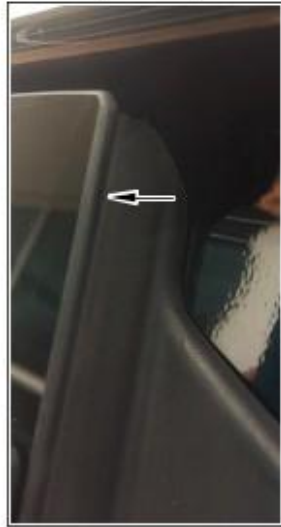
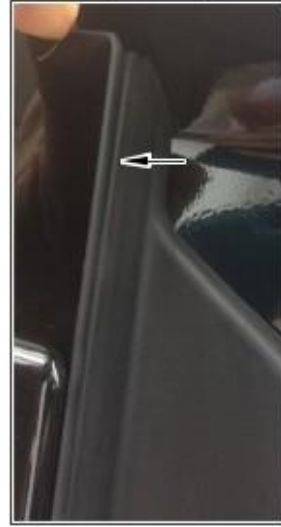
E268337

C-pillar exterior finisher trim to rear quarter window alignment incorrect.

The image with the **RED 'X'** shows the C-pillar exterior finisher trim installed incorrectly behind the rear quarter window.

The image with the **GREEN '✓'** shows the C-pillar exterior finisher trim installed correctly with a 1-1.5 mm protrusion from the rear quarter window.

Install the new C-pillar exterior finisher trim.

- Remove the adhesive tape backing.
- **Make sure the C-pillar exterior finisher trim protrudes 1-1.5 mm away from the rear quarter window, as shown in the illustration, before fully securing.**
