Traces of Coolant Close to the Coolant Reservoir or Under the Vehicle (241/22)

Model Line: **718 Boxster (982) / 718 Cayman (982)
911 (992)**

Model Year: **As of 2022**

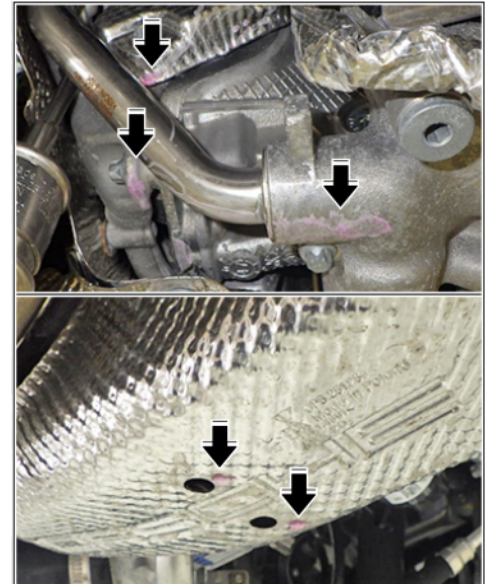
Coolant leaking in this area ⇒ *Traces of coolant -Arrows-* is often due to a correct release of excess pressure through the cap.

This can occur, for example, due to heat or strong movement of the vehicle during loading and transportation on a ship. For this reason, some of the incidents are already noticed during the handover inspection as part of the sales check.

Traces of coolant

Action required: If traces and residues of coolant can be seen, then the cooling system must be checked before replacing the cap or the coolant reservoir and other components. For work procedure, see: ⇒ *Workshop Manual '190101 Checking cooling system'*

If the leak test shows no leakage from the cooling system, remove any coolant residue with a clean cloth. These traces and residues of coolant do not constitute a defect with regard to the tightness of the cooling system and do not entitle the user to replace the sealing cap and/or the coolant reservoir.
