VOLUNTARY SERVICE CAMPAIGN

Classification: RS23-006	Reference: NTB23-066	Date: August 15, 2023
-----------------------------	-------------------------	--------------------------

VOLUNTARY SERVICE CAMPAIGN 2020-2023 TITAN; AIR BAG CONTROL UNIT REPROGRAM

CAMPAIGN ID #: PC977
APPLIED VEHICLES: 2020-2023 Titan (A61)

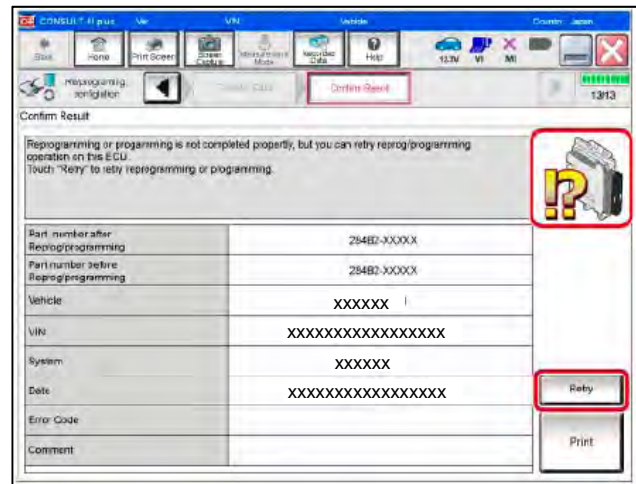
Figure 22

If reprogramming does not complete and the “!?” icon displays as shown in Figure 22:

- Check battery voltage (12.0–15.5 V).
- Ignition is ON, engine OFF.
- External Bluetooth® devices are OFF.
- All electrical loads are OFF.
- **Select retry and follow the on screen instructions.**
- “Retry” may not go through on first attempt and can be selected more than once.

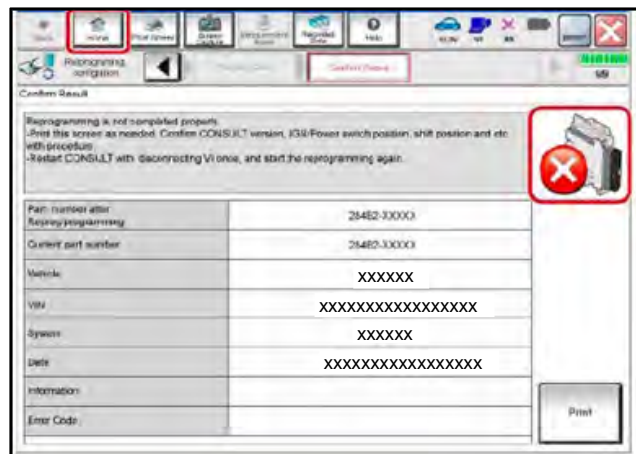
Figure 23

If reprogramming does not complete and the “X” icon displays as shown in Figure 23:

- Check battery voltage (12.0–15.5 V).
- CONSULT A/C adapter is plugged in.
- Ignition is ON, engine OFF.
- Transmission is in Park.
- All C-III plus / VI cables are securely connected.
- All C-III plus updates are installed.
- **Select Home, and restart the reprogram procedure from the beginning.**
