TECHNICAL SERVICE BULLETIN

| Classification: BT23-013 | Reference: NTB23-069 | Date: August 30, 2023 |

FRONT PASSENGER INSTRUMENT LOWER COVER FITMENT

APPLIED VEHICLES: 2023 ARIYA (FE0)
APPLIED DATES: Built on or before June 13, 2023

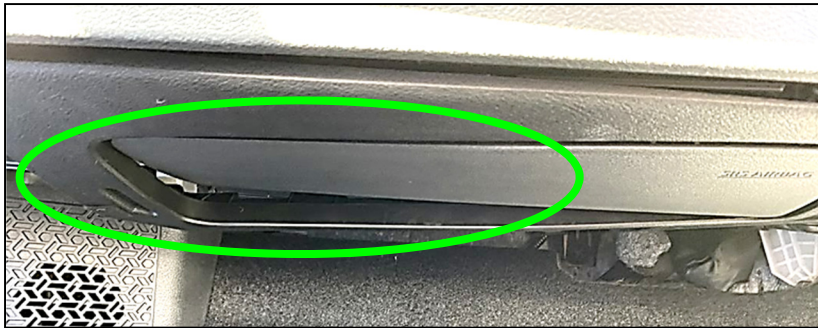
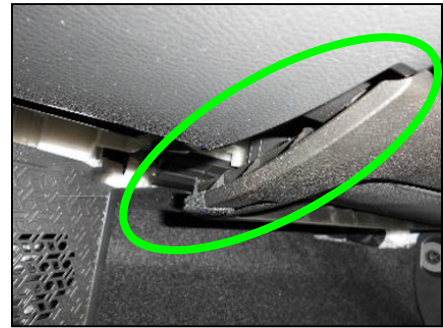
Figure 1

The front passenger (RH) side instrument lower cover hangs low causing poor fitment and appearance (Figure 1 and Figure 2).

Follow the **SERVICE PROCEDURE** on page 2 to trim the instrument lower cover for proper fitment.
