Service Bulletin

Bulletin No.: 19-NA-129

Subject: Squeak and/or Clunking Noise from Rear of Vehicle

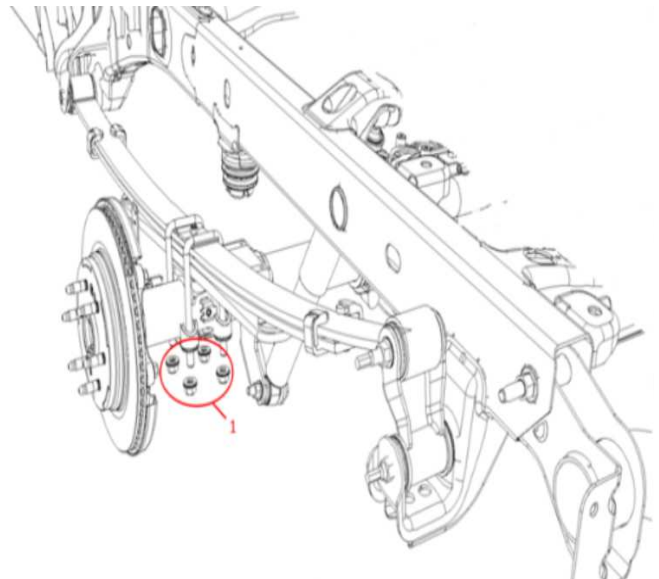
5357922

Caution: Ensure that the proper torque procedure for the U-Bolts is followed in SI. Excessive fastener torque will extrude, and damage, the spring isolators making the condition worse.

2. Loosen the anchor plate U-bolts (1).

3. Re-torque the anchor plate U-bolts (1). Refer to Fastener Specifications in SI.
4. Repeat steps 2 and 3 for the opposite side leaf spring.
5. Re-test the vehicle for the same clunking noise. If the issue remains, follow the regular repair procedure.
