Service Bulletin

Bulletin No.: 19-NA-167

Subject: Water Leak into Interior and/or Various Electrical Concerns, Wind Noise, Liftgate Actuator Noisy or Inoperative

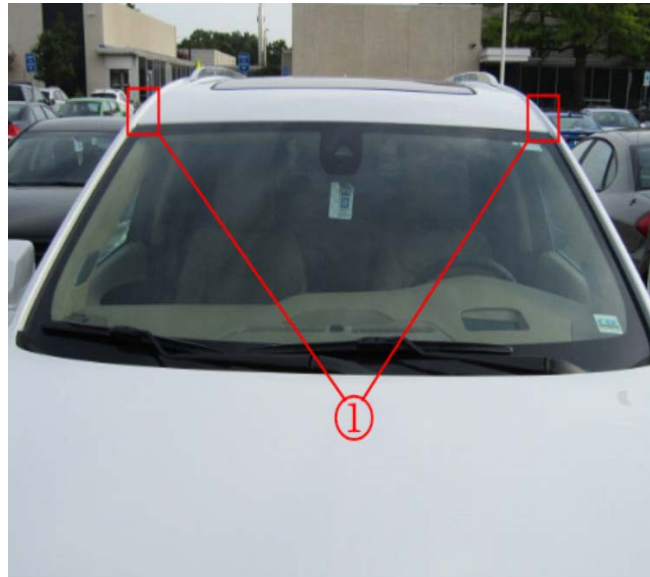
5379776

The cause of the condition may be possible "pin hole" voids in the roof panel to outer ring laser braze and seam sealer. The pin holes are most commonly found near the top of the windshield at the A-pillars, or the top of liftgate near the D-pillars. Examples of the leak areas are shown below.

Possible Front Laser Braze Water Leak Areas (1)

1. Visually inspect the front right and left roof laser braze, then the rear right and left roof laser braze, for pin holes or a crack.
2. Seal the holes/crack in any laser braze area following the steps below:
 - 2.1. Mix a small amount of Kent® High-Tech Seam Sealer Clear P10200, or Wurth Euroseal Gel Clear 18920104, or equivalent WITH the proper touch-up paint color.
 - 2.2. Avoiding excess sealer build up within the ditch, work a small amount of the sealer into the hole with a gloved finger.
 - 2.3. Wipe away any excess sealer with a light amount of solvent on a rag or paper towel. The solvent will help the sealer flow into the hole/crack.
3. Clean and dry any wet trim. Refer to *Floor Carpet Drying* in SI.
4. Address and repair any electrical concerns as necessary.

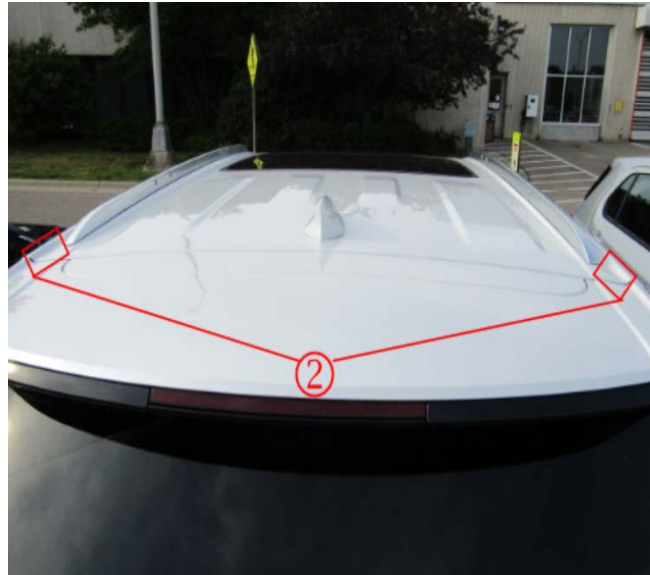
5379781

Possible Rear Laser Braze Water Leak Areas (2)

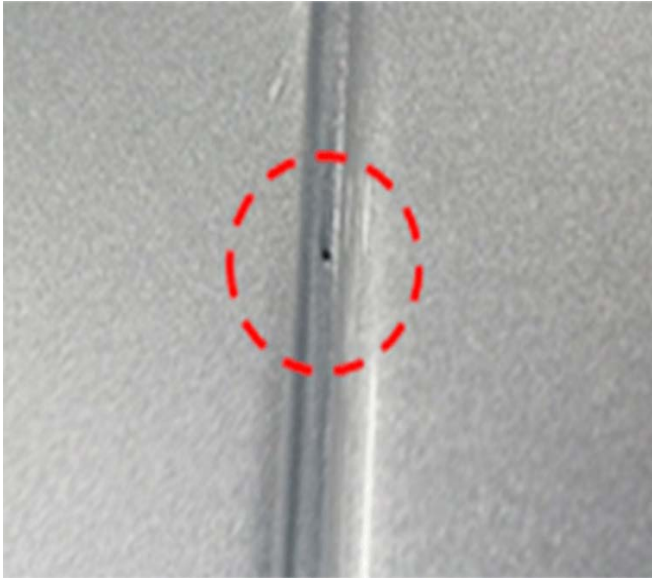
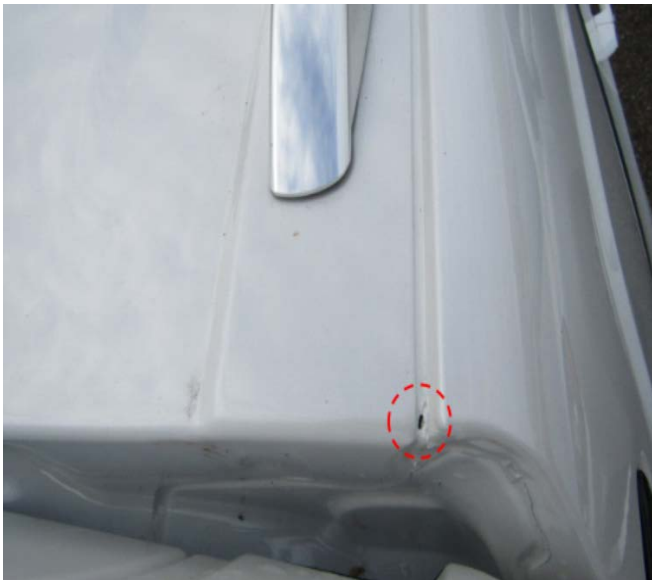
Note: The pin holes/cracks may be more difficult to see on darker color finishes. A front and rear example of a visible pin hole are shown in the graphics above.
