Service Bulletin

Bulletin No.: 23-NA-082

Subject: Information for Vehicles Having Rear Park Assist Button But Rear Park Assist Does Not Function

Brand:	Model:	Model Year:		VIN Breakpoint:		Engine:	Transmission:
		from	to	from	to		
Chevrolet	Blazer	2023	2023	—	—	—	—

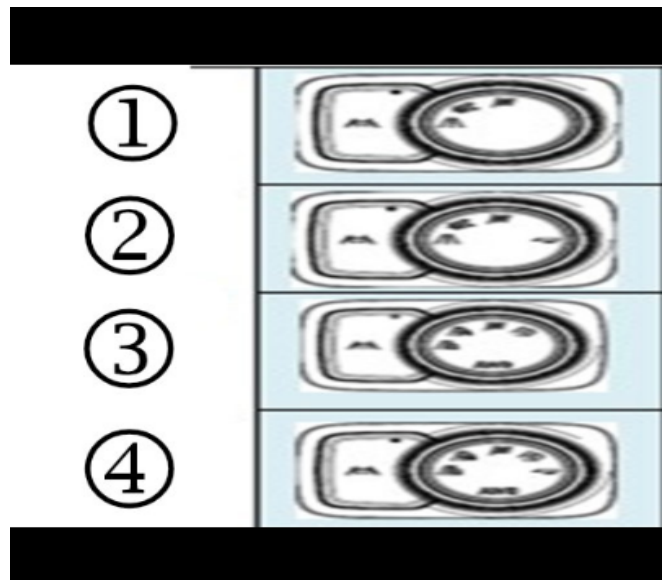
6328900

Involved Region or Country	Middle East, Israel, Chile, Colombia, Aruba, Cayman Islands, Costa Rica, Curacao, St Martin, Honduras, Nicaragua, North America
Additional Options (RPOs)	Equipped with PARK ASSIST-REAR, LANE ACTIVE SAFETY-KEEP ASSIST, DELETE CODE PARK ASSIST (RPOs UD7, UHX, 060)
Condition	Some customers may comment on having a rear park assist button, but the rear park assist does not function.
Cause	The condition is due to a design change to remove the rear park assist system completely with NO retrofit. The 2023 Blazer will never have a functional rear park assist system even though some vehicles were built with a ride control switch that still contains the rear park assist button on it. Note: This button DOES NOT function and has NO effect on how the vehicle operates.
Correction	If the customer desires to have the correct ride control switch without the rear park assist button, replace the ride control switch.

Remove the front floor console trim to remove the ride control switch. Refer to *Front Floor Console Trim Plate Replacement* in SI.
