Service Bulletin

Bulletin No.: 23-NA-115

Subject: Ticking, Tapping or Snapping Noise from Engine - 5.5L RPO LT6 Realign Camshaft Caps as Required

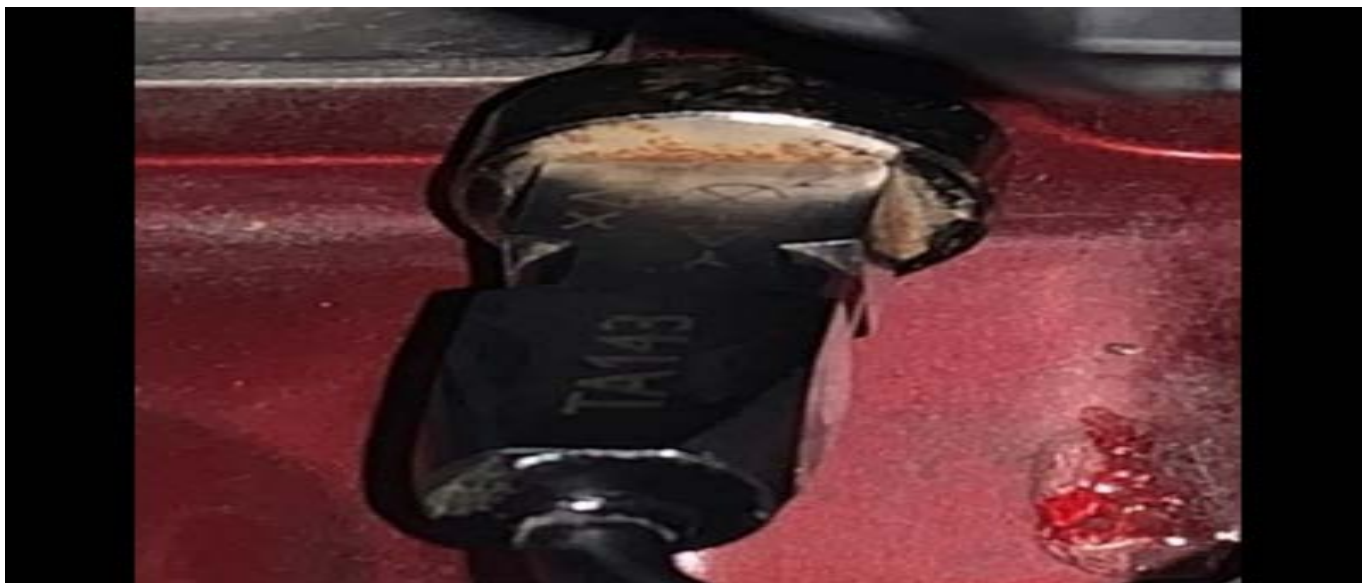
6374737

- ⇒ With the suspect bank determined, prep/position the accelerometer so the X, Y, Z coordinate system (that's laser etched) is facing upwards before securing to the bolt head. After accelerometer is placed on bolt head, double check to ensure its centered and did not rotate on the bolt head. Doing so will ensure the best results.

Important: Ensure accelerometer coordinates are facing up towards the intake.

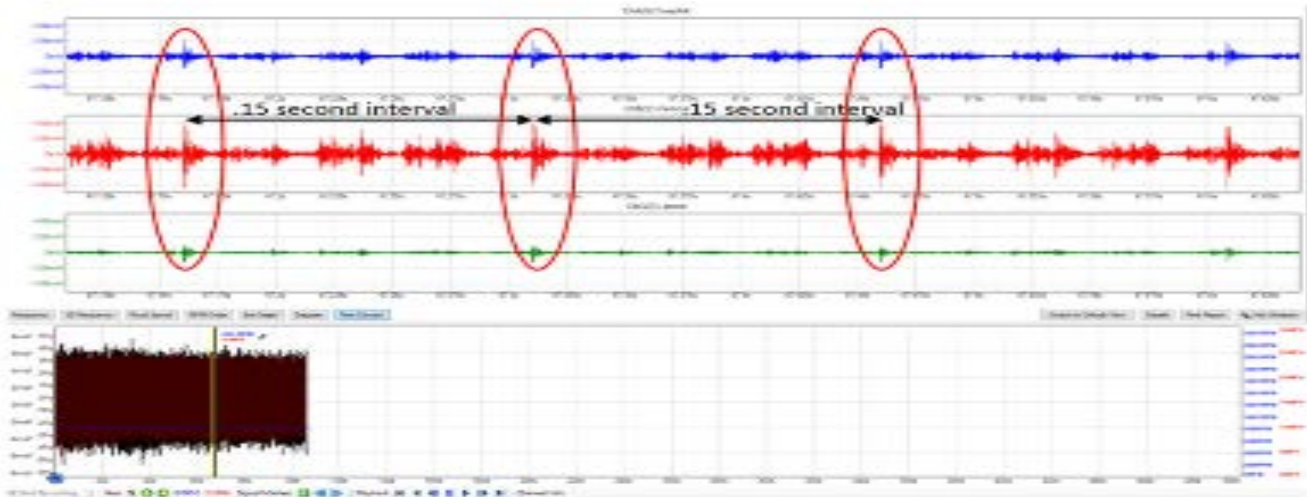
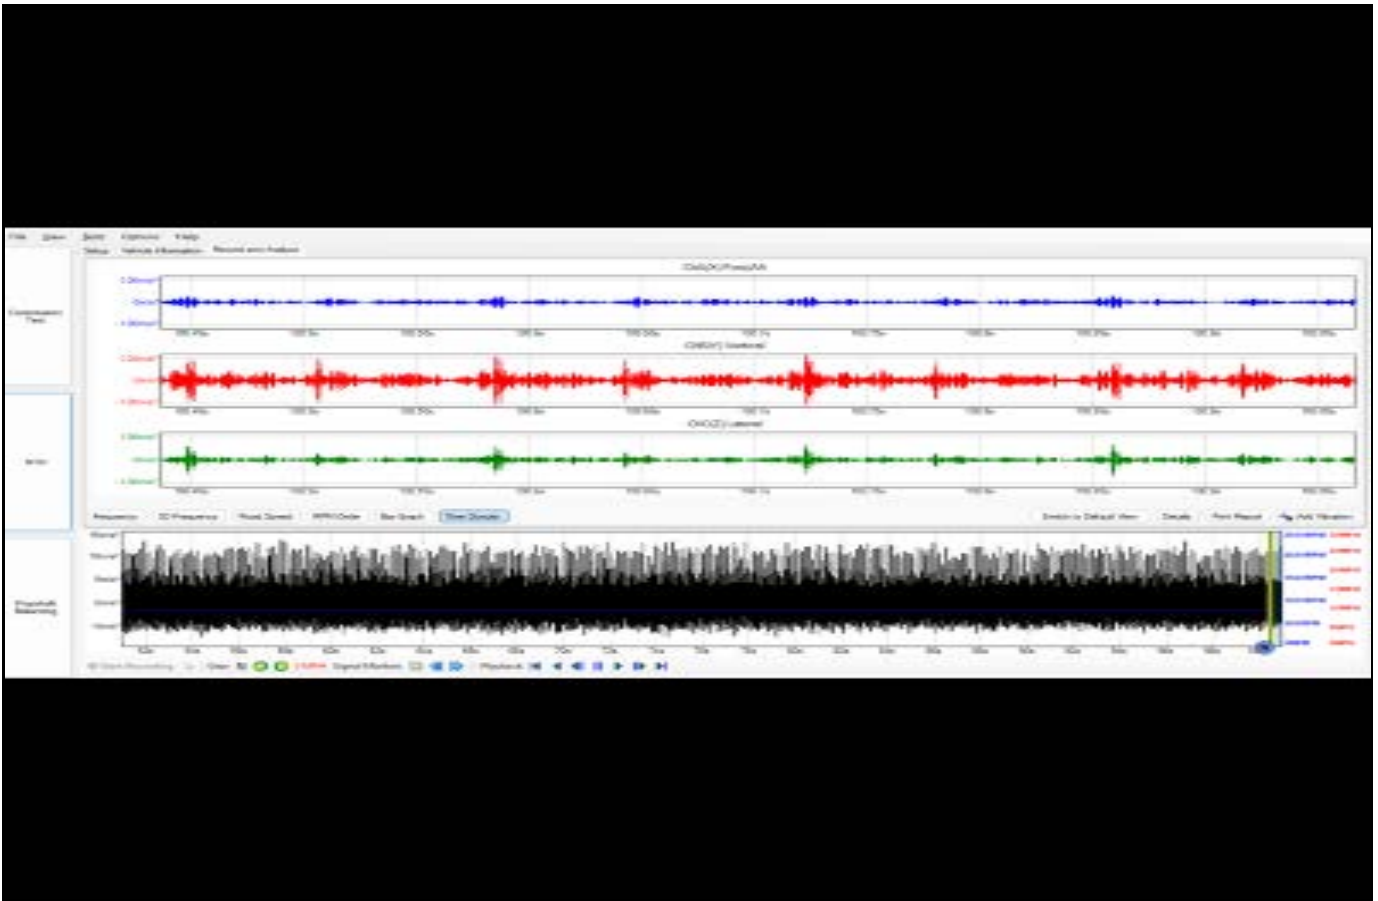
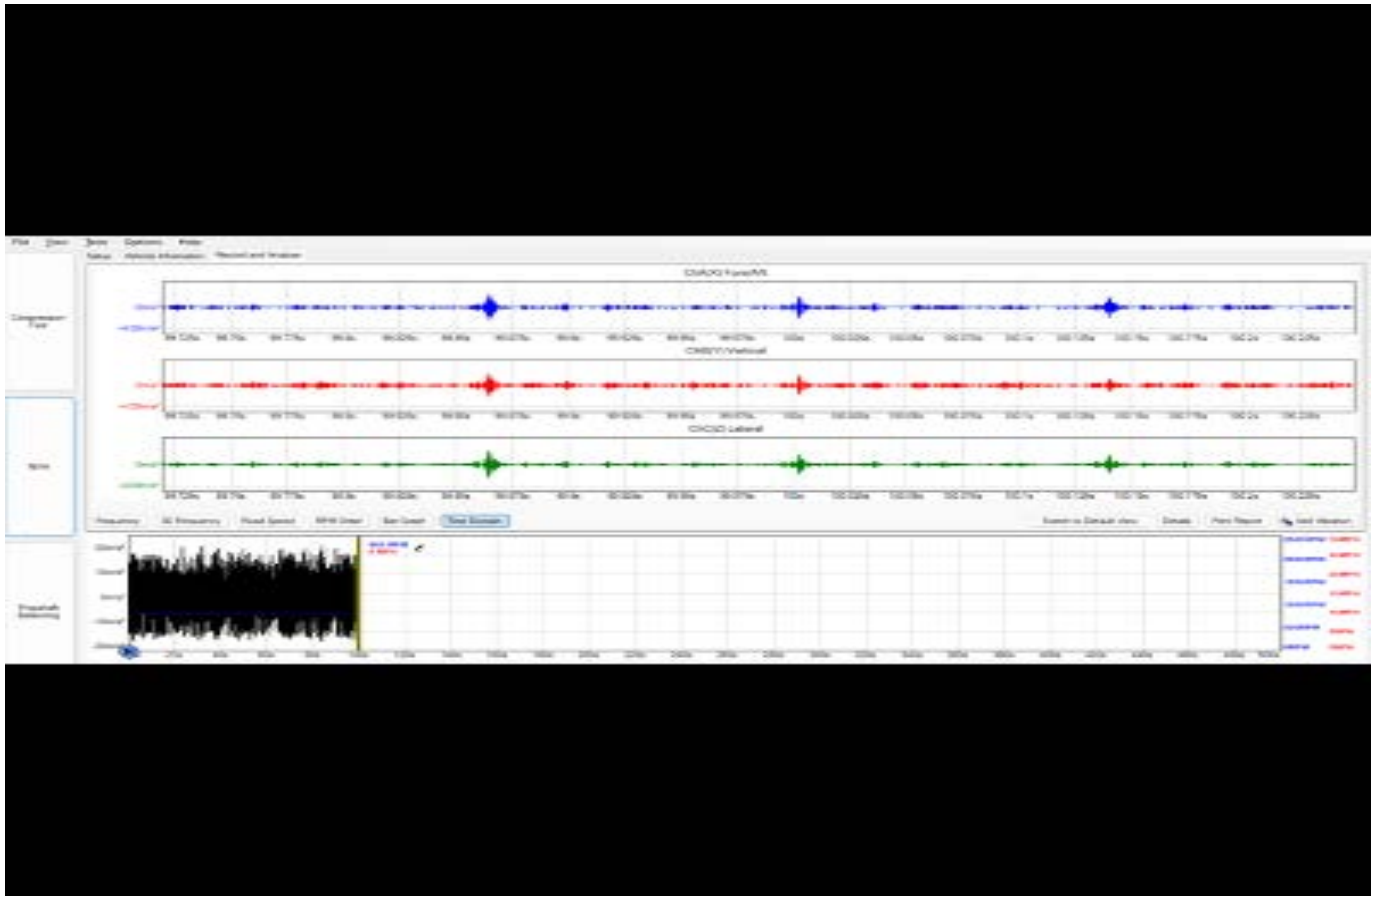
Examples of Tick:

- Right click in the time domain display and change the display mode to single.
- If scales on the left end for each channel are not ranging from -4 m/s² to 4 m/s², right click in the time domain display and select “reset scale.”
- Pull the yellow window cursors on the bottom in as close together as they will go.
- Look at the channel lines in the time domain window for ticks with a .15s gap between them.
 - ⇒ Compare to the examples below for an engine with a tick and an engine without a tick:

Once it is determined which bank the noise is coming from, it will be necessary to follow the service procedure below to adjust the camshaft cap torque.
