PIP5847A Diagnostic Tip: Abnormal Engine Ticking or Tapping Noise From Cam Carrier Area And Possible Misfire Or Rough Run With DTC P0300

| Brand: | Model: | Model Years: | VIN: | | Engine: | Transmissions: |
|---|---|---|---|---|---|---|
| Chevrolet | Silverado | 2019 - 2023 | All | All | 2.7 L3B | All |
| GMC | Sierra | 2019 - 2023 | All | All | 2.7 L3B | All |

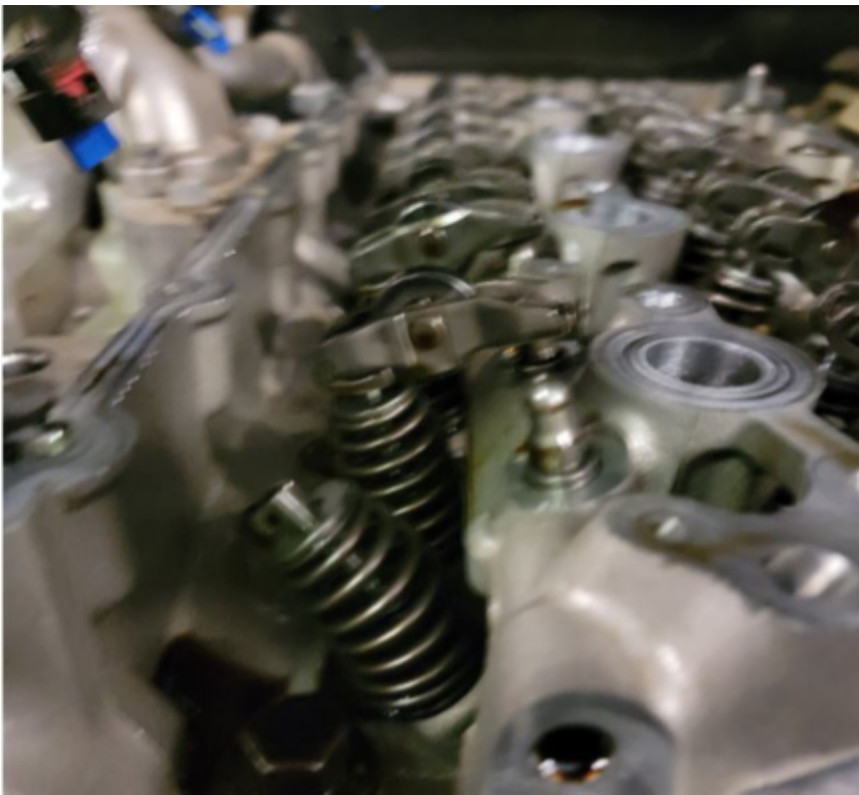
Once the Cam Carrier has been removed inspect each of the Exhaust Follower rollers for increased wear or up and down movement in the roller. The excessive up/down movement is an indication of increased axle pin wear and in worst cases the rollers can come out of position leading to a bent valve or damaged valve stem.

(Picture below showing bent valve due to worn Exhaust Roller Follower)

If a worn Exhaust Roller Follower is found, replace all 8 of the Exhaust Hydraulic Lash adjusters and Exhaust Followers. Also the Exhaust Camshaft should be inspected at this time for damage or premature wear caused by this concern.

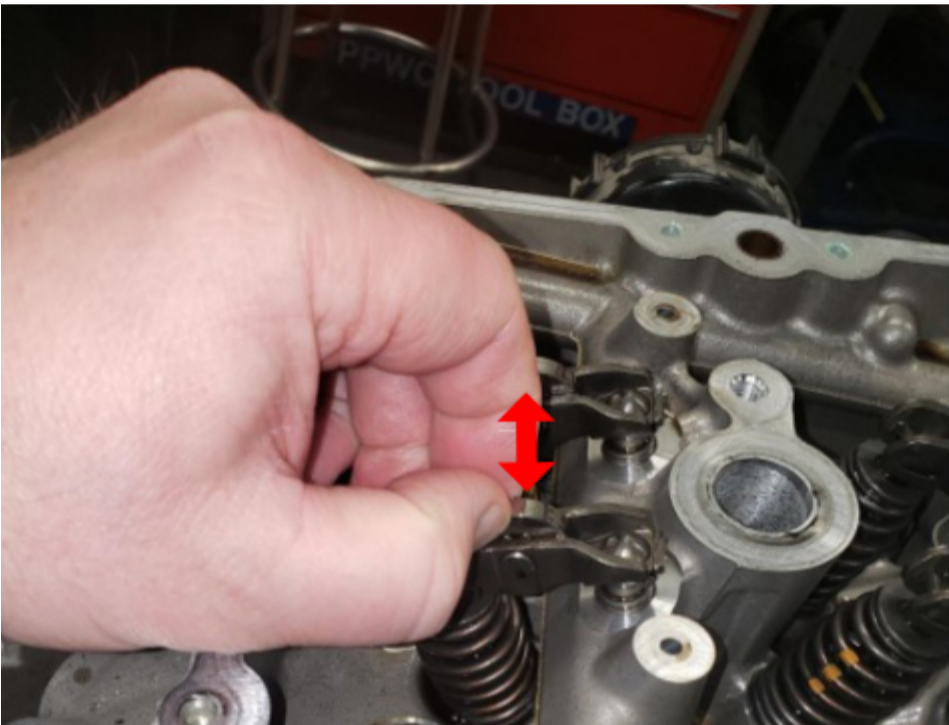
(Picture below shows a typical method used to check for worn roller followers)

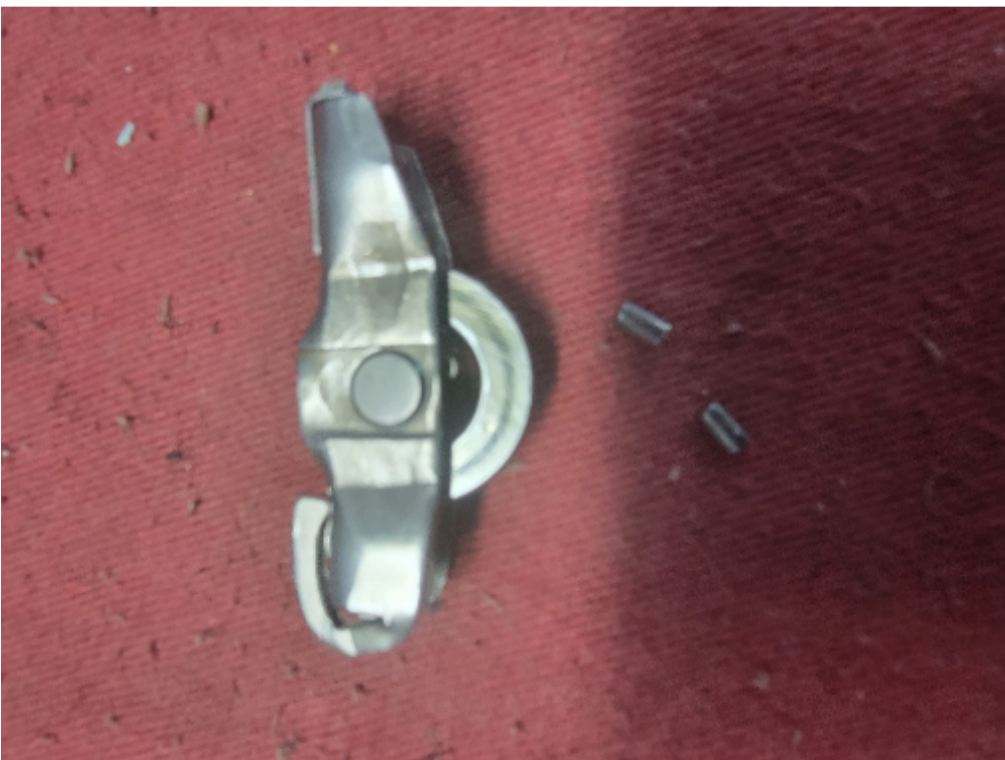
(Picture below shows example of excessive axle pin wear)

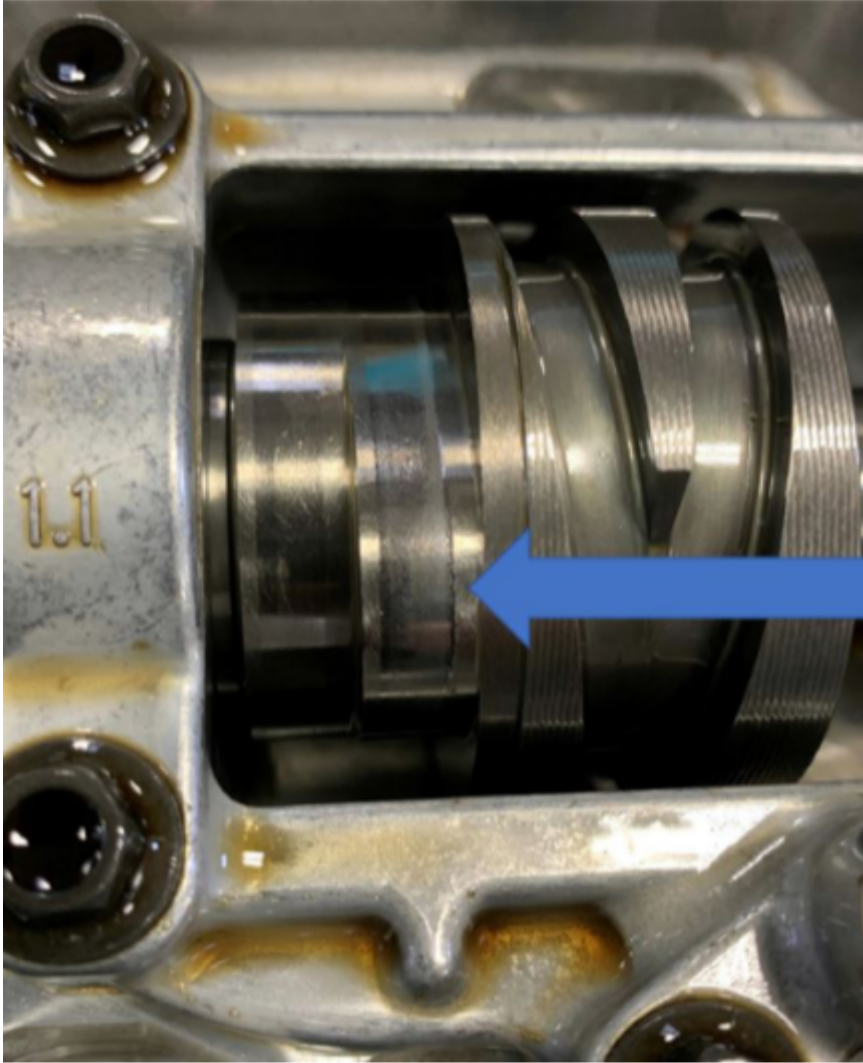
(Blue arrow in picture below showing Exhaust Cam lobe wear due to worn roller follower)
