Preliminary Information

PIP5938 Diagnostic Tip: Information Regarding Normal Fine Particles Found In Engine Oil Or Oil Pan Generated By Wet Belt System Wear In

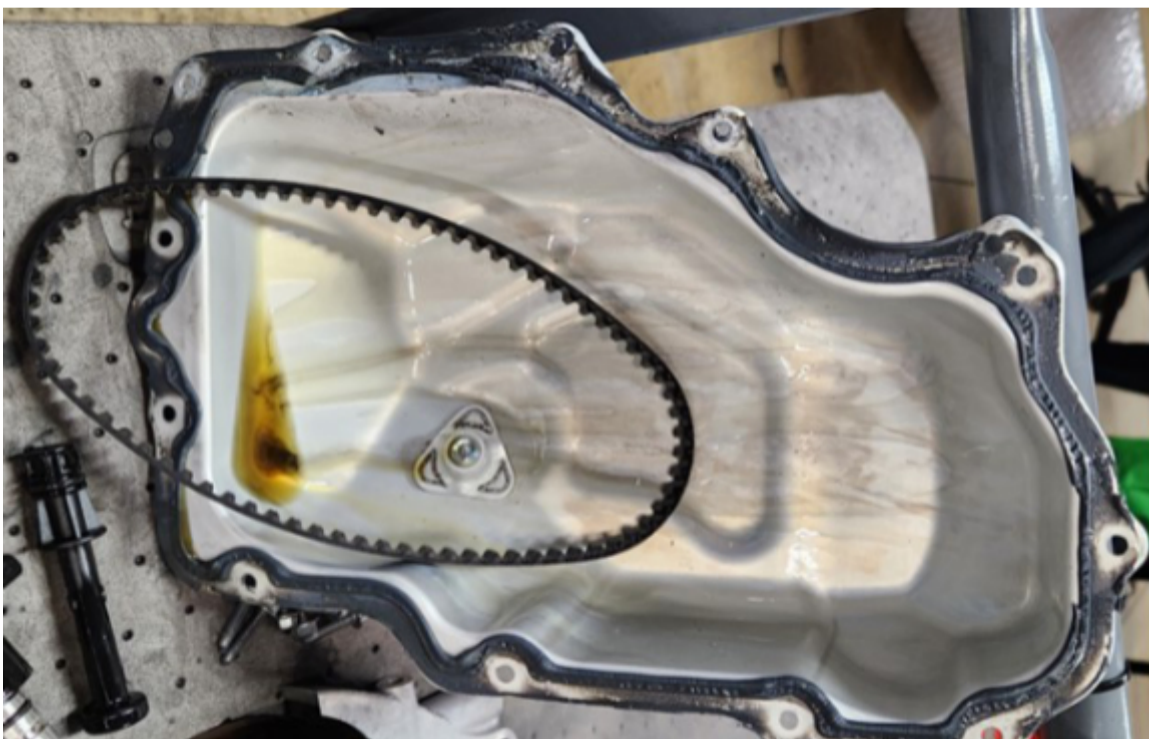
During service work if the engine oil pan is removed you may notice a darker colored fine particle substance in the bottom of the engine oil pan or suspended in the engine oil. These fine particles are generated by the wet belt system wear in and are considered to be normal and require no further action.

Picture below shows normal amount of fine particles generated by wet belt system wear in on an engine with 12 miles
