# VW Elsa Newsletter

Edition 106: October 6, 2014

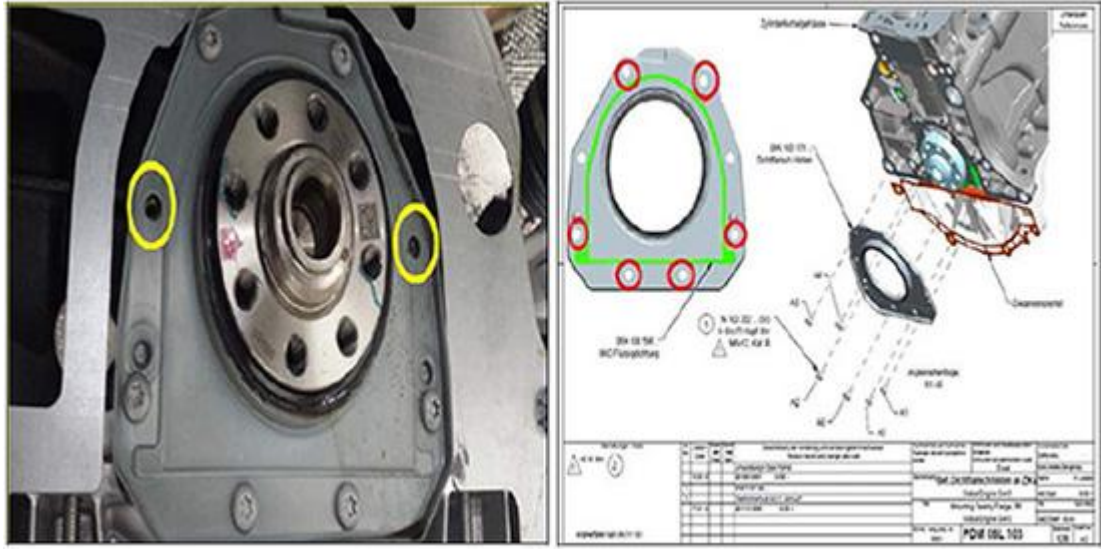
### 13-14-01 Rear Main Seal Bolts Missing

There are no bolts installed at the 9 and 3 o'clock positions from the factory. No bolts need to be installed in these locations while performing repairs. See photos for reference.
