SIB 63 10 23

MOISTURE/CONDENSATION IN THE REAR TAILLAMPS

E-Series	Model Description
U11	X1 Sports Activity Vehicle

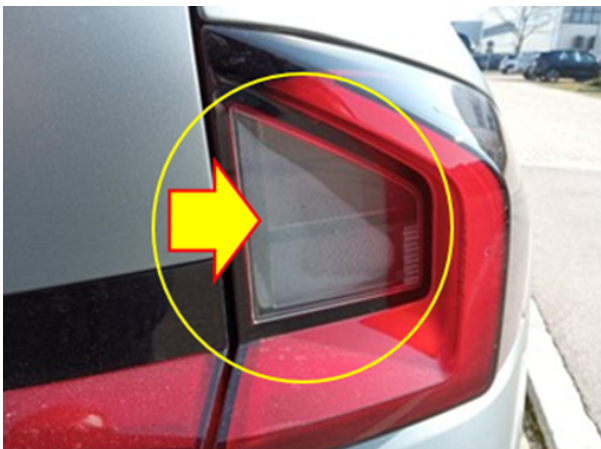
- A. Thermal/environmental conditions that result in the formation of condensation is not a defect.
- B. Water/moisture in the taillamp housing is considered a defect.

A. Normal/natural condensation.

If normal environmental conditions are the cause of the condensation, no correction is required.

- The taillamps will dissipate the condensation through venting. This venting process should be completed within 24 hours with the vehicle sitting in temperatures of 68 – 77 degrees Fahrenheit.

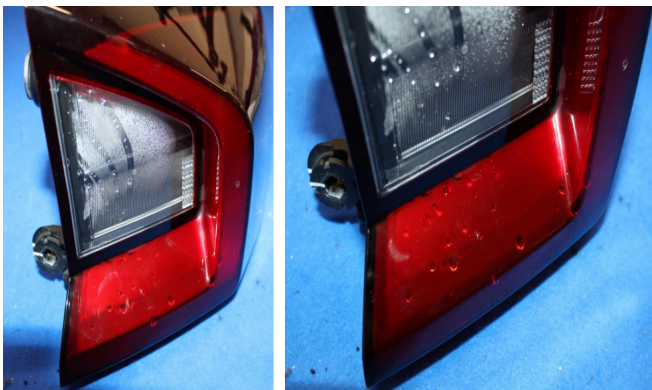
**B. Water/moisture in the taillamp.**

If the taillamps do not vent/dry within the described time frame, inspect the taillamp for leaks/damage and replace it if necessary.
