SIB 51 13 23

2023-08-04

## OUTER A-PILLAR TRIM PANEL PROTRUDES TOWARDS THE COWL SEAL

E-Series	Model Description	Production Date
G29	Z4 Roadster	November 1, 2018 – June 30, 2023

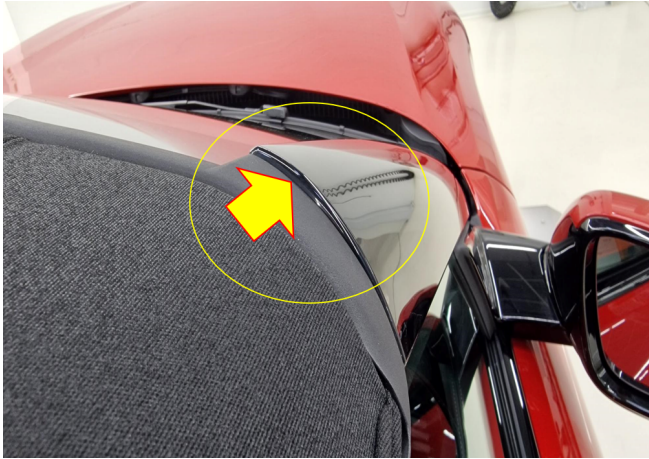
The outer A-pillar trim panel (arrow) protrudes outward (circled) towards the cowl seal.

The passenger side is shown, but the situation can also occur on the driver's A-pillar.

Upon installation of the trim, the mounting clips were lubricated to make installation easier. However, this reduces the retaining force, and the trim can easily be unclipped.

Degrease/clean the clips/clip holes using a clean dry rag.

1. Remove the outer A-pillar trim panel along with the clips.
2. Clean/remove any grease from the clips.  
**Note: Replace any broken/damaged clips/trim.**
3. Reinstall the clips and trim panel onto the vehicle and verify the repair.
