SIB 52 09 20

2023-08-23

**HEAD RESTRAINT AND/OR BACKREST OF 3RD ROW SEATS CANNOT BE FOLDED DOWN**This Service Information Bulletin (Revision 5) replaces SI B52 09 20 **dated August 2023**.**What's New:**

E-Series	Model Description
G07	X7 Sports Activity Vehicle

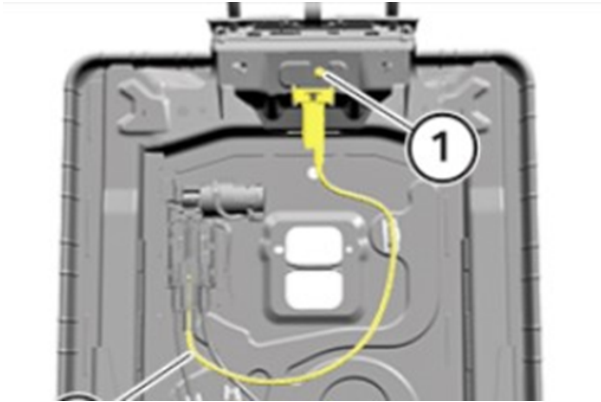
**NO** = Check if the Bowden cable is correctly mounted and properly routed.

If the Bowden cable is mounted properly and cable correctly routed and the electric motor moving the common housing pulls all 3 Bowden cables equally but the headrest Bowden cable does not travel far enough, replace the Bowden cable for the headrest (shown in yellow in picture).

See REP 52 30 253 Replace Bowden cable for left or right head restraint (Bowden cable unlocking device for head restraint).

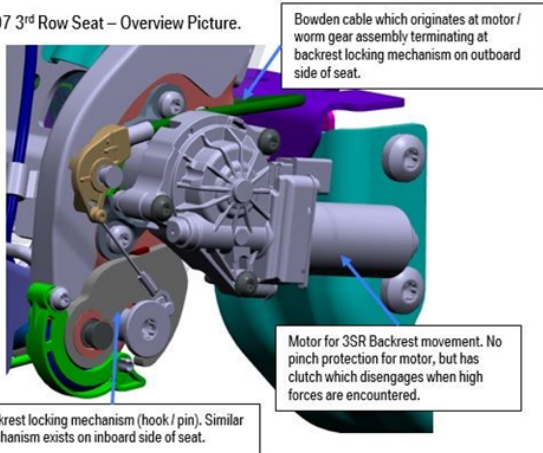
G07 3<sup>rd</sup> Row Seat – Overview Picture.

Check if the latch (the fastener on the left or right side) of the third row of seats is open or closed? (this is the hook/pin shown in green in picture)

If the head restraint stays in the seat position, the latch is closed.

If the head restraint falls into the folded position again, the latch is open.

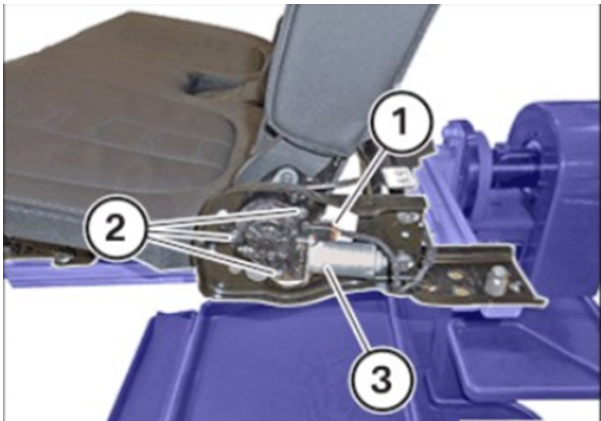
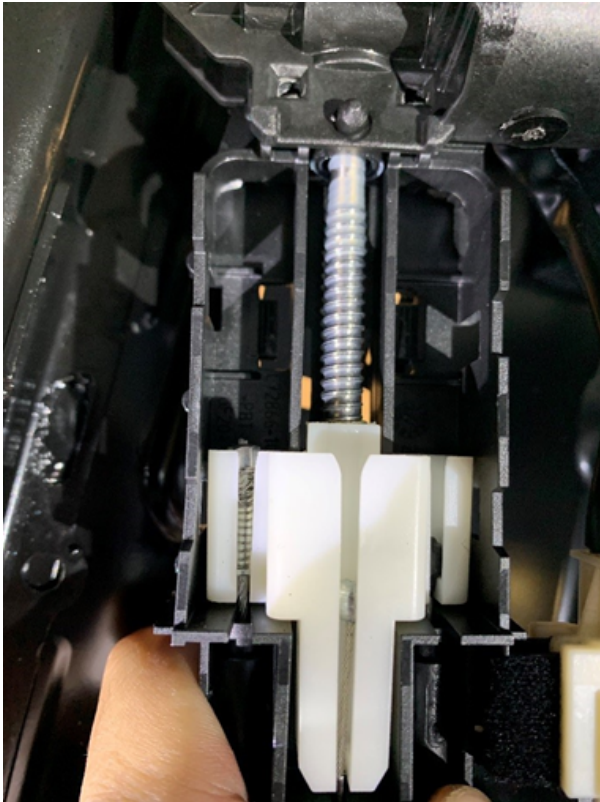
**NOTE: If the seat was moved manually with excessive force, it may cause damage to the internal gear of this actuator. The motor may spin but the seat backrest may not move. In this case replacement of the drivetrain for backrest tilt adjustment is needed and the seat frame would not need replacement. There may be noise from the motor if it is internally damaged. To check the gear mechanism, the motor can be removed for inspection.**

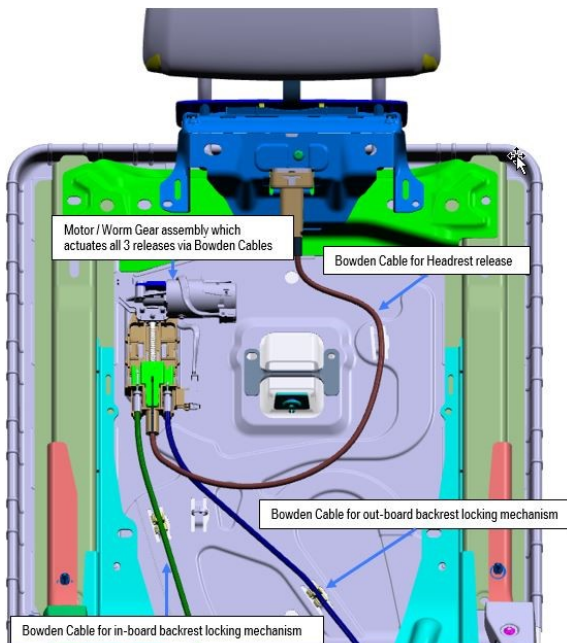
**NOTE:** The 3 Bowden cables are housed in a common housing that moves along a worm gear assembly.

When the electric motor activates, it spins the worm gear to pull up on the housing so that all 3 cables move simultaneously.

One of the cables controls the head restraint folding. Once pulled, the headrest will release and pivot downwards. **Raising the headrest back into the upright position must be done by pushing up on it by hand.**

(The other two cables control the latch release at the seat pivot to enable the seat to fold.)

Is the drivetrain for the backrest release (actuator) broken?

**YES** = Replace only the drivetrain for backrest release (actuator).

See REP 67 31 645 Remove and install/replace drivetrain for backrest release of third-row seating (left or right) (according to vehicle diagnosis)

**NO** = Replace BOTH the Bowden cable(s) and drivetrain for backrest release (actuator).

See appropriate repair instruction:  
REP 52 30 256 Replace Bowden cable for left or right rear seat backrest (Bowden cable for outer backrest release)

REP 52 30 255 Replace Bowden cable for left or right rear seat backrest (Bowden cable for inner backrest release)

REP 67 31 645 Remove and install/replace drivetrain for backrest release of third-row seating (left or right) (according to vehicle diagnosis)
