## STAR ONLINE PUBLICATION

**Case Number:** S2308000042 Rev.A

**Symptom/Vehicle Issue:** EPS And Other CAN C Modules Offline, U0001 And U0002 Can C Bus Diagnostic Trouble Codes (DTCs).

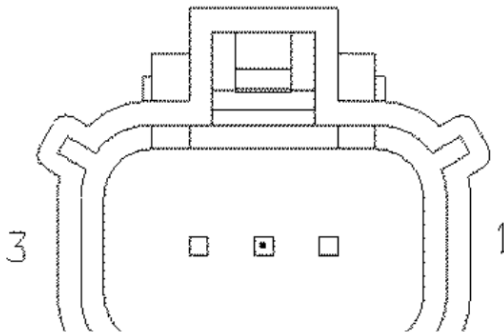
### MODULE-EPS C1

End View

Cav	Circuit	Gauge	Color	Function
1	D138	0.35	YE	CAN C (-)
2	D139	0.35	YE/BN	CAN C (+)
3	F942	0.50	PK/VT	FUSED IGNITION SWITCH OUTPUT (RUN-START)

Full Repair Kit: 68358151AA
