WARRANTY BULLETIN

NO: D-23-04
DATE: July 12, 2023

SUBJECT: 2018 - 2023 (Current) Jeep
Wrangler (JL) and 2020 - 2023 (Current)
Jeep Gladiator (JT) - Corrosion Warranty
Claim Simplification (Rev. B)

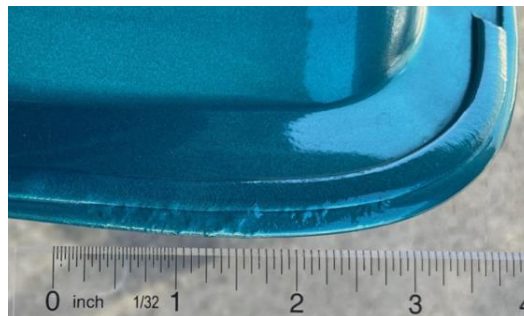
2. Corrosion found on the seam of the panel (Fig. 2)

Seam Panel Area Examples (Fig. 2)

Note: If corrosion is found on the seam of the panel, the door shell will be replaced. No additional sanding in the hinge or seam area is supported.

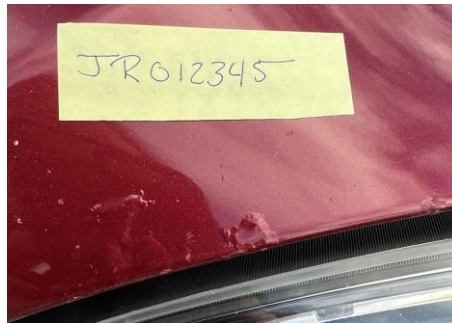
VIN Example (Fig. 3)

Dealers will need to take photos of the affected areas identified during the inspection to support the repair. A clear photo of the corrosion is needed and **MUST** include the VIN. The VIN can be included on a sticky note, written with a grease pen, a copy of the RO in the photo, masking tape, etc. (Figure 3)
