FCA CARIBBEAN WARRANTY BULLETIN

NO: ID-23-03

DATE: July 12, 2023

SUBJECT: 2018 - 2023 (Current) Jeep
Wrangler (JL) and 2020 - 2023 (Current)
Jeep Gladiator (JT) - Corrosion Warranty
Claim Simplification (Rev. B)

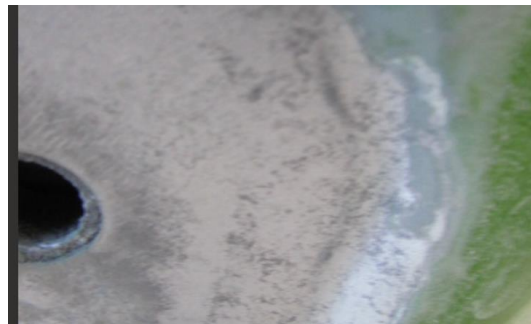
1. Pitting found after sanding the affected area (Fig. 1)

Pitting Found After Sanding Example (Fig. 1)

Note: If pitting is found during the sanding process, please use LOP 23-75-XX-XX for up to 0.5 hours in conjunction with the 23-85 replacement LOP.

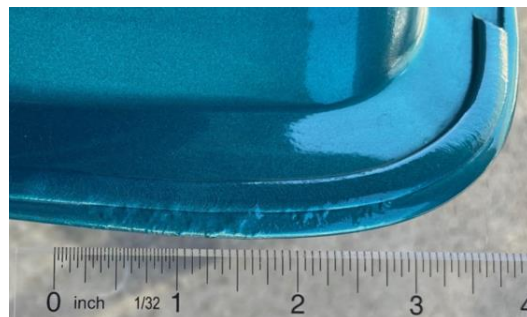
2. Corrosion found on the seam of the panel (Fig. 2)

Seam Panel Area Examples (Fig. 2)

Note: If corrosion is found on the seam of the panel, the door shell will be replaced. No additional sanding in the hinge or seam area is supported.
