<b>REFERENCE:</b>	TSB: 09-006-23 REV. C GROUP 09 - Engine	<b>Date:</b>	July 22, 2023	<b>REVISION:</b>	09-006-23 REV. B
<b>VEHICLES AFFECTED:</b>	<p>2022 - <b>**2024**</b> (B1) Jeep Renegade                  2022 - <b>**2024**</b> (H1) Jeep Commander                  2022 - <b>**2024**</b> (M1) Jeep Compass                  This bulletin applies to vehicles equipped with a 1.3L I4 Turbo Mair DI Eng w/ESS E100 (Sales Code EYJ):</p> <ul style="list-style-type: none"> <li>• M1 built on and after April 28, 2021 (MDH 0428XX) and built on and before <b>**June 18, 2023 (MDH 0618XX)**</b>.</li> <li>• H1 built on and after December 26, 2021 (MDH 1226XX) and built on and before <b>**June 18, 2023 (MDH 0618XX)**</b>.</li> <li>• B1 built on and after January 14, 2022 (MDH 0114XX) and built on and before <b>**June 18, 2023 (MDH 0618XX)**</b>.</li> </ul> <p>This bulletin applies to vehicles equipped with a 1.3L I4 Turbo Mair DI Engine w/ESS (Sales Code EYF):</p> <ul style="list-style-type: none"> <li>• M1 built on and after January 29, 2022 (MDH 0129XX) and built on and before <b>**June 18, 2023 (MDH 0618XX)**</b>.</li> <li>• H1 built on and after March 25, 2022 (MDH 0325XX) and built on and befo

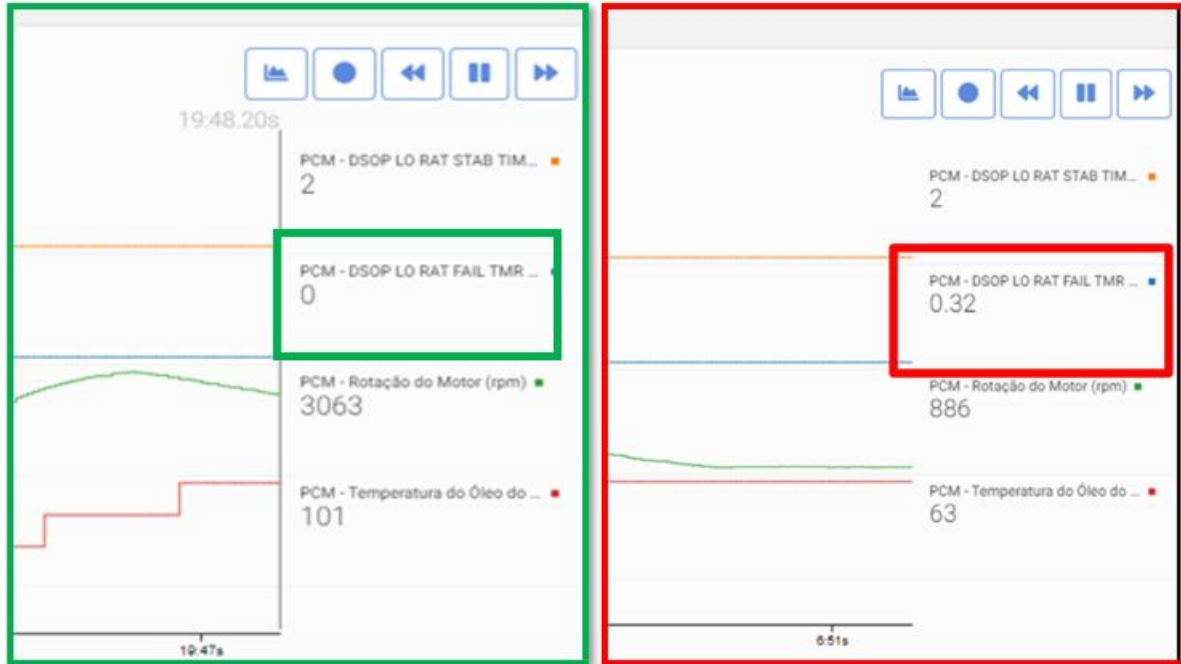
**Fig. 1**  
**Graph Showing Correct And Not Correct Values**

1. Using wiTECH check if DTC P06DD is set in the Powertrain Control Module (PCM).
2. Was DTC P06DD found in the PCM?
  - YES>>> Replace the timing chain cover. Proceed to [Step 6](#).
  - NO>>> Proceed to [Step 3](#).
3. Start the engine at let it run at idle until the engine oil temperature reaches more than 85° C (185° F).
4. Create a graph of “DSOP LO RAT FAIL TMR” and review the value. **If it shows anything but “0”, the timing cover needs to be replaced (Fig. 1) .**

**NOTE: The “DSOP LO RAT FAIL TMR” value can change in less than 20 seconds, then the oil pump (timing chain) is faulty and will need to be replaced.**

5. Did the “DSOP LO RAT FAIL TMR” value read anything but “0”?
  - YES>>> Create a screen shot of the graph showing values other than “0” and attach it to the work order. Proceed to [Step 6](#).
  - NO>>> If the value always shows “0” and DTC P06DD was not found, this bulletin has been completed. Use Inspection LOP (09-65-01-74) to close the active RSU.
6. Replace the timing chain cover. Refer to the detailed service procedures available in DealerCONNECT/ Service Library under: 09 - Engine, 1.3L I4 16V Multi Air Turbo / Valve Timing / Cover(s), Engine Timing / Removal and Installation.
7. Using wiTECH clear any DTCs that may have been set.
