# TECHNICAL SERVICE BULLETIN

## Equipped With Hybrid Engines - Illuminated Powertrain Malfunction Indicator Lamp With DTC P0A1E In The PCM

23-2279

31 August  
2023

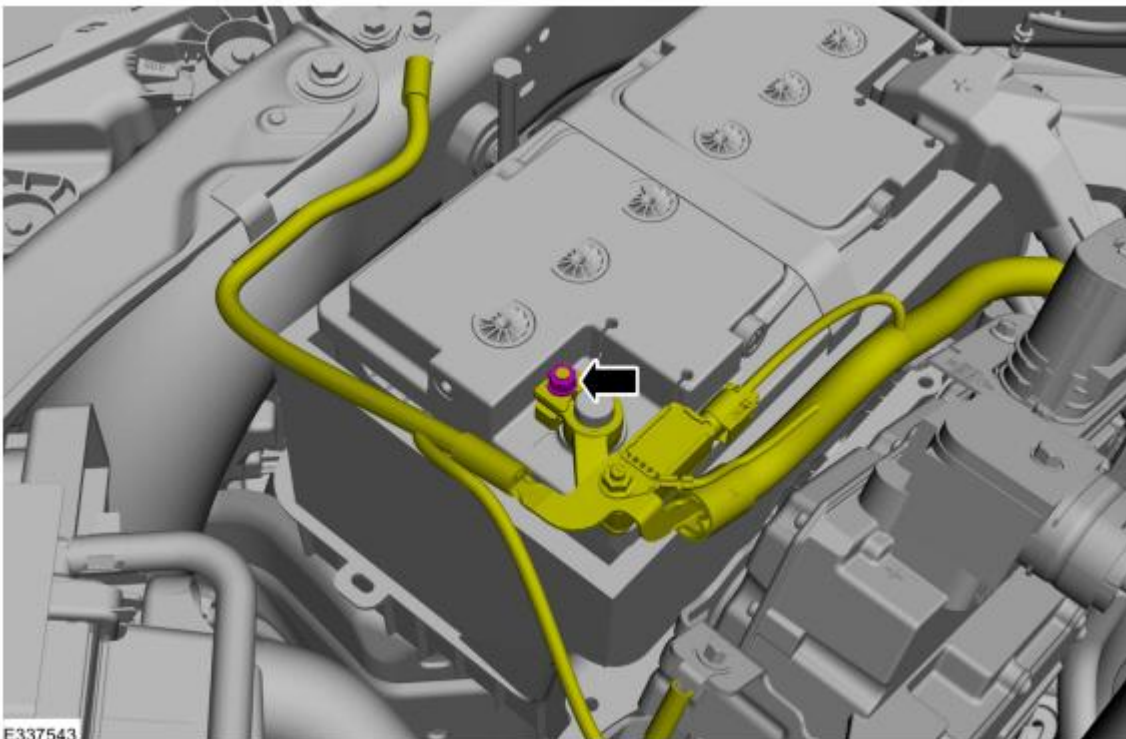
Figure 1 - F-150

- (1). Yes - repair is complete.
  - (2). No - proceed to Step 5.
5. At the 12V battery negative post, inspect the nut securing the battery monitoring sensor to the negative battery post. (Figures 1-2) If it is loose, tighten the nut to the specified tightening value. Refer to WSM, Section 414-01 Battery, Mounting and Cables, General Procedures, Battery Disconnect and Connect.

- For F-150 vehicles with a 3.5L hybrid engine, tighten to 55 lb.in (6.2 Nm).
  - For Explorer/Aviator vehicles equipped with a hybrid engine, tighten to 48 lb.in (5.4 Nm).

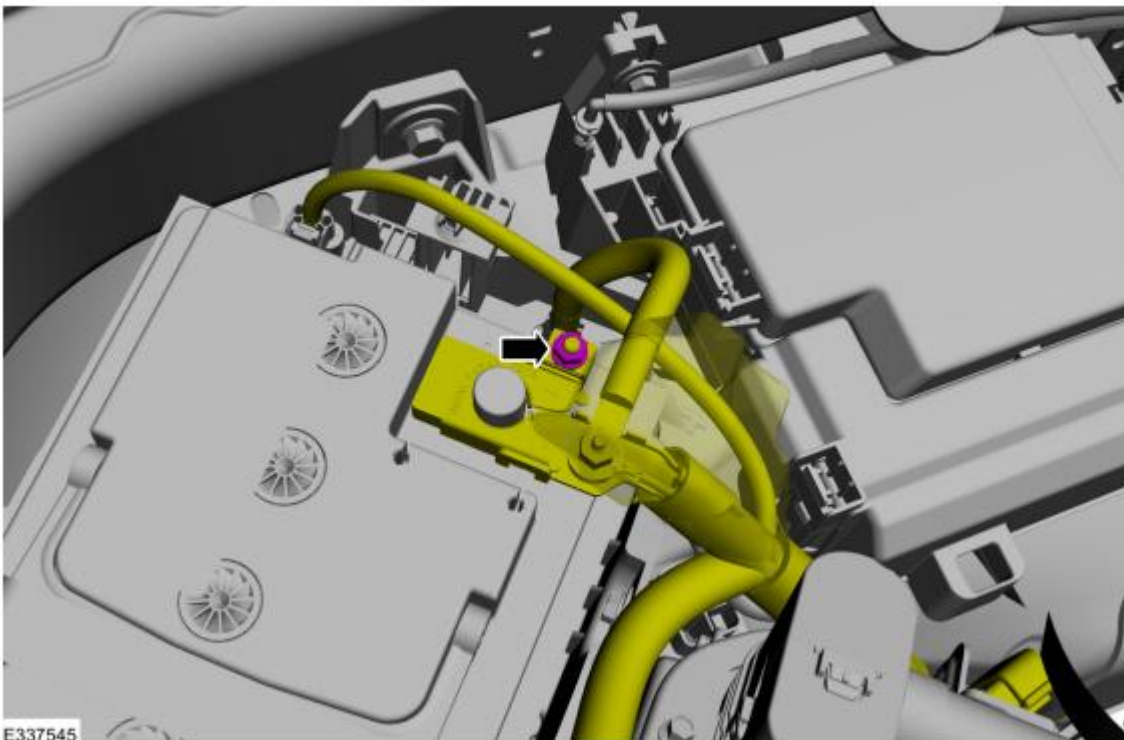
Figure 4 - F-150

7. At the 12V battery positive post, inspect the nut securing the positive battery cable to the post. (Figures 4-5) If it is loose, tighten the nut to the specified tightening value. Refer to WSM, Section 414-01 Battery, Mounting and Cables, General Procedures, Battery Disconnect and Connect.

- For F-150 vehicles with a 3.5L hybrid engine, tighten to 55 lb.in (6.2 Nm).

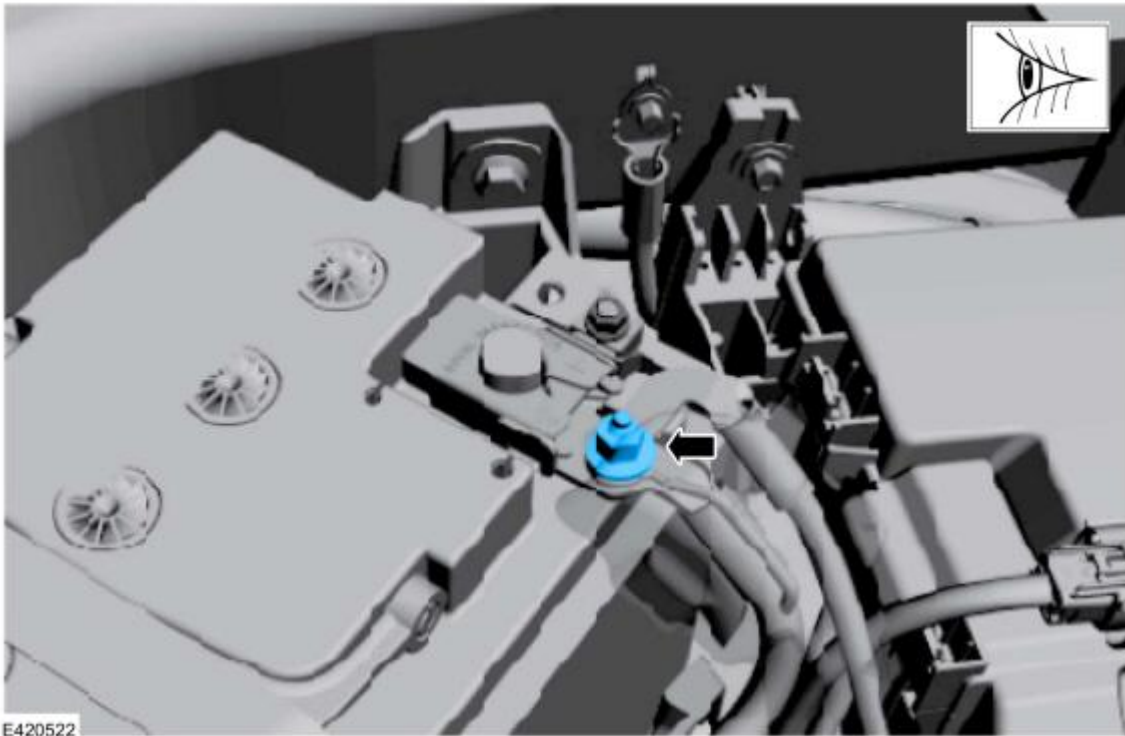
Figure 6 - F-150

**8.** At the 12V battery positive post, inspect the nut securing the positive cable eyelet lug. (Figures 6-7) If it is loose, tighten the nut to the specified tightening value. Refer to 414-01, Battery, Mounting and Mounting Cables, Removal and Installation.

- For F-150 vehicles with a 3.5L hybrid engine, tighten to 80 lb.in (9 Nm).
- For Explorer/Aviator vehicles equipped with a hybrid engine: 80 lb.in (9 Nm).

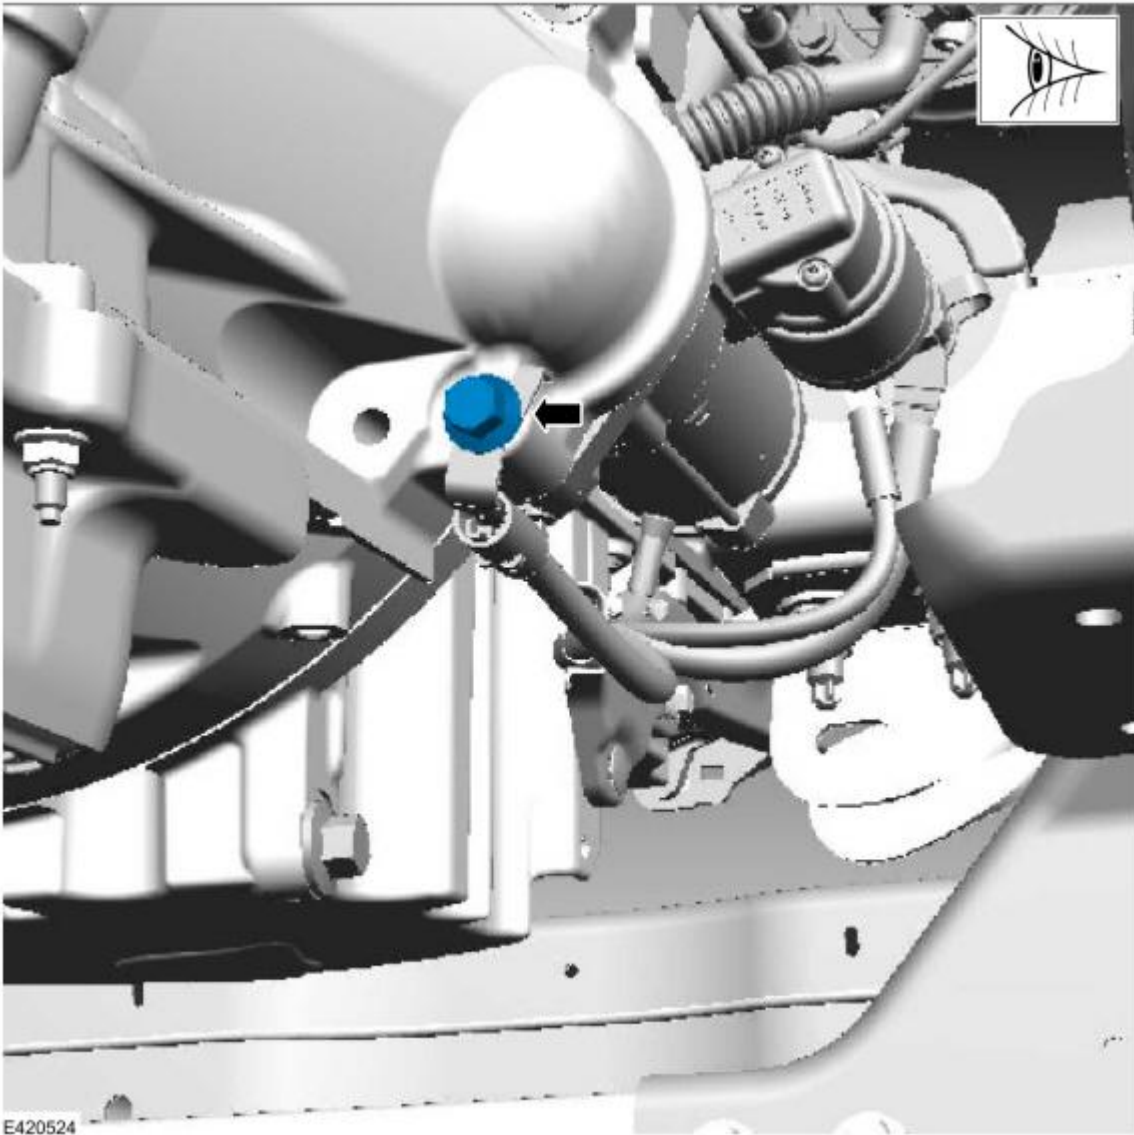
Figure 8 - F-150

9. Inspect engine ground G105. (Figures 8-10) Refer to Wiring Diagram, Cell 010, G105. If it is loose, tighten the bolt to the specified tightening value.

- For F-150 vehicles with a 3.5L hybrid engine, tighten to 35 lb.ft (48 Nm).
- For Explorer/Aviator vehicles equipped with a hybrid engine, tighten to 106 lb.in (12 Nm).
