Technical Service Bulletin

01 MIL on, Whistling noise, leaking air Bank 2 - DTC P2ADF00, Engine Crankcase breather

01 23 78 2071318/2 September 20, 2023. Supersedes Technical Service Bulletin Group 01 number 23-72 dated August 23, 2023 for reasons listed below.

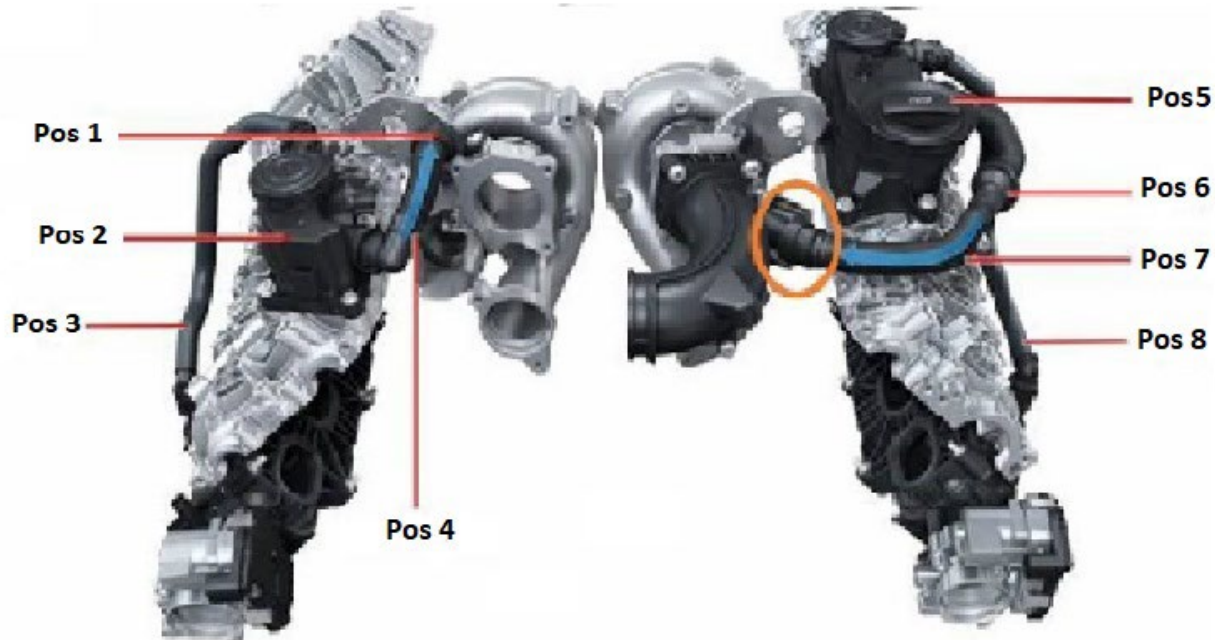
- Item 1: Non-return valve
- Item 2: Oil separator for bank 1
- Item 3 Part load breather line for bank 1
- Item 4: Full load breather line for bank 1
- Item 5: Oil separator for bank 2
- Item 6: Non-return valve
- **Item 7: Full load breather line for bank 2**
- Item 8: Part load breather line

In this case, replace the full load breather line for cylinder bank 2.

1. Do not replace the oil separator for bank 1 or bank 2 or the part load breather lines.
 - a. Please refer to image of the crankcase from the Self Study Program 920493 as a guide.
