Technical Service Bulletin

46 Brake pulsation diagnostic guidelines

46 23 50 2022584/12 September 18, 2023. Supersedes Technical Service Bulletin Group 46 number 22-26 dated January 31, 2022, for reasons listed below.

Model(s)	Year	VIN Range	Vehicle-Specific Equipment
All Audi Vehicles	2015 – 2025	All	Not Applicable

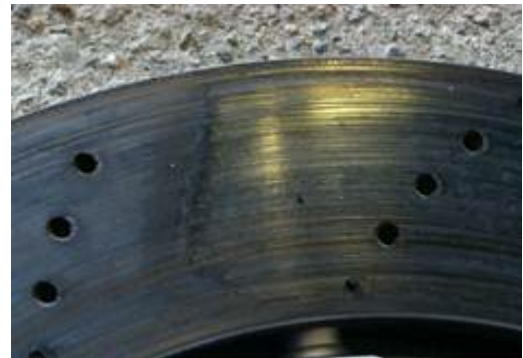
Condition: Brake pad material smeared on the brake disc (Figure 2). This condition can create DTV.

Common cause: An overly-aggressive driving style, which results in frequent sharp braking without proper cooling off periods.

Figure 2. Deposits on the brake disc.

Service: Replace the brake discs and pads.

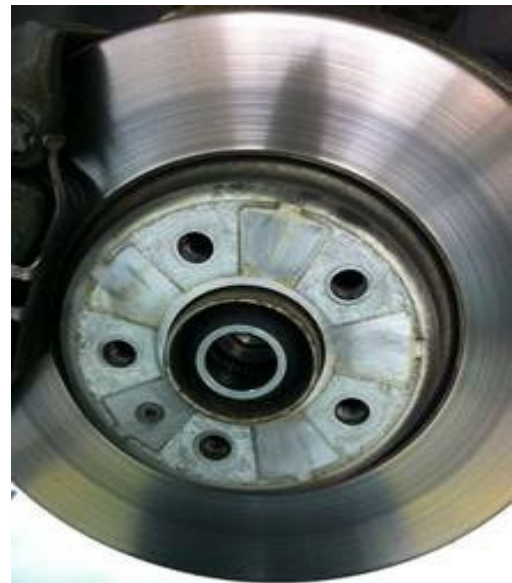
Condition: Blue-tempered or overheated brake discs (Figure 3).

Common cause: Failed component(s) causing constant brake application. This can also be caused by an overly-aggressive driving style, which results in frequent sharp braking without proper cooling off periods.

Figure 3. Brake disc with heat marks.

Service: Replace the brake disc and pads.

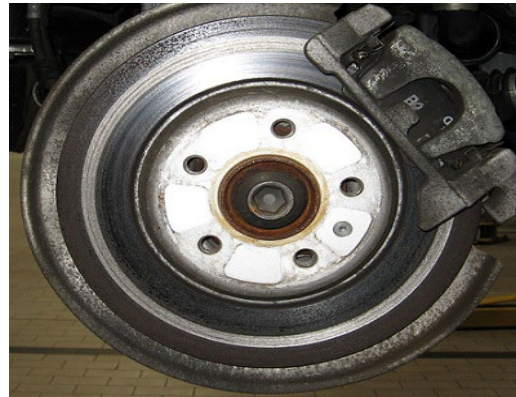
Condition: Corrosion/rust build-up on the brake discs (Figure 4). This condition can create DTV.

- Exposure to road salt during winter months, high humidity, or moisture.
- Vehicle not being driven for prolonged periods of time.
- A gentle driving style with very light brake application may not be enough to remove build-up (such as rust or corrosion) on the brake discs and pads.

Figure 4. Corrosion/rust build-up.

Service: With careful consideration of the traffic situation, perform 2-3 ABS stops from speeds above 50mph. Between each stop, allow the brake components to cool by driving the vehicle for more than one minute at speeds greater than 50mph. Do not perform ABS stops if brand new pads and/or discs are installed. Replace brake disc and pads if the condition is not eliminated.

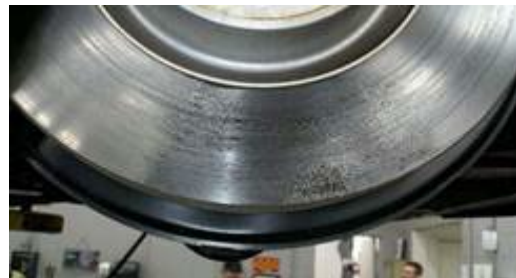
Condition: Pad material transfer or corrosion marks from brake pads on the brake disc, also known as “pad marks” (Figure 5). This condition can create DTV.

Common cause: These marks can appear if the vehicle has not been driven for a prolonged period of time or if the brakes are exposed to high humidity or moisture.

Figure 5. Pad marks on the brake disc.

Service: With careful consideration of the traffic situation, perform 2-3 ABS-stops from speeds above 50mph. Between each stop, allow the brake components to cool by driving the vehicle for more than one minute at speeds greater than 50mph. Do not perform ABS stops if brand new pads and/or discs are installed. Replace brake disc and pads if the condition is not eliminated.

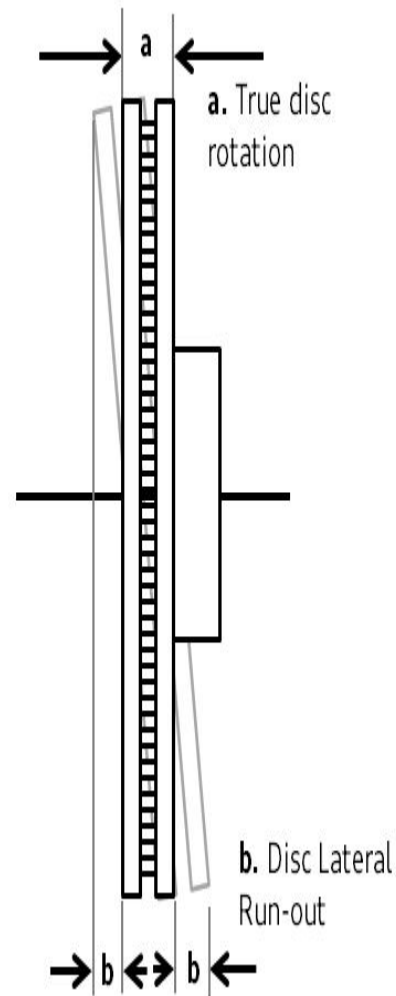
Condition: Excessive brake disc or wheel hub run-out (Figure 6). Measure according to the *Run-out Measurement Instructions* listed below.

- **Over-torqued or improperly-torqued wheels** (torque sticks, impact gun, etc.) can distort the brake disc and hub, causing a run-out condition. Refer to Elsa for proper torque values and procedures for the VIN.
- **Wheels that are not Audi-approved** may not have the same contact surface on the back of the wheel and may not have the correct center bore dimension, which can distort the brake disc and hub, causing a run-out condition.
- **External impact or rust build-up** between brake disc and hub.

Figure 6. True disc rotation (a) and disc lateral run-out (b).

Service: Replace brake disc(s) and/or hub(s) if measurements exceed the maximum value listed in the *Run-out Measurement Instructions*.

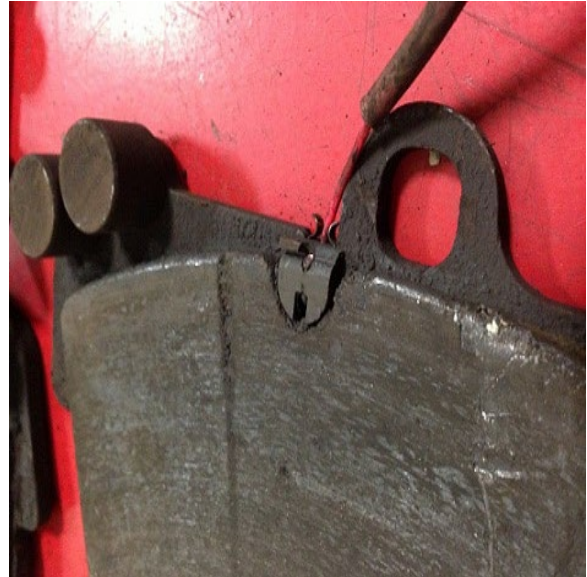
Condition: Worn brake pads (Figure 7).

Common cause: As brake pads and discs reach their wear limit, their dampening characteristics are reduced.

Figure 7. Worn brake pad.

Service: Replace worn brake pads and discs.

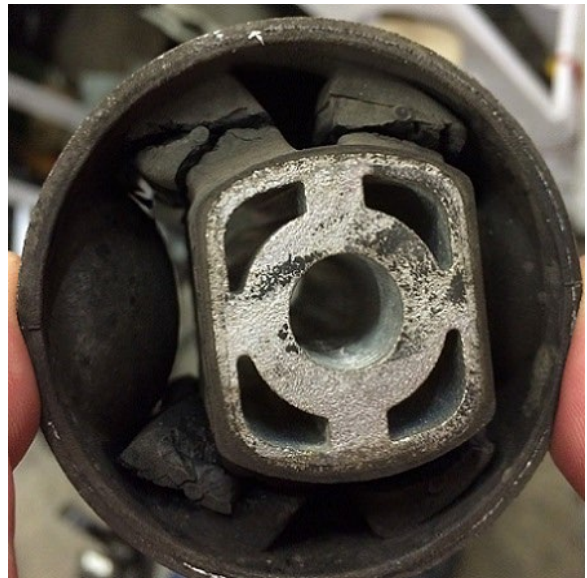
Condition: Faulty, damaged, or aftermarket suspension components (ball joints, links, tie rods, bushing, etc.) can significantly amplify vibration/pulsation or lead to body vibrations which only become noticeable when braking (Figure 8 and Figure 9).

Figure 8. Damaged suspension bushing.

Service: Diagnose these components accordingly.

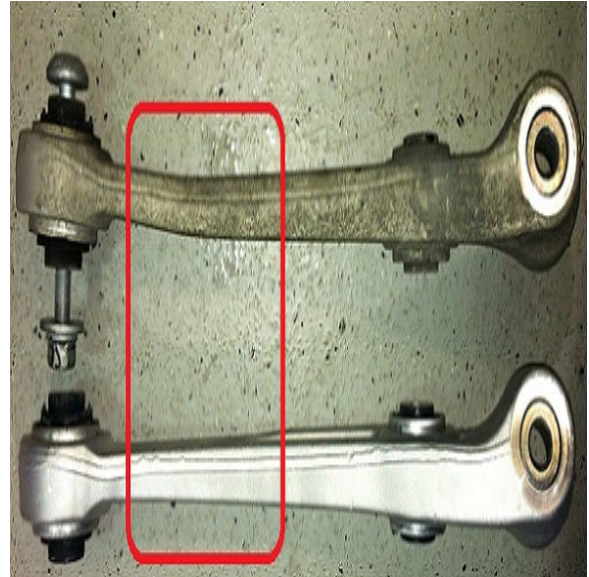
Figure 9. Damaged suspension link.

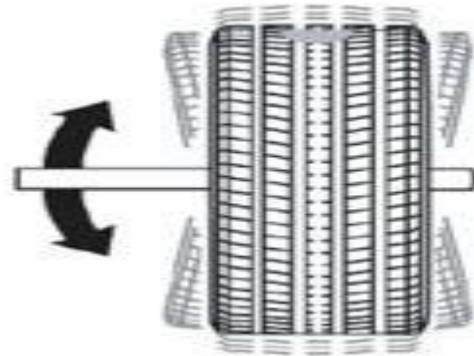
Condition: Wheel/tire imbalance (Figure 10) or radial run-out can significantly amplify the vibration/pulsation or lead to body vibrations which only become noticeable when braking.

Figure 10. Wheel/ tire imbalance.

Service: Inspect the condition of these components and diagnose accordingly.

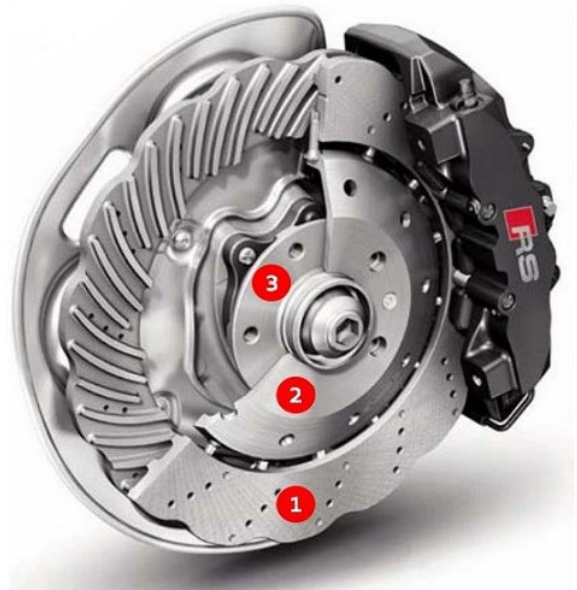
Figure 12. Run-out measurement locations: disc braking surface (1), disc hub (2), wheel hub (3).

Disc braking surface (Figure 12, point 1):

- Disc hub and wheel hub run-out impact this value.
- Maximum run-out: **0.06 mm / 0.002"**.

Disc hub (center of the brake disc) (Figure 12, point 2):

- Wheel hub run-out impacts this value.
- Disc hub run-out impacts the disc braking surface run-out.
- Maximum run-out: **0.03 mm / 0.0012"**.

Wheel hub (without the disc installed) (Figure 12, point 3):

- This value impacts the disc hub and disc braking surface run-out. High run-out can distort the brake disc.
- Maximum run-out: **0.02 mm / 0.0008"**.
