Technical Service Bulletin

93 Unable to charge - connector does not lock/unlock - charge connector lock mech. malfunction P33E800/P33E900 in C6

93 23 24 2071328/1 September 8, 2023.

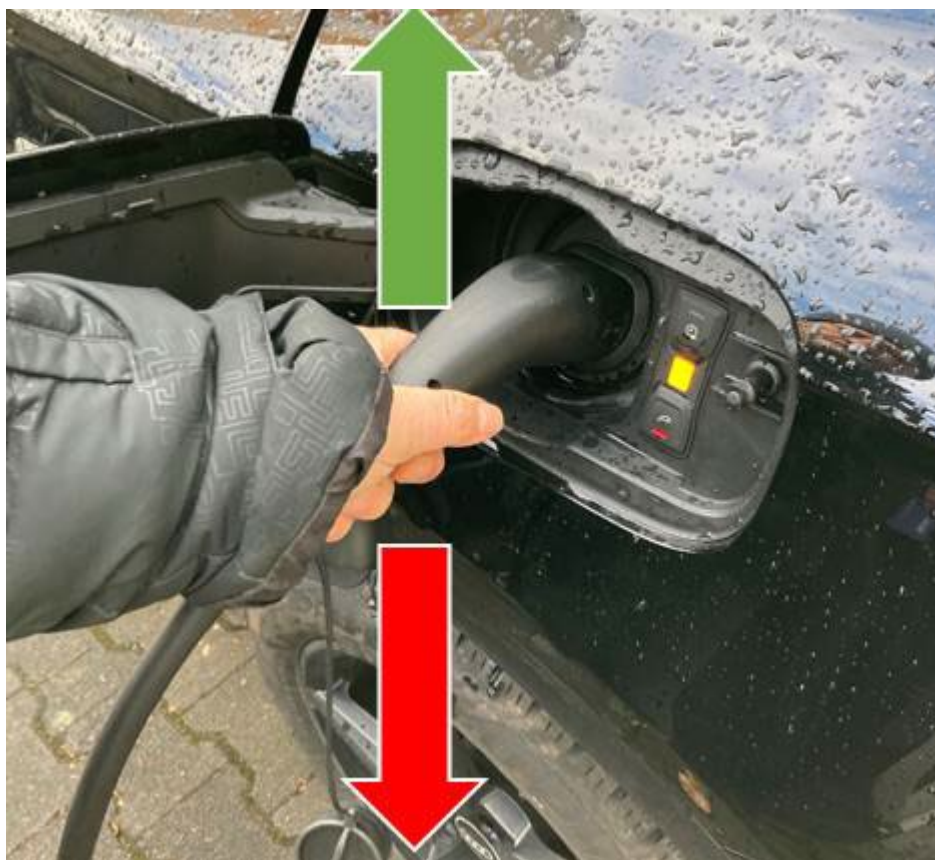
During both AC and DC charging, in rare cases the locking pin on the charging socket may not be able to enter its recess in the charging connector despite multiple attempts.

Charging connector lock OK if connector is lifted during locking procedure

Charging connector lock not OK if pushed downwards during locking procedure

(Example image from a Q5 Hybrid)

Please inform the customer that lifting the charging connector slightly immediately after plugging it in until it is locked causes the pin to enter the charging connector without any problems.

This will prevent the connector from dropping (see example image from Q5 Hybrid).
