VW Elsa Newsletter

Edition 114: December 1, 2014

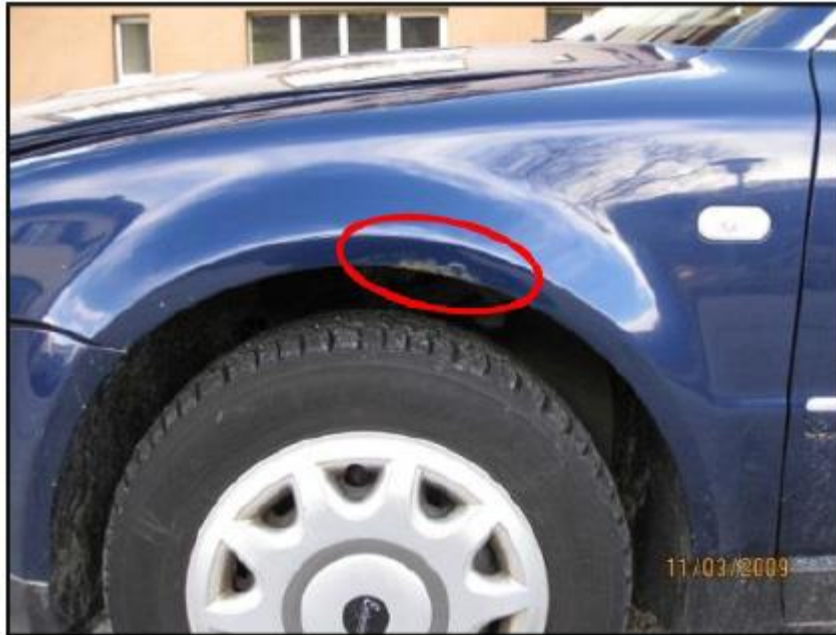
50 14 01 - 2038981 Front Fender - Corrosion on Wheel Arch					
Model(s)	Year	Eng. Code	Trans. Code	VIN Range From	VIN Range To
Passat Sedan, Passat Wagon	2001–2010	All	All	All	All
Customer states: Corrosion on the wheel arch area of the front fender (Figure 1).

Figure 1 (corrosion on left wheel arch)

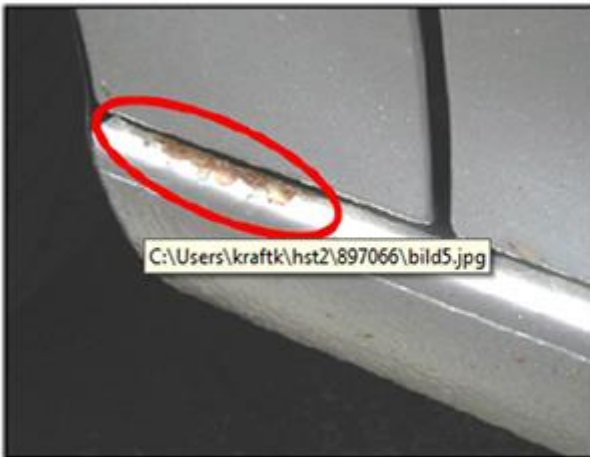
- Corrosion between the rocker panel (side member) and the fender (Figure 1, red outline).

Figure 1 - corrosion in the area of the rocker panel/front fender

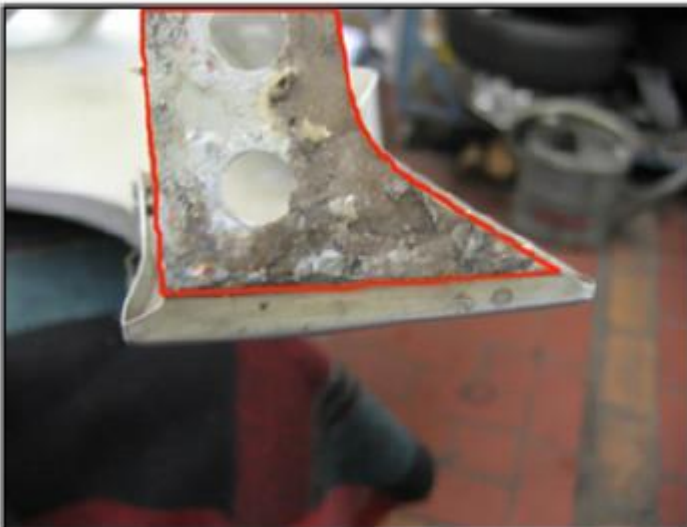
- Corrosion on the contact surface of the fender (Figure 2, in red outline).

Figure 2 - fender removed (corrosion on the contact surface of the fender)

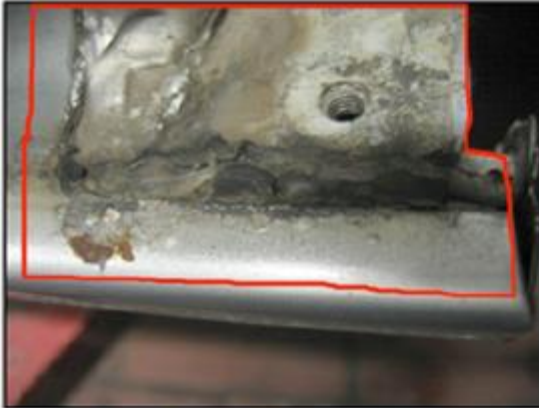
- Corrosion on the contact surface of the rocker panel (side member - Figure 3, in red outline).

Figure 3 - fender removed (corrosion on the contact surface of the rocker panel [side member])
