VW Elsa Newsletter

Edition 115: December 8, 2014

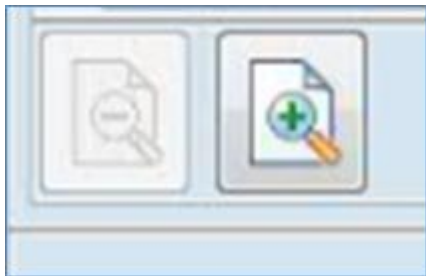
5. The main ODIS screen may not refresh due to an anti-virus or anti-malware application locking a file or files, resulting in a blank window. To refresh the screen manually, use the zoom in / zoom out buttons at the bottom left corner of the main screen. (see below)

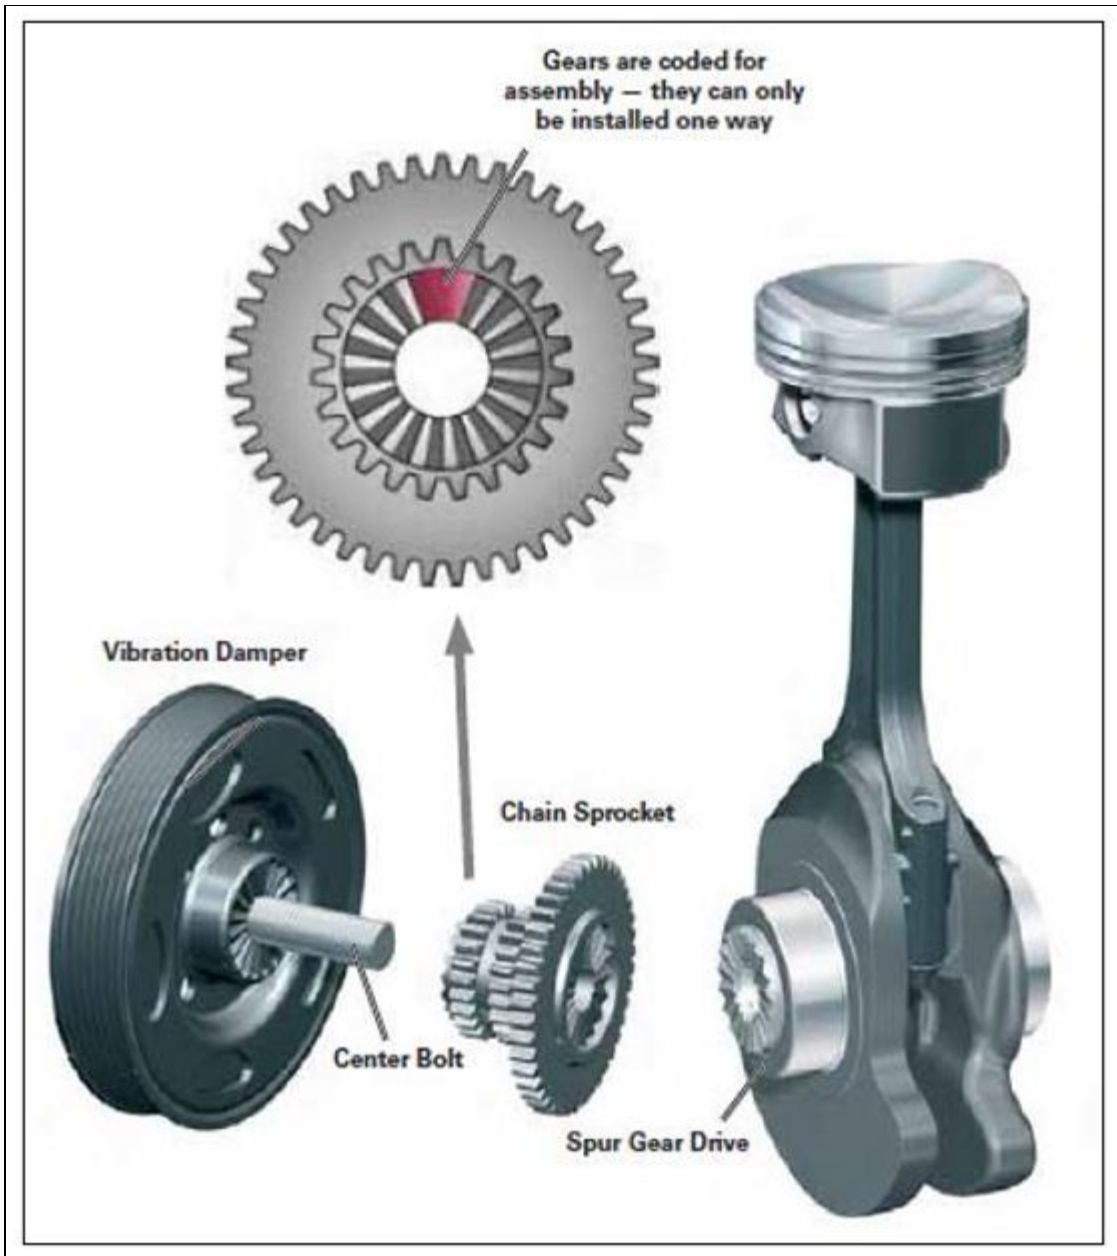
13-13-01 Vehicles with CCTA or CBFA 2.0T TSI Engine – Crank Gear/Timing Chain Service Tip

When servicing the timing chain sprocket or removing the vibration damper, be aware that one bolt holds both the vibration damper (harmonic balancer) and the crankshaft timing chain sprocket to the crankshaft. Once the damper is removed, the crankshaft should not be rotated unless special tool spacer T10368 has been installed. The crankshaft timing chain sprocket and spur gear drive on the crankshaft have a coupling that must be seated correctly during assembly. Failure to install special tool spacer T10368 before rotating engine will cause the engine to skip time and bend valves.
