VW Elsa Newsletter

Edition 116: December 15, 2014

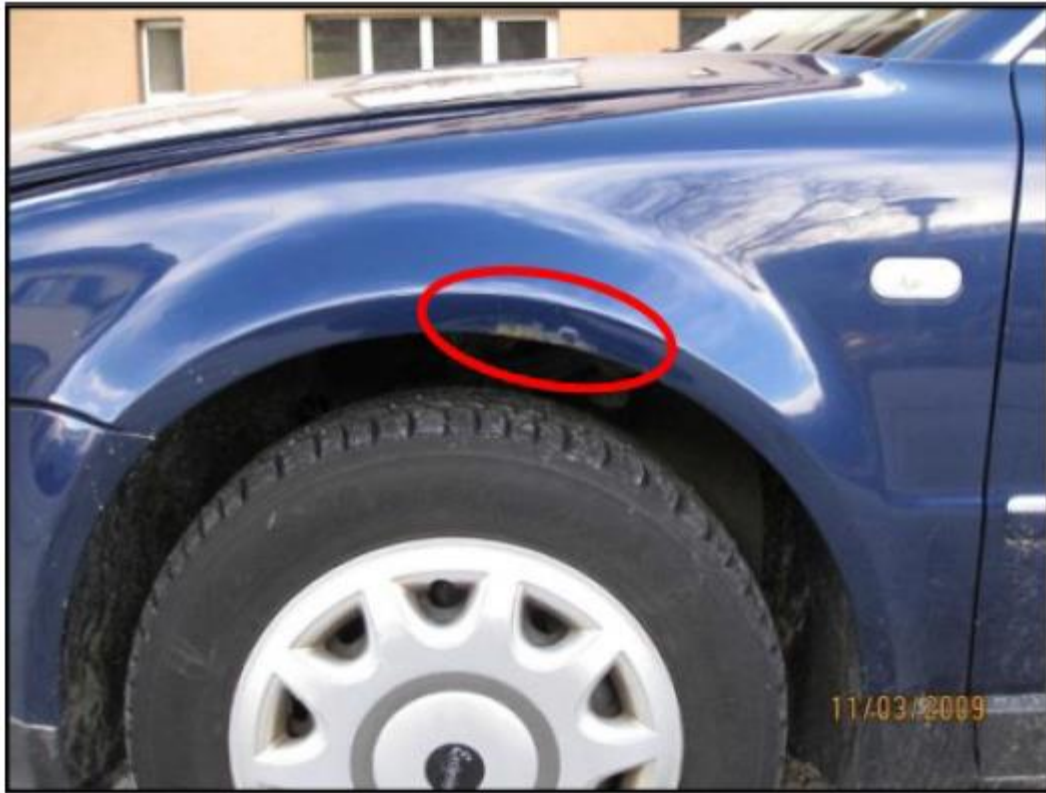
Front Fender - Corrosion on Wheel Arch

Customer states:
Corrosion on the wheel arch area of the front fender (Figure 1).

Figure 1 (corrosion on left wheel arch)

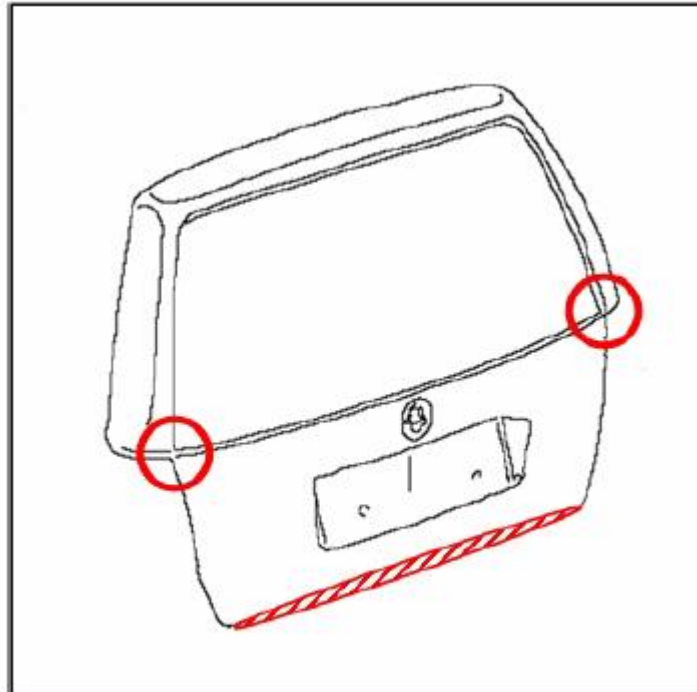
Corrosion in Corner Area of Rear Lid towards Rear Lights

Corrosion in the corner area of the rear lid towards the rear lights (Figure 1).

Figure 1 - Red circles - corrosion on the rear lid

Hatch area - possible fold corrosion on the rear lid

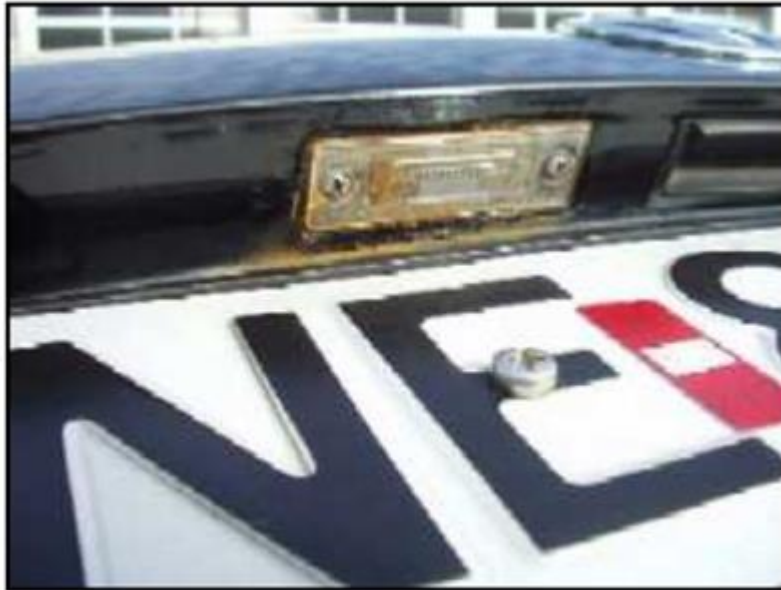
Figure 1 – Corrosion around License Plate Light

Rear lid - edge corrosion in the cut-out sections for the license plate light / handle assembly.

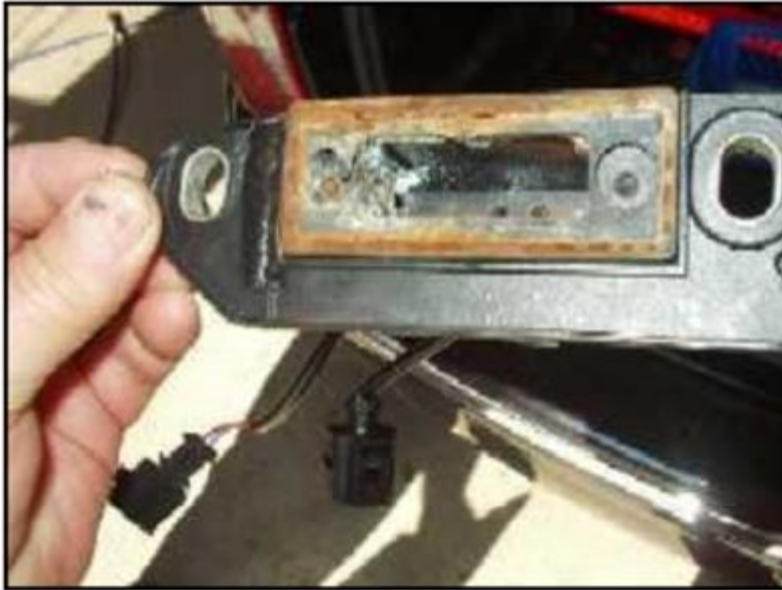
Figure 2 – Corrosion around License Plate Light

Rear lid – corrosion in the contact area (inside and outside) of the license plate light / handle assembly.
