VW Elsa Newsletter

Edition 109: October 27, 2014

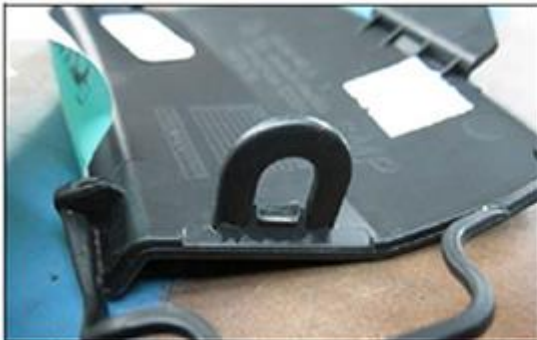
Figure 1.1

63-14-02 Rear Tow Hook Cover Tabs Broken

If the condition is found where the rear tow hook cover tabs are broken as shown in Figure 1.1.

Replace the rear tow hook cover (Part# 5C6807441D 9B9) and verify the part that is being installed is of the current production level (09S) as show in Figure 1.2

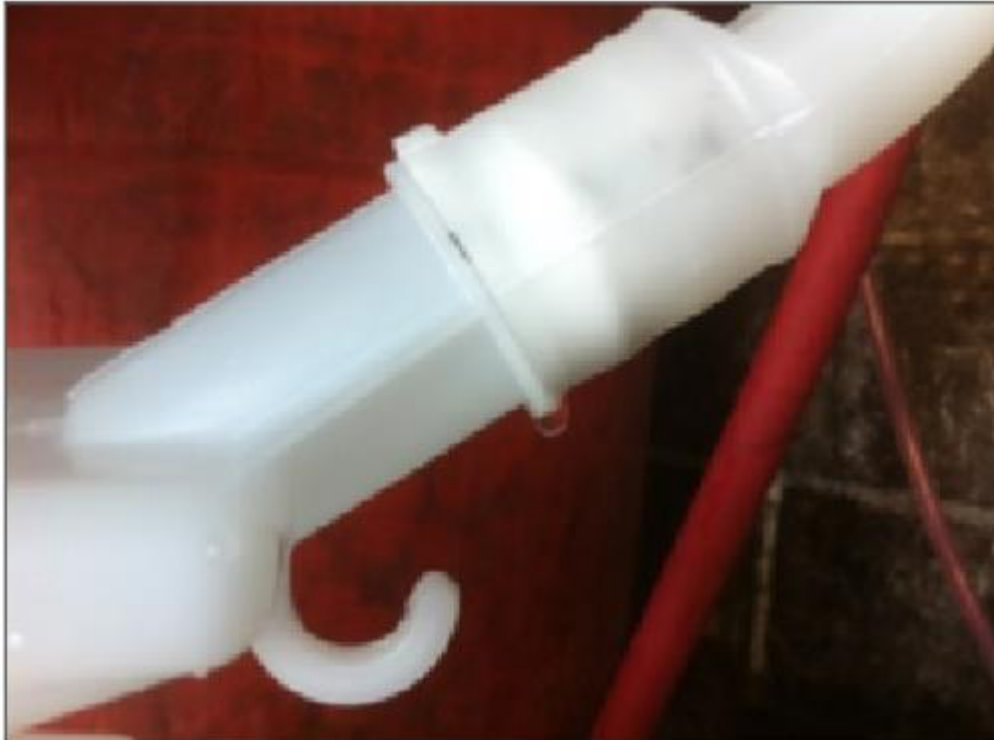
92-14-05 Washer Bottle Replacement due to Leaking at the Filler Pipe Seam

When replacing the washer bottle, DO NOT separate the filler neck assembly from the tank during removal. Please leave all parts together for possible part return and review.
