# WARRANTY BULLETIN

**NO:** D-22-17

**SUBJECT:** 2017 – 2023 (Current) Chrysler  
Pacifica (RU) and 2013 – 2016 Chrysler  
Town & Country/ 2013 – 2020 Dodge  
Caravan (RT) - Corrosion – **Complete  
Hood Panel Warranty Claim  
Simplification (Rev. B)**

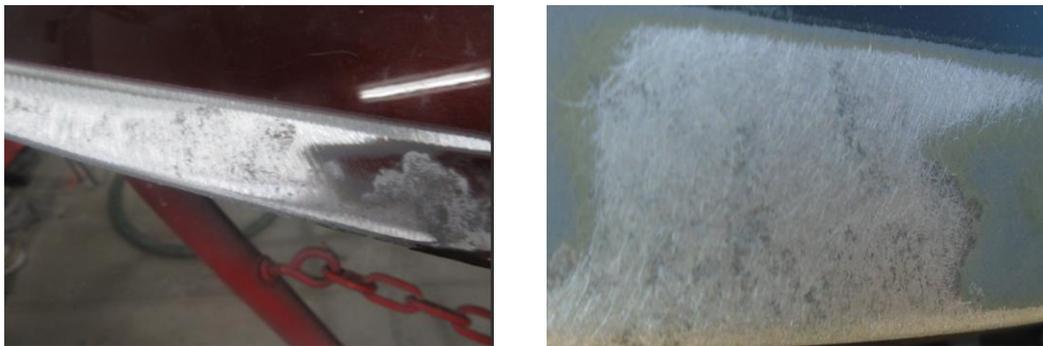
**Perforation/Pitting Found After Sanding Examples (Fig. 1)**

1. Perforation/ Pitting found during the sanding process (Fig. 1)

Note: If pitting is found during the sanding process, please use LOP 23-75-21-01 for up to 0.5 hours in conjunction with the 23-85 replacement LOP.

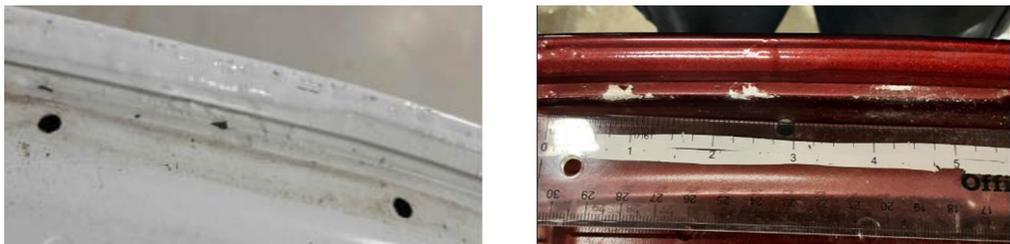
**Hem Flange Area Examples (Fig. 2)**

2. Corrosion found on the Hem Flange on the underside of the hood (Fig. 2)
