<b>HYUNDAI</b> <b>Technical Service Bulletin</b>	<b>GROUP</b> <b>AUTOMATIC TRANSMISSION</b>	<b>NUMBER</b> <b>23-AT-008H-1</b>
	<b>DATE</b> <b>SEPTEMBER 2023</b>	<b>MODEL</b> PALISADE (LX2) SANTA FE (TMA) SANTA FE HYBRID (TM HEV) SANTA FE HYBRID (TMA HEV) SONATA (DN8/DN8A) SONATA HYBRID (DN8 HEV) TUCSON (NX4/NX4A) TUCSON HYBRID (NX4 HEV)
<b>SUBJECT:</b> <p style="text-align: center;"> AUTOMATIC TRANSAXLE (8-SPEED FWD)  POSITION SENSOR DTC P070500, P070512, P070514,  P07051C, P070600, P070661 &amp; P070696 DIAGNOSIS AND  REPLACEMENT </p>

***This TSB supersedes TSB 23-AT-008H to add harness information for Tucson (NX4/NX4A), Step 7.***

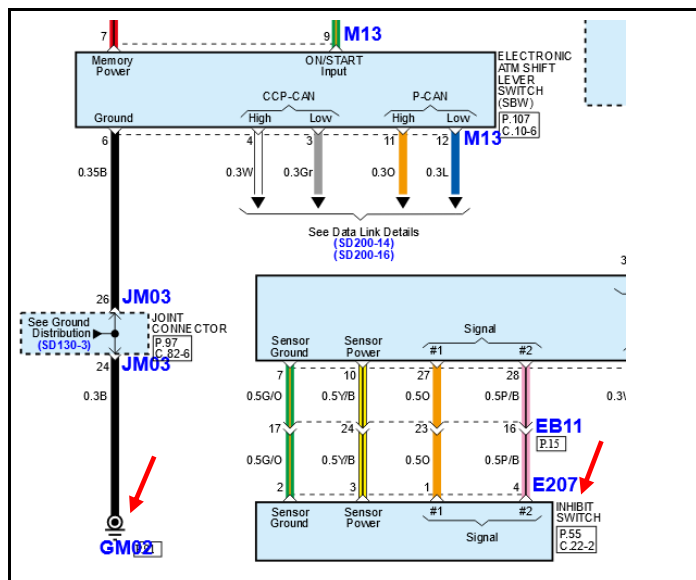
6. Check the grounds for the electronic shift lever. (Refer to ETM, SD450-1).  
Turn the ignition and headlights on. Use a DVOM to check the voltage drop between the wiring terminal and ground.

**Specification: Less than 0.2 V.**

- If more than 0.2V, clean the terminal and bolt threads and tighten the bolt.
- If less than 0.2V, go to Step 7.

**Torque: 7~9 lb-ft, 1.0~1.2kgf.m, 10~12 N.m**

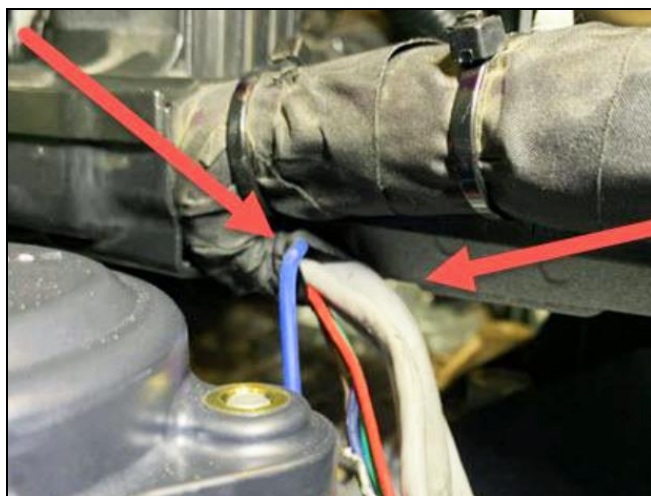
**Santa Fe (TMa) 2.5L – VINs begin with 5NM**  
Carefully unwrap the harness protector in the area shown below. Check the insulation on the wires to see if the insulation has been damaged by contact with the battery tray. If so, repair or replace the control harness.

If replacing the control harness, make sure the replacement harness does not contact the battery tray/other components. Otherwise, the harness may become damaged again.

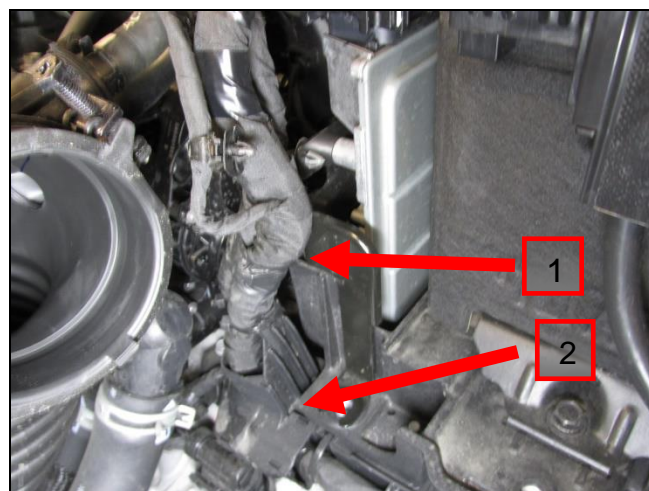
**Tucson (NX4/NX4A) 2.5L –VINs KM8 or 5NM**  
Carefully unwrap the harness protector in the areas shown below:  
1. Check if the insulation has been damaged by contact with the metal bracket.  
2. Check for broken wires in the area of the 90 degree bend in the harness.  
If so, repair or replace the control harness.

Damage to the wiring harness may still be present, even if there is no external damage to the harness protector. Even slight damage to the wiring harness can cause these faults.
