**SERVICE BULLETIN**

**APPLICABILITY:** 23MY Outback/Legacy Models (including Wilderness models)  
 23MY Ascent Models

**NUMBER:** 15-305-22R  
**DATE:** 11/15/22  
**REVISED:** 09/05/23

**SUBJECT:** Reprogramming File Availability for Optimization of Gen 4.5 Denso CP1.5 Infotainment Systems

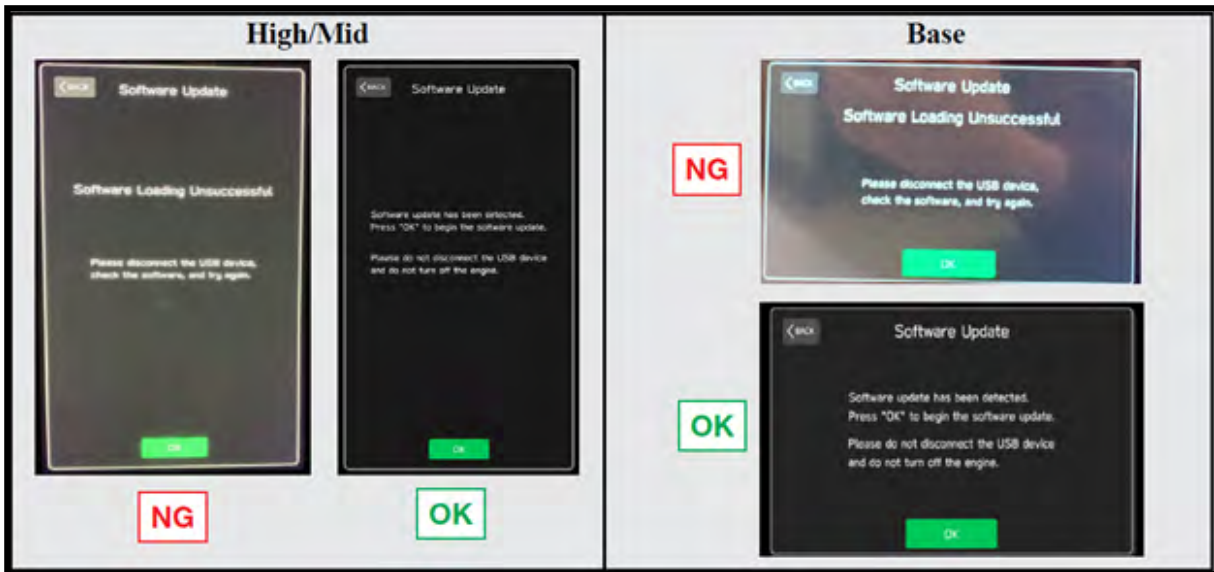
**NOTE:** If after plugging in the USB, the screen displays a **Software Loading Unsuccessful** message, confirm the USB device has been properly formatted and the software on the device matches the system being reprogrammed (example: Base software is being used to update a Base system) and retry.

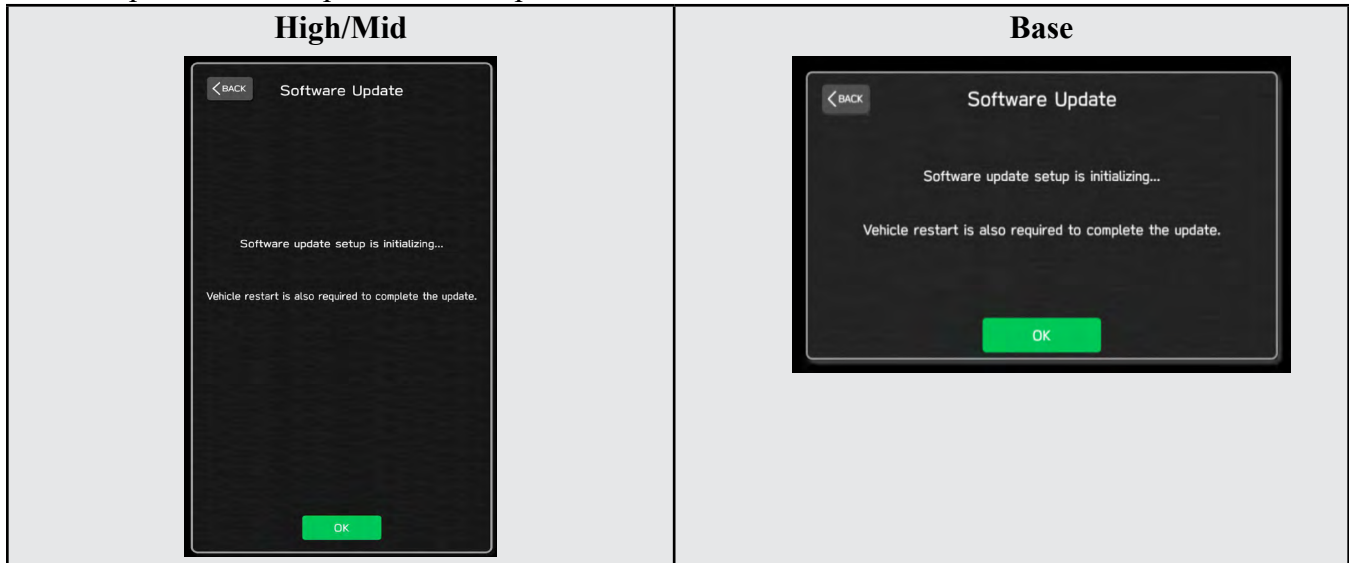
- If the screen shown below appears, **WAIT** for approximately 30 minutes or as long as necessary (waiting for longer than 60 minutes might indicate system malfunction). In that case please perform recovery according to the instructions in “Appendix B” to allow the Software update setup initialization process to complete.

**IMPORTANT NOTE:** If this procedure is required, contact Techline as additional action may be necessary.

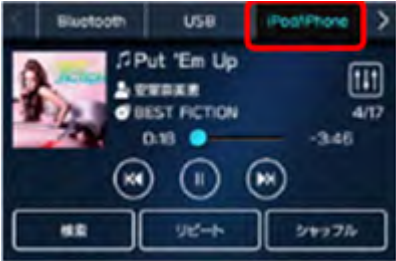
Number	Symptoms to be Improved:
1	iPod/iPhone tab in Media screen cannot be selected, when connected by USB.  The symptom occurs when the iPhone is connected to CP1.5 via Bluetooth in parallel to USB connection by error. (It is supposed to be connected either via Bluetooth or by USB.)
