HYUNDAI Technical Service Bulletin	GROUP CAMPAIGN	NUMBER 23-01-080H
	DATE SEPTEMBER 2023	MODEL SANTA FE (TMA) TUCSON (NX4A)
SUBJECT: AUTOMATIC TRANSMISSION CASTING INSPECTION & REPLACEMENT (SERVICE CAMPAIGN TAS)

Description: This TSB applies to certain vehicles with 8-speed transmissions that may have had a machining operation out of specification that could lead to a higher mileage durability issue regarding the transmission oil pump. Follow the steps listed below to inspect the transmission. Replace the transmission if needed.

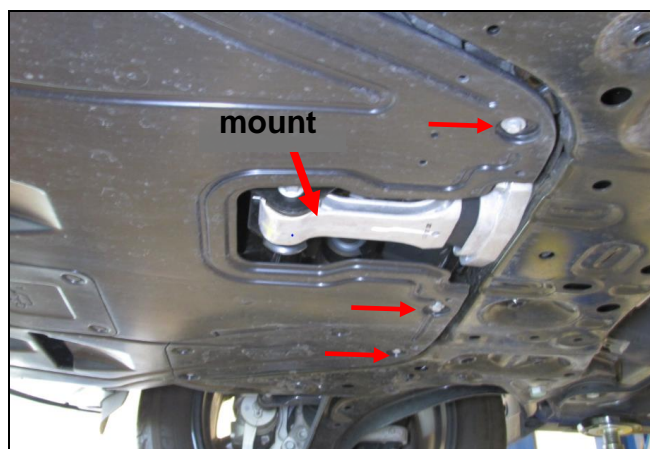
1. Raise the vehicle on lift.
Remove the bolts and remove the undercover.
Inspect the transmission near the transmission torque mount.

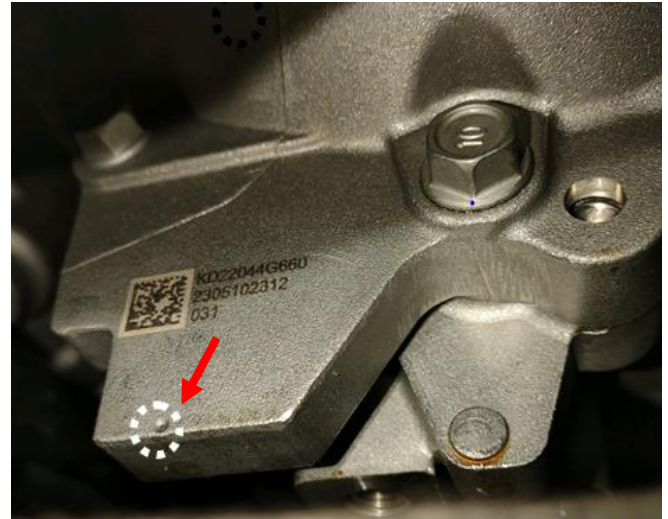
2. Inspect the transmission just below the QR code for a machine mark.

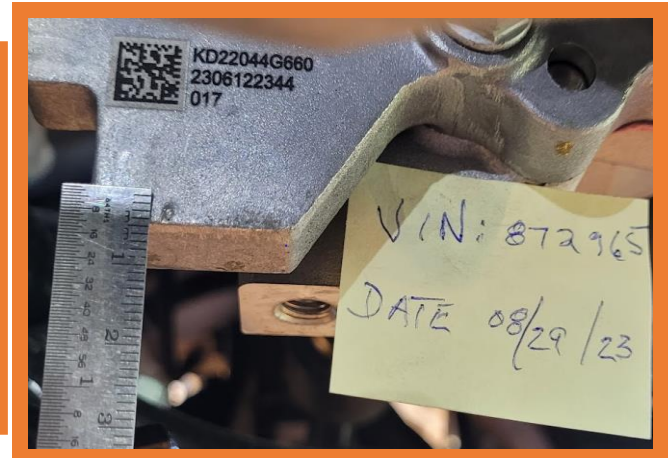
Using STUI, take a photo of the casting mark measuring the distance from the bottom of the tab and the last 6 digits of the VIN and the date of repair on a piece of paper.

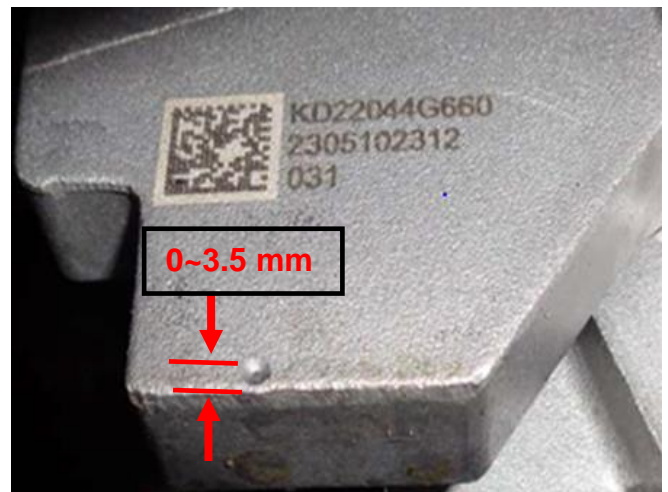
4. **Transmission NG - Must be replaced:**

Mark is **0~3.5 mm (0~9/64")** from the bottom of the tab:

If the stamping mark is round as shown, the transmission must be replaced.

Refer to [hyundaitechinfo: Shop Manual](#) ->
[Automatic Transaxle System](#) ->
[Automatic Transaxle System](#) ->
[Automatic Transaxle](#)->
[Repair Procedures](#)

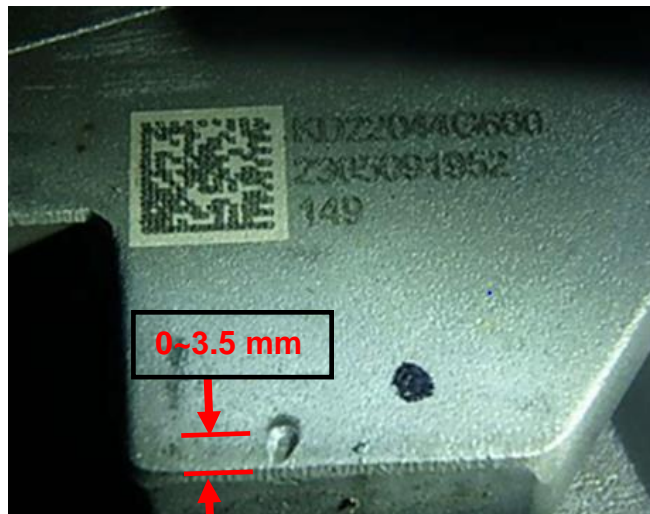
5. **Transmission GOOD - Replacement not needed.**

Mark is **0~3.5 mm (0~9/64")** from the bottom of the tab:

If the stamping mark is not perfectly round, but elongated as shown, the transmission is OK and does not need to be replaced.

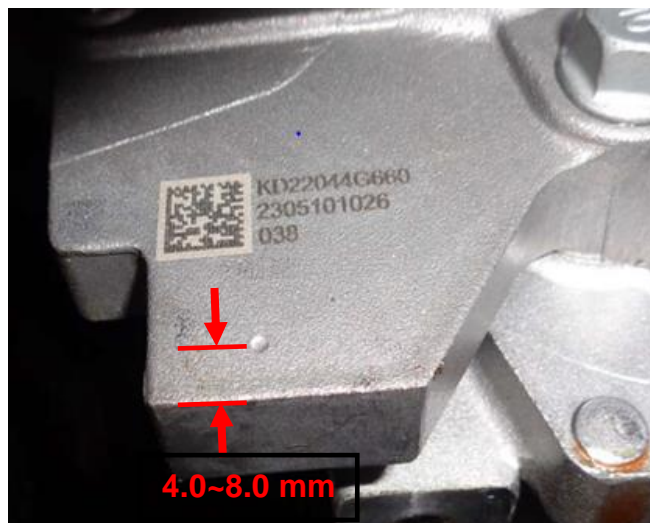
6. **Transmission GOOD - Replacement not needed.**

Mark is **4.0~8.0 mm (5/32~5/16")** from the bottom of the tab:

If the stamping mark is round as shown, the transmission is OK and does not need to be replaced.
