SERVICE BULLETIN

APPLICABILITY: 2019-22MY Ascent
 2020-22MY Legacy & Outback 2.4L Turbo

NUMBER: 16-136-22R

SUBJECT: Vibration & Possible Judder Concern on Turns Under Acceleration

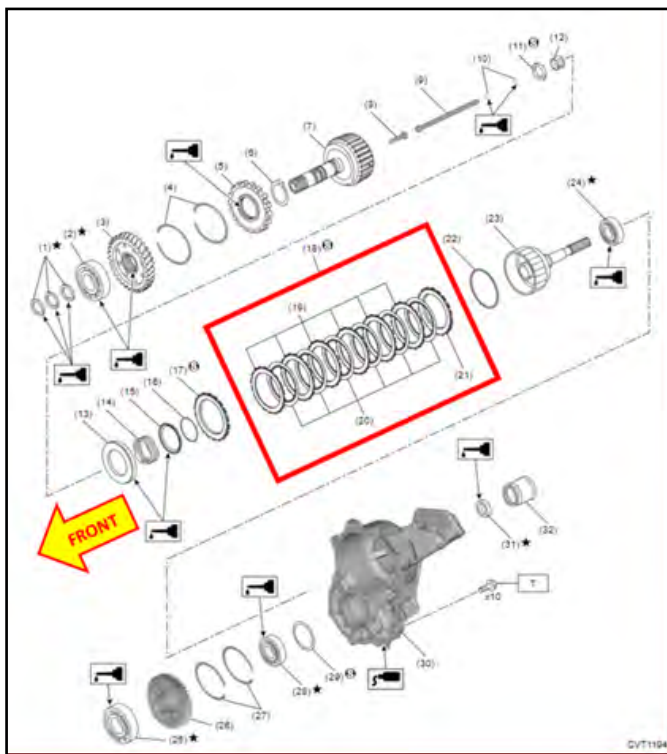
There is a specified sequence of assembly for the Driven Plates (19) and the Drive Plates (20).

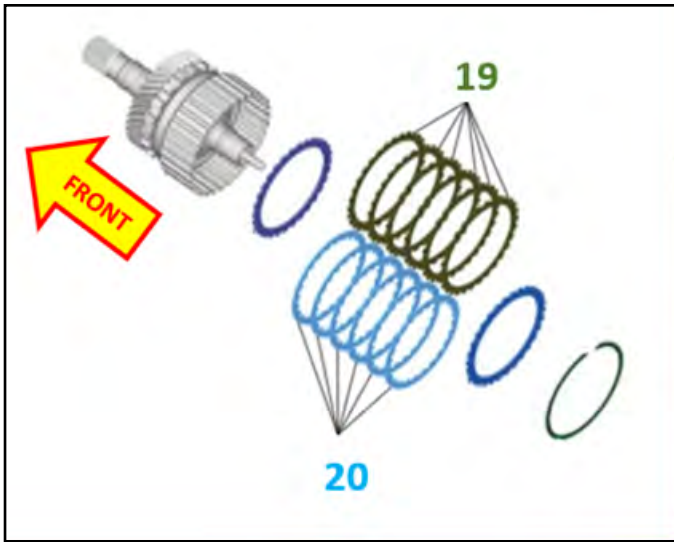
As per the applicable Subaru Service Manual, assembly of the Plates must start with the external toothed Driven Plates (19) and then alternately assembled with the internally toothed Drive Plates (20).
