Model Year 2017, 2018 - US17 GHG Common Rail Fuel System Component Electrical Faults

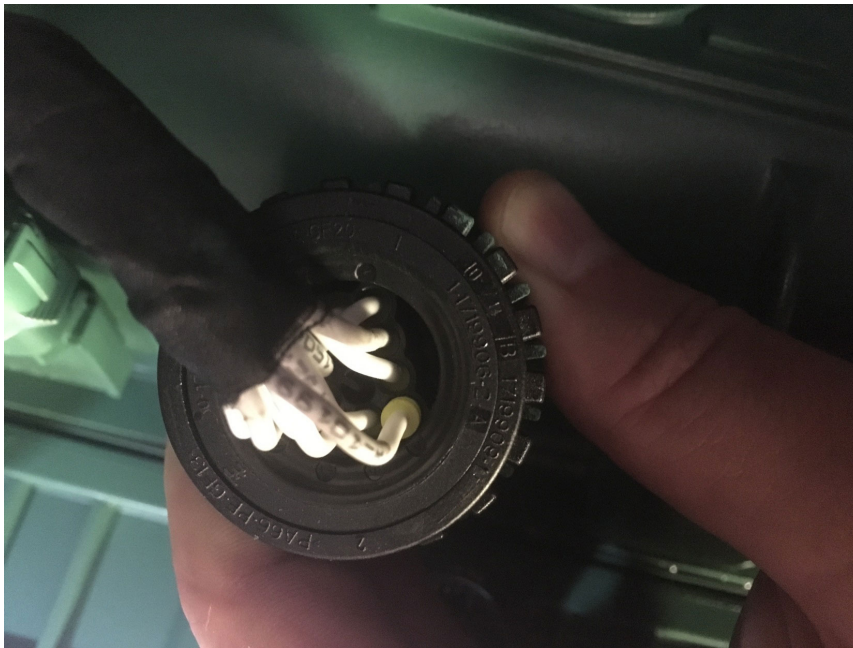
Follow Guided Diagnostics for any of these components with associated electrical faults. However, the cause for some of these faults has been identified with terminals not locked properly in place on the VCI 1 and VCI 2 connector. The VCI connectors are located on the lower valve cover base. The plastic wire cover on the connector should be removed for better visual inspection. This is an area where special attention should be taken to inspect for an issue.

Picture below of plastic wire cover on the VCI connectors.

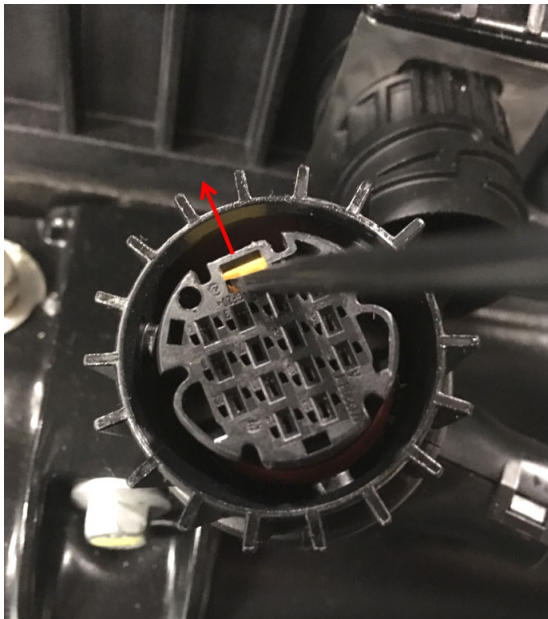
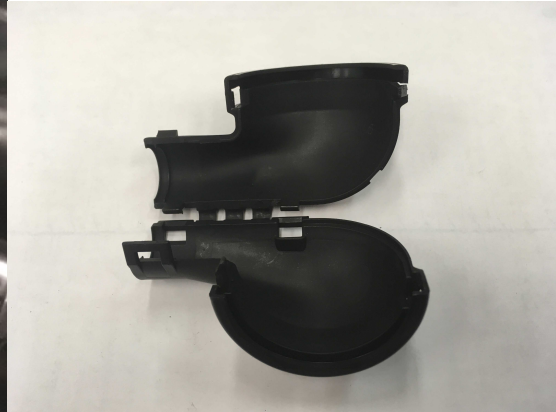
Examples of terminals not properly locked in the VCI connectors causing electrical faults. See pictures below

Remove terminal completely from the VCI connector and inspect the locking tab. (see picture below) If the tabs are ok reinsert the terminal in the VCI connector and pull on wire with steady force to ensure positive lock of the terminal. Push the yellow lock tab back down when completed.

NOTE: If terminal will **NOT** properly lock in the VCI connector, the external engine harness will **NEED** to be replaced.
