# TECHNICAL SERVICE BULLETIN

## 1.5L - Hissing Noise From Rear Liftgate Area When Driving Straight Between 35-50 MPH (56-80 Km/h)

**23-2298**

<b>Ford</b> 2021-2023 Bronco Sport	Engine: 1.5L Built on 24-Jul-2021 and through 31-Aug-2023
---------------------------------------	--

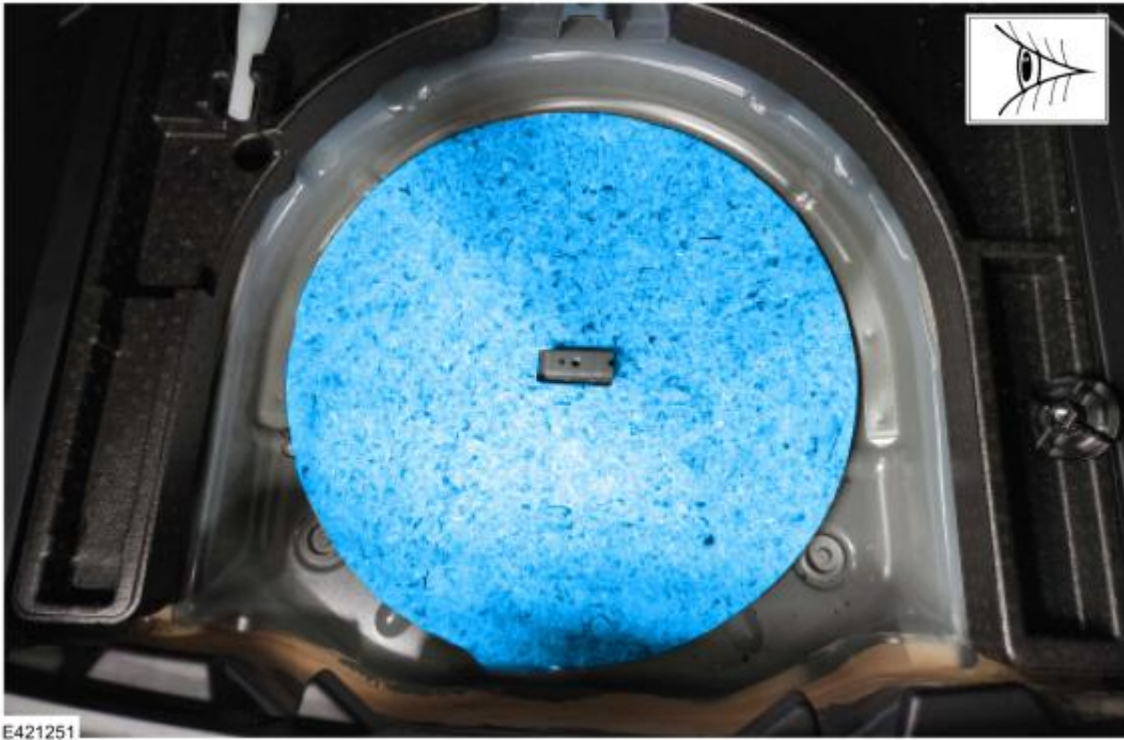
Figure 3

**Issue:** Some 2021-2023 Bronco Sport vehicles equipped with a 1.5L engine built on 24-Jul-2021 and through 31-Aug-2023 may exhibit a hissing noise from rear liftgate area when driving straight between 35-50 mph (56–80 km/h). This may be due to the absence of the rear floor insulator located in the spare tire compartment. To correct the condition, follow the Service Procedure to install a rear floor insulator in the spare tire compartment.

6. Install the rear floor insulator. (Figure 3)
