**718 GTS 4.0 - Brake Booster (Power Brake) Warning in Instrument Cluster**

**Vehicles Affected**

Models	Model Year	Model Type	VIN Range	Vehicle-Specific Equipment
718	2021 - 2024	982160 982360 982370	n/a	n/a

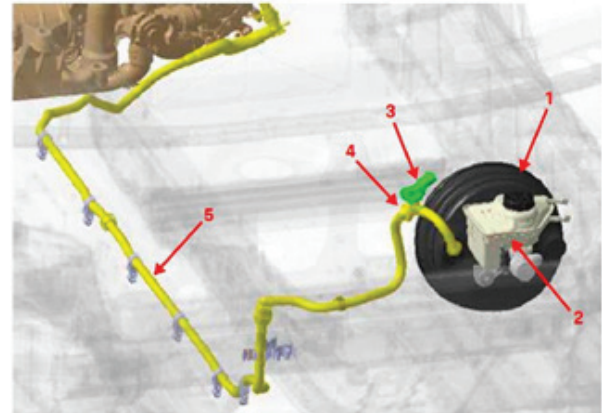
The value of the vacuum line pressure sensor (3 in Figure 1 below) upstream of the brake booster is stored immediately after Terminal 15 is activated. The value is recorded again after 1.5 seconds. Fault P055600 sets if the difference between the two values does not meet or exceed the threshold defined by the DME.

Although this fault is possible at any altitude, it is more likely to occur at higher altitudes due to the lower ambient pressure.
