BOSE Poor Sound Quality

Models	Model Year	Model Type	VIN Range	Vehicle-Specific Equipment
911	As of 2022 up to 2024	992	N/A	9VL (BOSE® Surround Sound System)

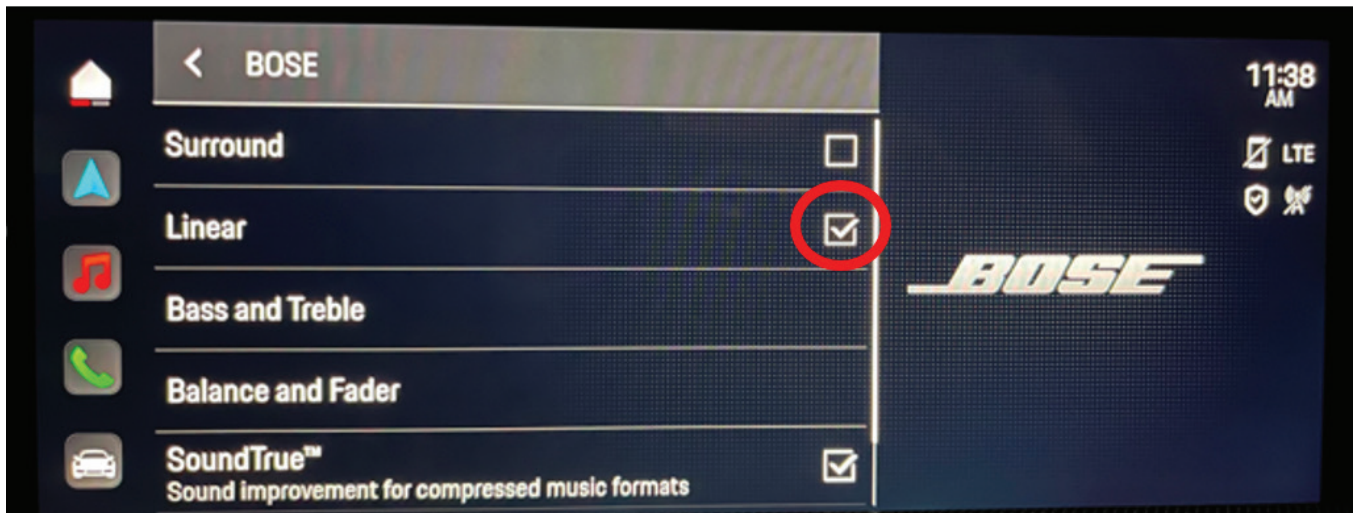
Figure 1 - BOSE settings

Due to too tight tolerances in the woofer (**BOSE**), there is friction occurring internally of the speaker. To alleviate the internal collisions of the woofer, it is advised to change the sound system setting of “**Linear**” to on/checked within the PCM.

1. Verify the sound system is **BOSE**.
2. Using GFF, verify the concern is isolated to the specified conditions described above.
3. In sound system settings, check off "**Linear**" (Reference Figure 1).
4. Check sound quality of audio system.
