Technical product information

Topic	HVAC distribution/operational issues - HVAC Motor defect DTC's logged
Market area	Australia E04 Bentley rest Asia and Australia (6E04),China 723 Volkswagen (Anhui) Automotive CO (6723),China 796 VW Import Comp. Ltd (Vico), Beijing (6796),Germany E02 Bentley rest Europe (6E02),Japan E03 Bentley Japan (6E03),Korea, (South) E08 Bentley South Korea (6E08),United Arab Emirates E06 Bentley Middle East and Africa (6E06),United Kingdom E01 Bentley UK (6E01),United States E05 Bentley USA and rest America (6E05)
Brand	Bentley
Transaction No.	2051519/12
Level	EH
Status	Approval
Release date

- HVAC distribution/operational issues
- HVAC motor defect (DTC's) evident within address 08 - Climatronic control unit, the DTC's can be static or Intermittent

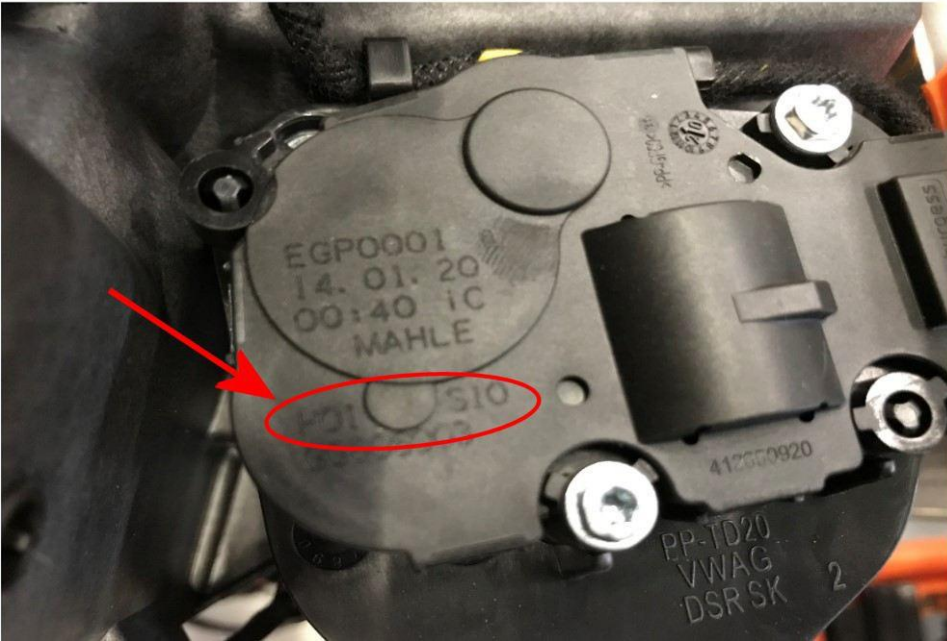
Figure 1 (Bentayga) and Figure 2 (New Continental GT/GTC and New Flying Spur) show motors with Hardware H01 and Software S10, these motors do not require replacement unless they are faulty

Any motors which can ONLY be accessed after the dashboard assembly/Head up display unit and/or HVAC unit have been removed AND are identified as not having Hardware H01 and Software S10 MUST be replaced. This instruction must be followed to avoid a repeat repair. A repeat repair would result in the dashboard assembly/Head up display unit and/or HVAC unit requiring removal again which must be avoided
