**Subject:** 3944061 - Incorrectly modified Studed Flange Cap Screw

09/15/2023: Incorrectly modified Studded Flange Cap Screw P/N : 3944061

STATUS: Open

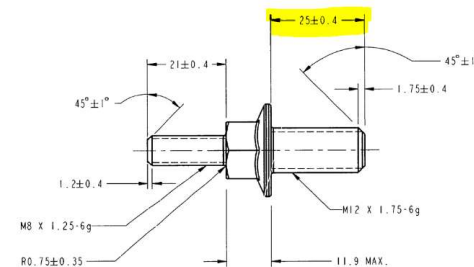
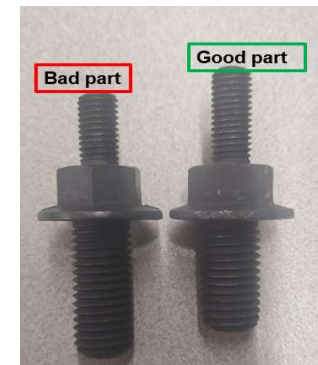
- Engine received with incorrect studded flange cap screw length causing interface issues at the OEM site. (P/N:3944061)
- Incorrect cap screw led to OEM not being able to install the bracket
- Approved waiver for P/N 3944061 allowed the supplier to ship an alternative cap screw in a modified condition due to shortages with the original part.
- Original P/N 3944061 is an M12 X 1.75X **25** / M8 X 1.25 X 21 Hexagon Double Ended Flange Stud – Class 8.8 – Zinc/ Phos c/w Felpro Coating
- Proposed one is M12X 1.75X **30**/ M8 X 1.25X 21 Hexagon Double Ended Flange Stud– Class 8.8 –Zinc /Phos c/w Felpro Coating. Supplier was supposed to modify to make it to 25 mm.

- M8 side of the studded flange cap screw being short could cause issue with the installation/assembly of the part at OEM.
- M12 side of the studded flange cap screw being longer would lead to the screw bottoming out while installing the lifting bracket bolt in a blind hole which could lead to **safety critical issue**.

- Supplier modified the M8 end of the studded flange instead of M12 end.
  - Lead to less threads available to assemble the parts at OEM on M8 side
- Lead to longer length on the M12 side by 5 MM.
  - Will result in bottoming out the studded flange cap screws.
  - Less clamp load resulting in safety related issues.

- RMEP onsite techs to perform the inspections and replace, if necessary, the studded flange cap screw for affected options while prioritizing lifting bracket options (LA 9241, LA 9242, LA 9353, LA 9805, LA 9730). – start on 09/19/23
- Provide the work instructions to onsite techs for the inspection and rework for replacing the incorrectly studded flange cap screws.- start on 09/19/23
- Replacement parts to be sent out to the techs to support the containments. – starting 09/15/2023. Target completion date : 09/20/23
