GLOBAL SAFETY FIELD INVESTIGATIONS
DCS6688
URGENT - DISTRIBUTE IMMEDIATELY

Subject: REVISION: N222375790-08 - Customer Satisfaction Program
Park Assist Retrofit
Population Update

N222375790 Park Assist Retrofit

Revision: 08

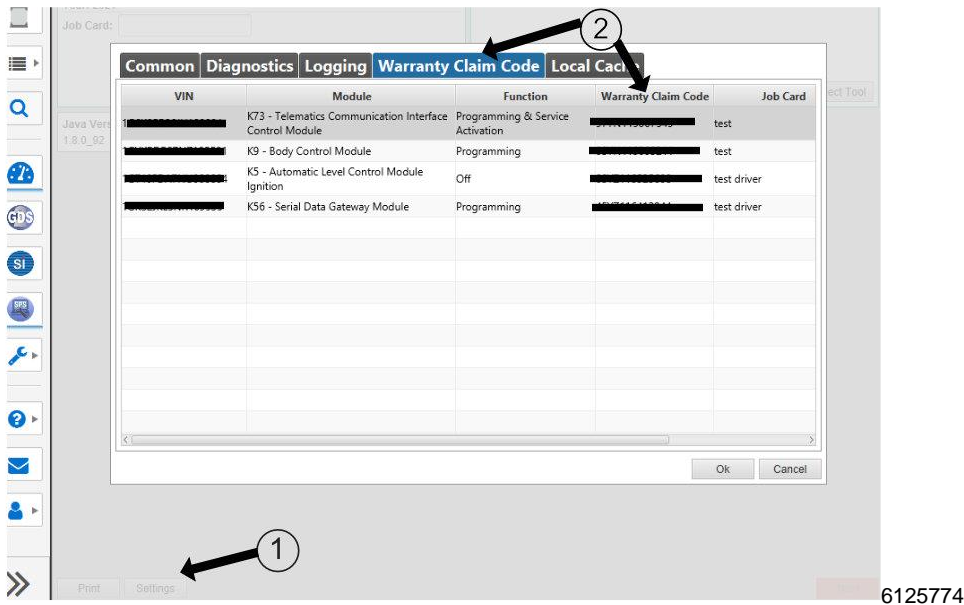
Warranty Claim Code Information Retrieval

If the Warranty Claim Code was not recorded on the Job Card, the code can be retrieved in the SPS2 system as follows:

1. Open TLC on the computer used to program the vehicle.
2. Select and start SPS2.
3. Select Settings (1).
4. Select the Warranty Claim Code tab (2).

The VIN, Warranty Claim Code and Date/Time will be listed on a roster of recent programming events. If the code is retrievable, dealers should resubmit the transaction making sure to include the code in the SPS Warranty Claim Code field.

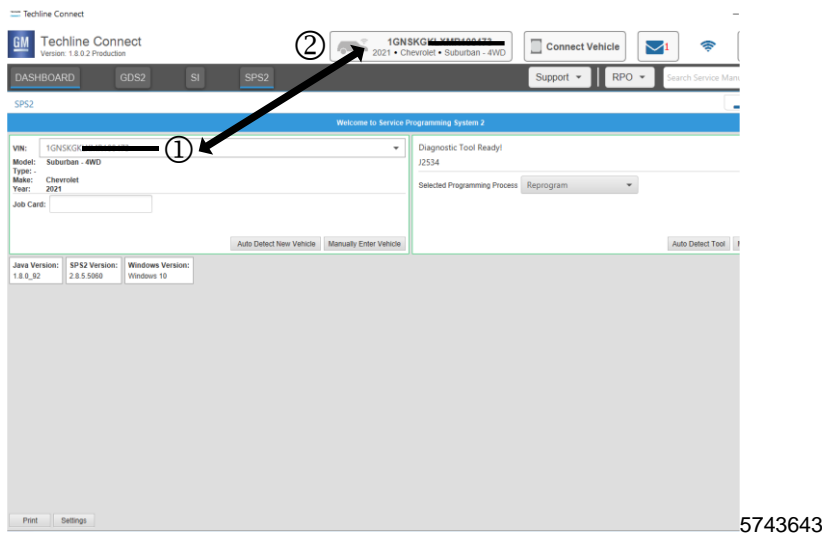
Caution: Be sure the VIN selected in the drop down menu (1) is the same as the vehicle connected (2) before beginning programming.

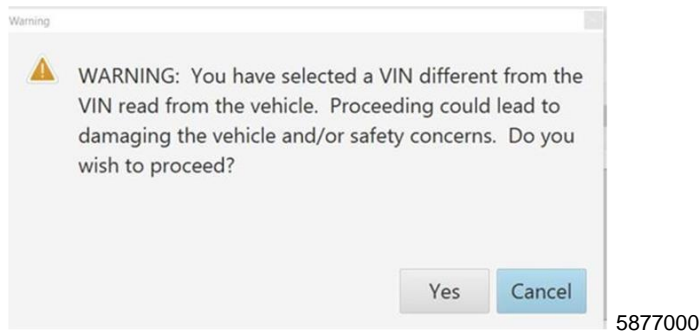
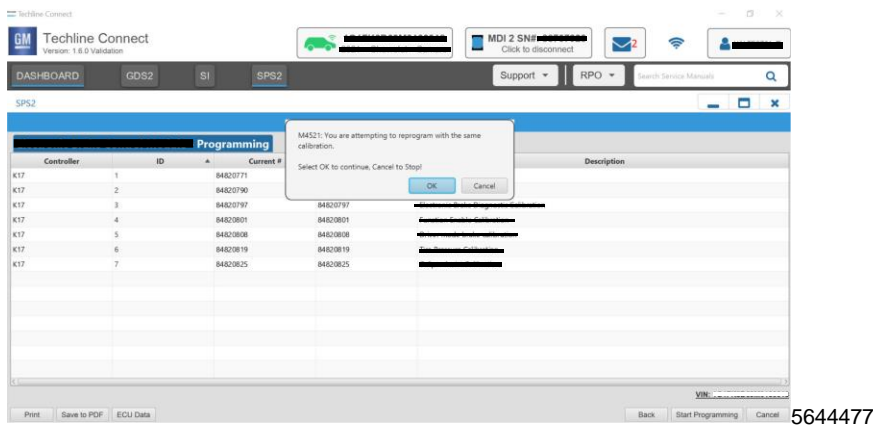
Important: If the vehicle VIN DOES NOT match, the message below will be shown.

Important: Techline Connect screens shown above.

Important: If the same calibration/software warning is noted on the TLC Summary screen, select OK and follow screen instructions. After a successful programming event, the WCC is located in the Service Programming System dialogue box of the SPS Summary screen. No further action is required. Refer to the Warranty section of the bulletin.
