GROUP	MODEL
ELE	2023MY Forte (BDm) w/ AVN5W
NUMBER	DATE
312	October 2023

TECHNICAL SERVICE BULLETIN

SERVICE ACTION: VOICE RECOGNITION DATABASE UNMATCHED SOFTWARE UPDATE (SA545)

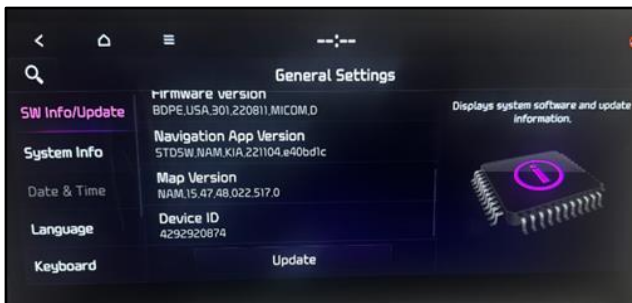
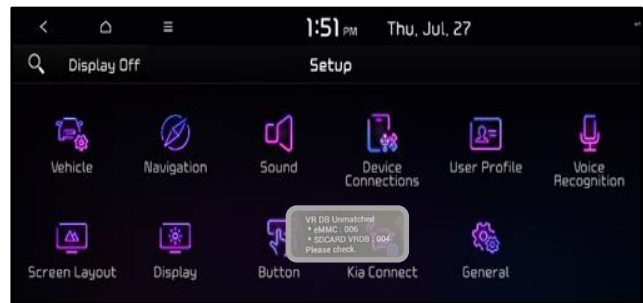
This bulletin provides information to update the navigation and map software on certain 2023MY Forte (BDm) vehicles equipped with 5th Generation AVN wide head units, produced from August 21, 2023 through August 26, 2023. When pressing the Voice Recognition 'VR' button on the steering wheel, a pop-up message 'VR DB Unmatched Please check.' may be displayed on the AVN screen. Follow the procedure outlined in this publication to update the navigation and map software on 5th Generation AVN wide units using the applicable USB Flash Drive B. Before conducting the procedure, verify that the vehicle is included in the list of affected VINs.

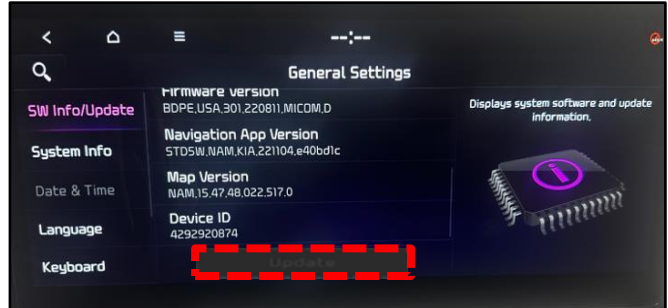
Note: If the USB Flash Drive is not recognized, the 'Update' button will not be activated, as shown. If this occurs, remove the USB Flash Drive, and repeat steps 3-7.

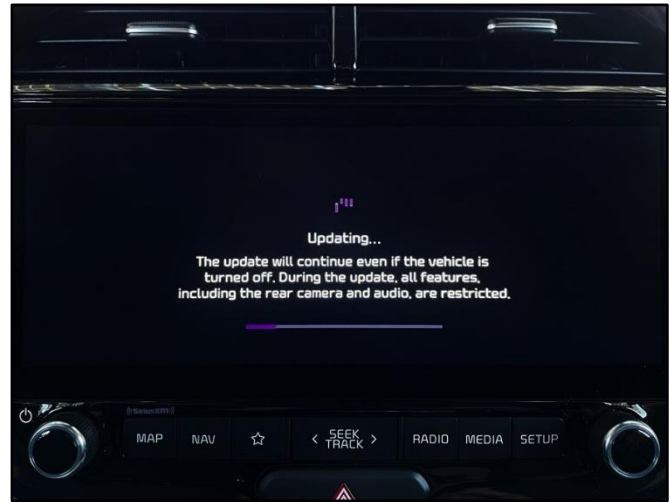
There will be multiple occurrences where the Kia logo will appear, the display will be black during the update process and/or display "Preparing System Update" for an extended period of time. This is normal.
