# Technical Service Bulletin

## 60 Panoramic sunroof opening outer perimeter seal is loose

60 23 68 2063187/4 October 9, 2023. Supersedes Technical Service Bulletin Group 60 number 23-64 dated March 31, 2023, for reasons listed below.

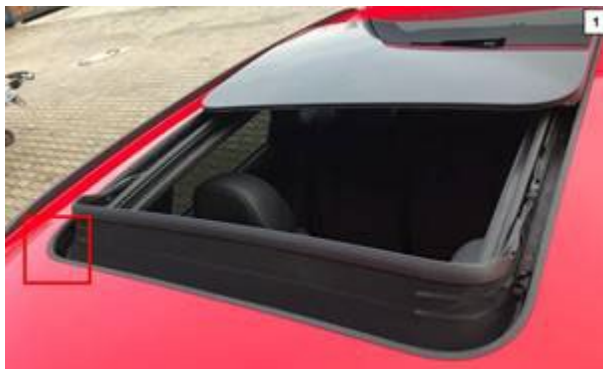
*Figure 1. Front sunroof panel open.*

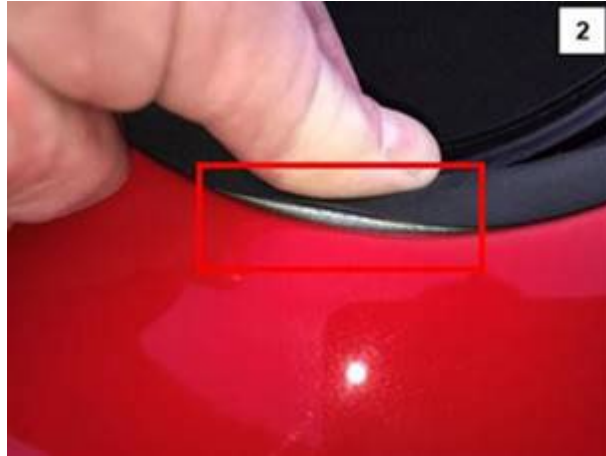
2. Press the seal downwards and inwards with your fingers until the adhesive tape for the seal is visible (Figure 2). The foam adhesive tape may be stretched but it must not be loose or detached from the roof panel to any degree.

**Figure 2.** Checking the adhesion quality.

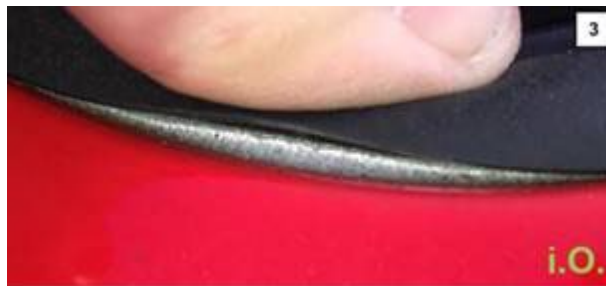
3. Figure 3 shows a properly adhered adhesive band.

**Figure 3.** A properly adhered perimeter seal.

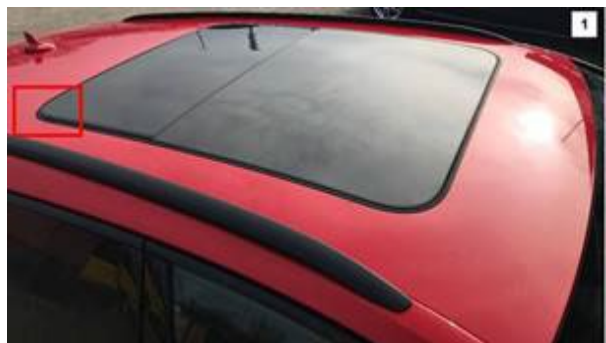
**Figure 4.** Begin inspection of the rear portion of the perimeter seal.

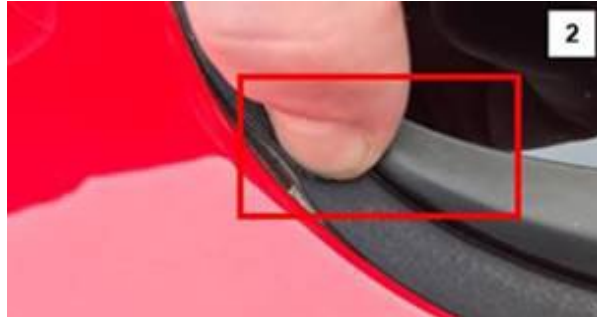
6. Figures 5 - 8 clearly show that the adhesive tape has come loose from the vehicle body. The obvious color and shape difference at the point of contact revealing the gaps is evidence of detachment.

**Figure 5.** Clear evidence of adhesive detachment.

8. The locations where the adhesion is compromised or has failed is a possible entry point for water into the cabin. The area directly below these openings is outside the area of the sunroof drainage. If any adhesion is found to be compromised or failed to any extent replace the sunroof opening perimeter seal. Follow the procedure in ElsaPro explicitly to ensure proper seal adhesion paying particularly close attention to the adhesion surface preparation.
9. Remember to set the sunroof panel and rollershade end stop adaptation after reassembly using the sunroof panel and rollershade switches. Refer to TSB 2054505: *60 Sunroof glass panel or sunroof rollershade do not operate* for instructions.

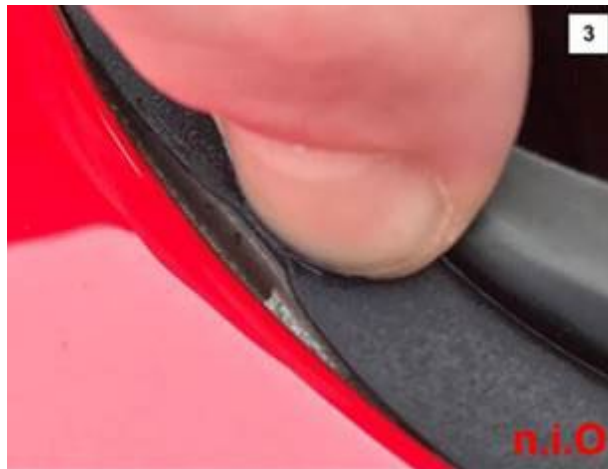
7. A gap in the attachment is revealed in the examples in Figures 5 - 8.

**Figure 6.** Seal adhesive band detachment revealed.

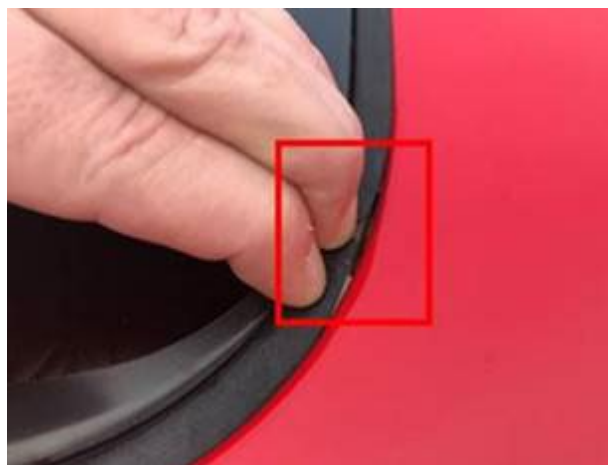
**Figure 7.** Adhesive band detachment.

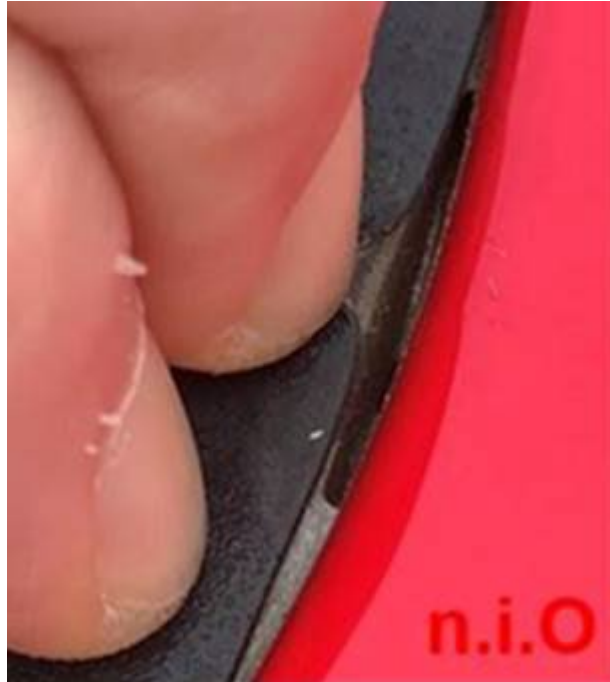
**Figure 8.** Close-up view of the detachment area from Figure 7.
