**93-23-06 - Service Information, HV-Connector Wrapped in Adhesive Tape**

Release date: 10/5/2023

Applicable Vehicles					
Model(s)	Year	Eng. Code	Trans. Code	VIN Range From	VIN Range To
ID.4	2021 - 2024	All	All	All	All

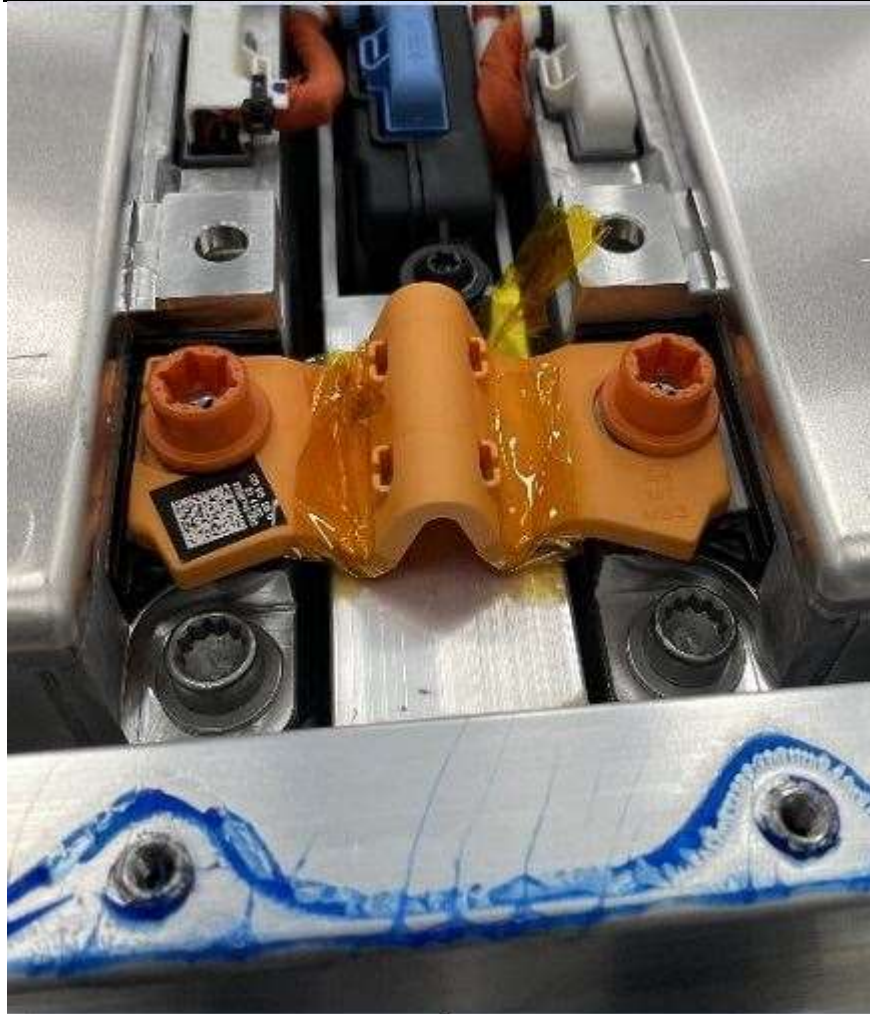
As part of a repair, the high-voltage battery was opened. During this repair it was found that one of the high-voltage connectors is wrapped with an adhesive tape (see Figure 1).

Figure 1. High-voltage connector wrapped in adhesive tape

The adhesive tape serves to improve the dielectric strength (insulation). Therefore, the adhesive tape must not be removed under any circumstances.

The adhesive tape has been intentionally applied and must not be removed!

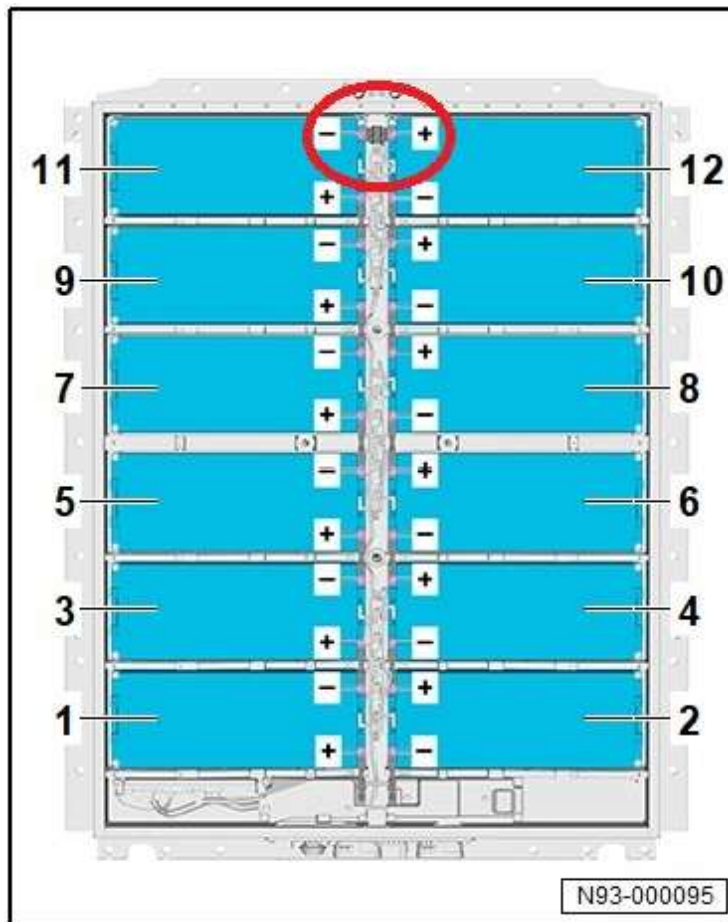
The high-voltage connector that is wrapped with adhesive tape is positioned opposite the coolant connections of the high-voltage battery (see Figure 2).

Figure 2. High-voltage connector is positioned opposite the coolant connection.
