Technical Service Bulletin

93 DTCs P0C4A00, P2B2800 and/or P0CFF00 Stored in the Hybrid Battery Management control unit

93 23 31 2068363/4 October 2, 2023. Supersedes Technical Service Bulletin Group 93 number 23-06 dated May 9, 2023 for reasons listed below.s

Model(s)	Year	VIN Range	Vehicle-Specific Equipment
Q4 e-tron, and Q4 Sportback e-tron	2022 – 2024	All	Not Applicable

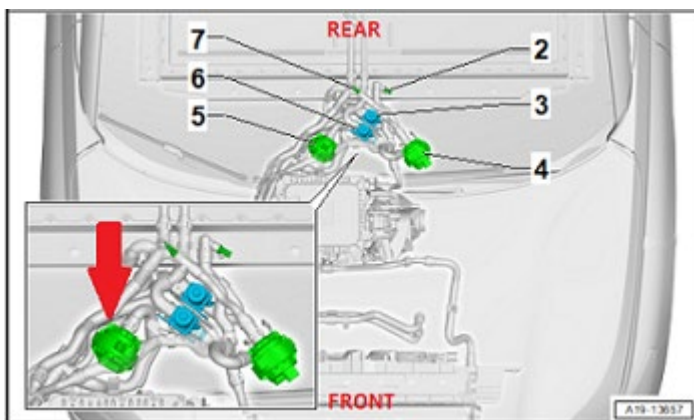
Figure 1: V590 location.

- The coolant pump (V590) must be replaced according to the Workshop Manual.
